Cause for the Water Leak from a Top Plate of a Tank at B South Area in Fukushima Daiichi NPS and the Leak Prevention Measures

December 6, 2013

Tokyo Electric Power Company

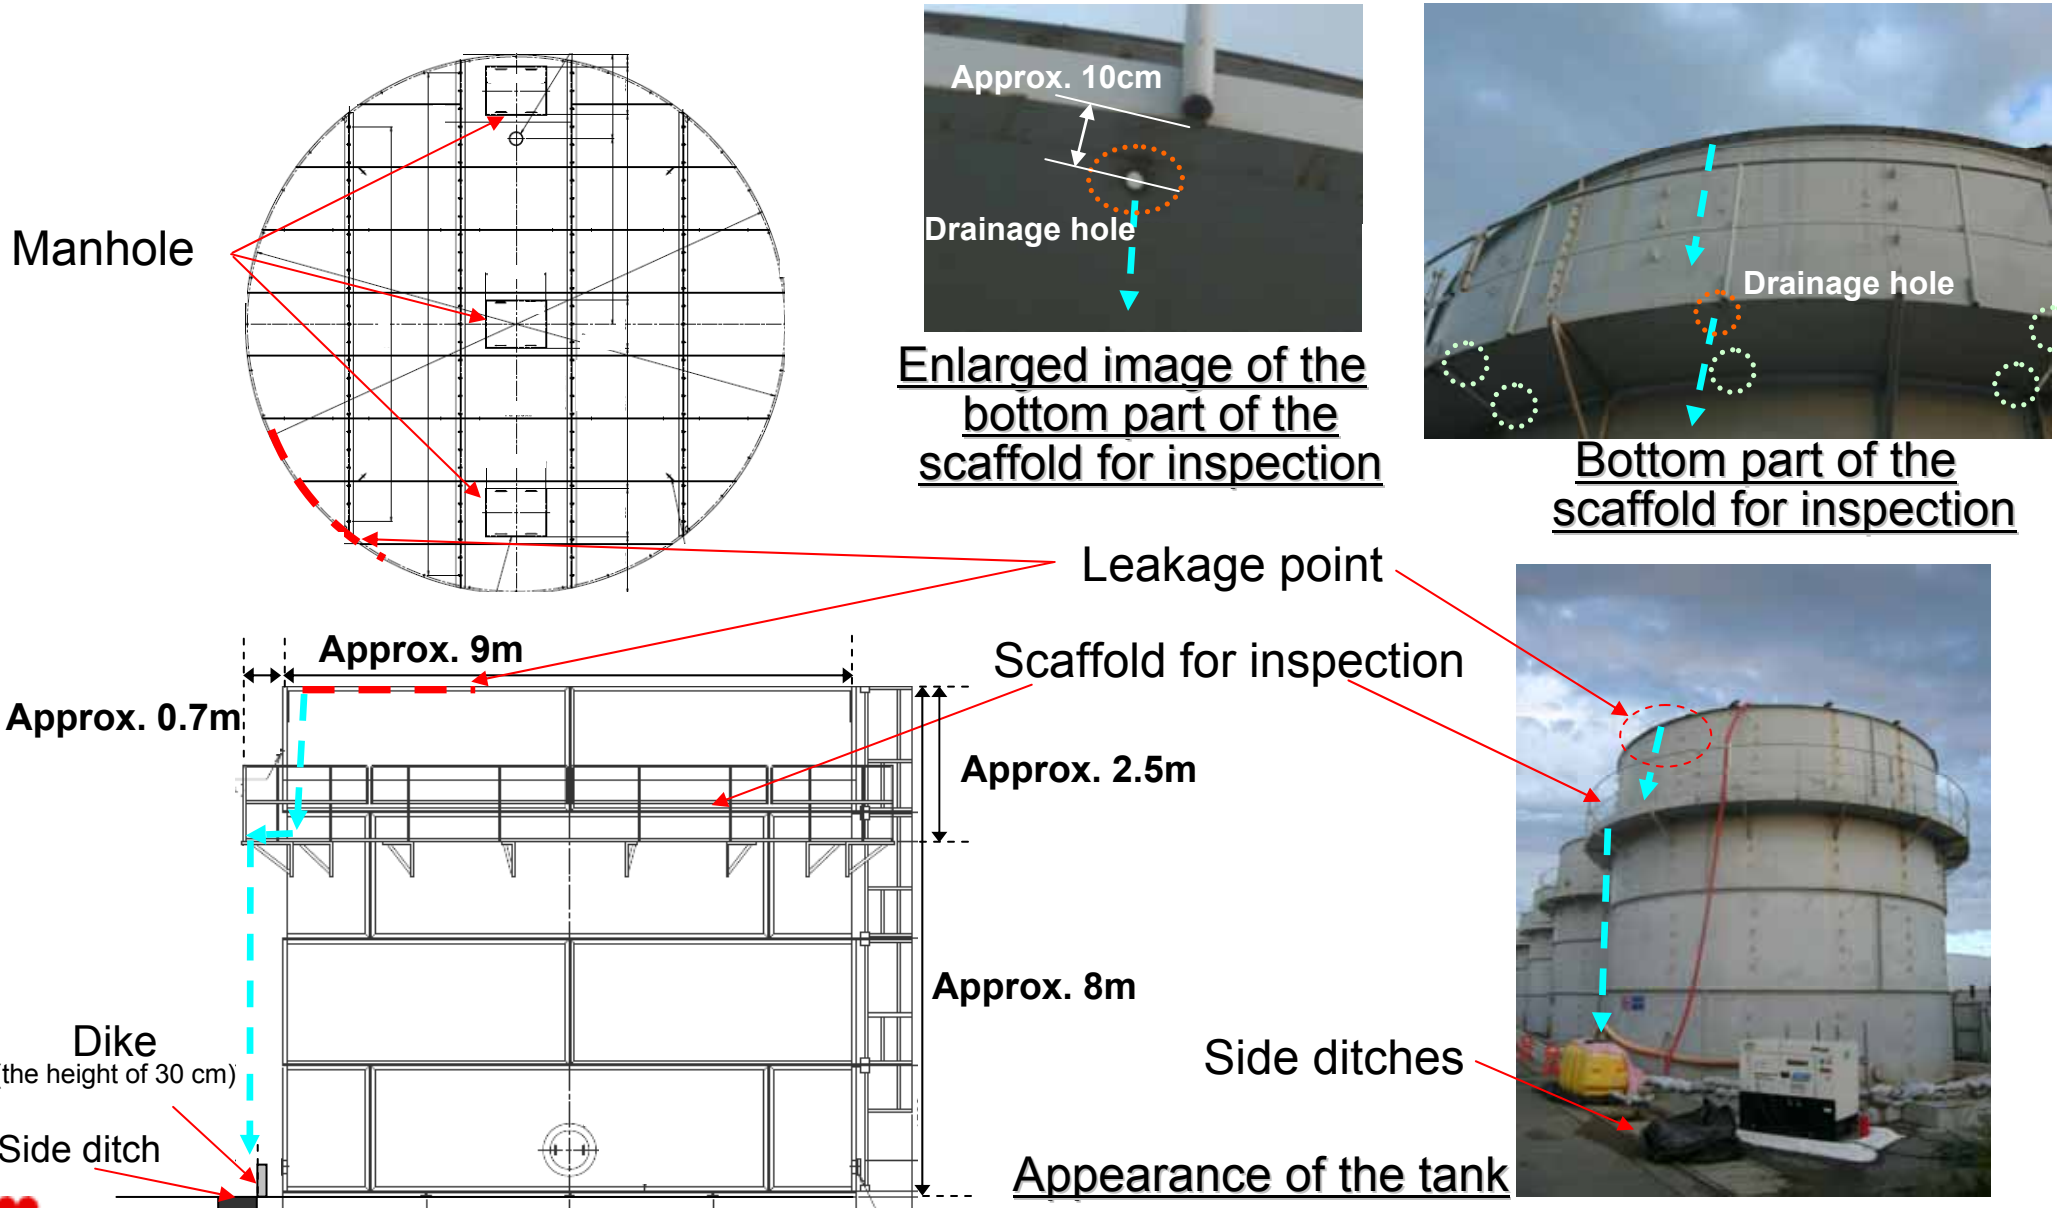
Leakage points at B-A5 tank

- On October 2, 2013, a TEPCO employee found 1) a water leak from around the top plate of a tank located on the east end (B-A5) at B south tank area, and that 2) a part of the leaked water leaked outside the dike in B south tank area via a drainage hole for discharging rainwater at the bottom of a scaffold installed for inspection, when pumping up the rainwater accumulated inside the dike surrounding each tank area where contaminated water was stored.

- Estimated amount of leak: Approx. 17m³ (inside the dike)
Approx. 430L (outside the dike)
 - We found that the leaked water was the RO treated water stored inside the B-A5 tank, after analyzing the leaked water inside the dike at the area*.

- Most of the RO treated water leaking from B-A5 tank leaked inside the dike at B south tank area via a chink between a tank side plate and a scaffold. Some of the water leaked on the ground outside the dike via drainage holes on the bottom of scaffold because a part of scaffold was sticking out over the dikes in the area.

- We installed sand bags inside the side ditch leading to the drainage channel because the water leaking outside the B south tank area could leak into the sea via the side ditches located on the south of B-A5 tank.

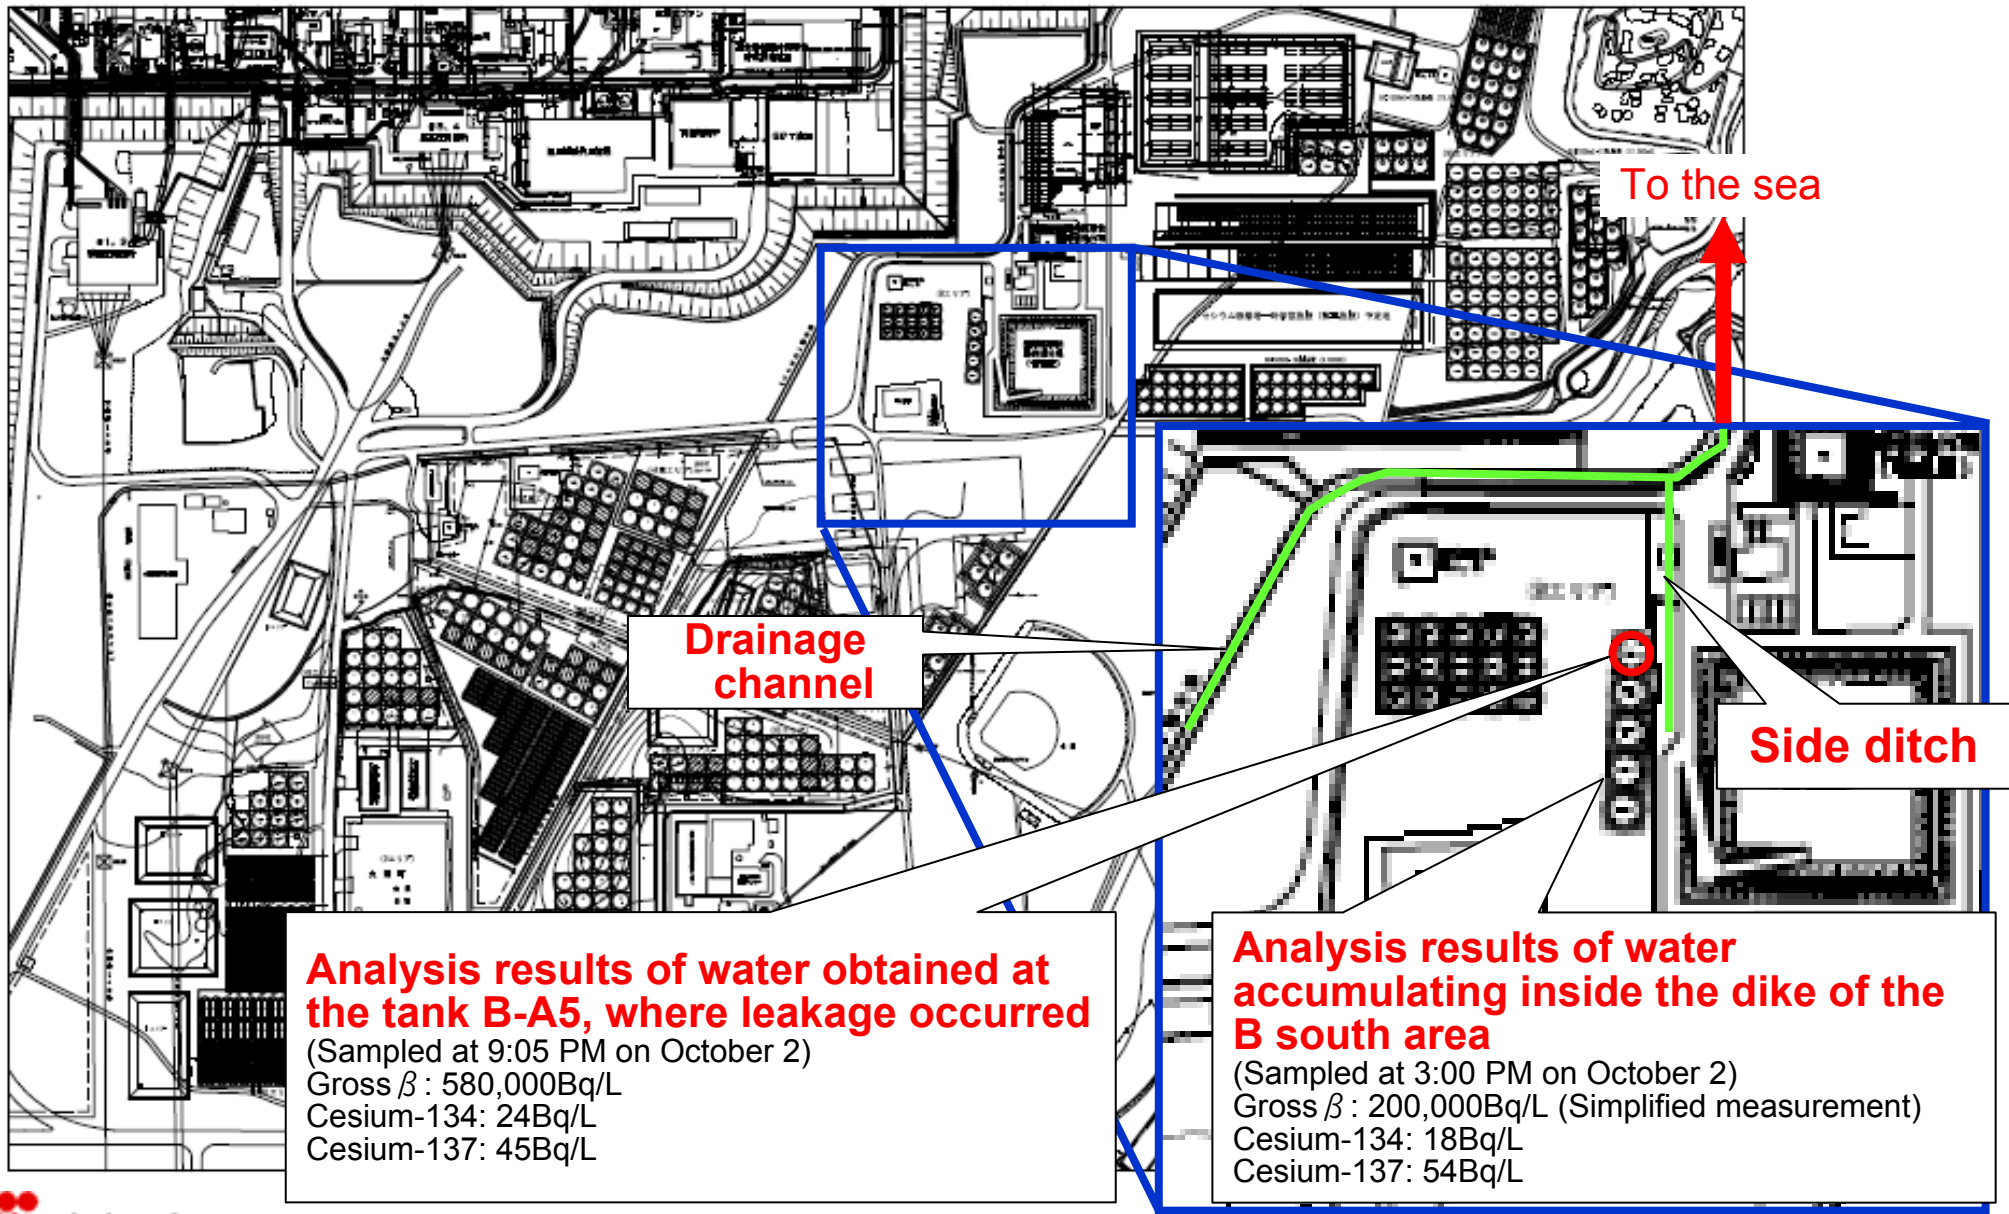
Assessment of influence on environment (the analysis results around B-A5 tank)

We determined there was no influence of radiation from the water leaked from B-A5 tank on environment.

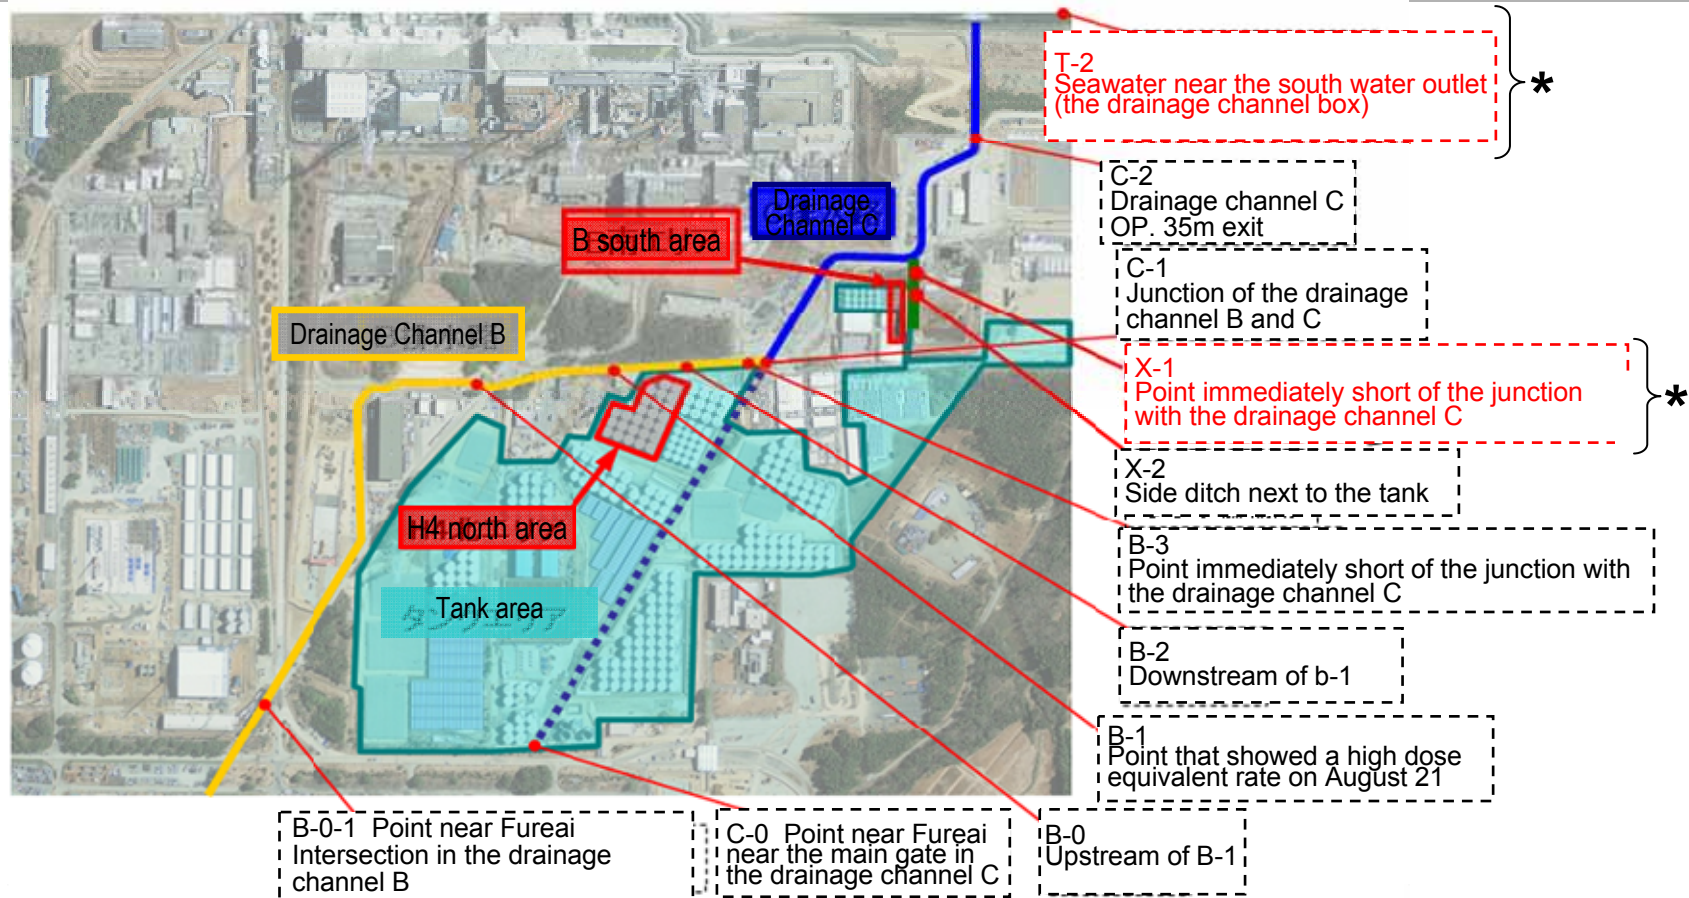
Assessment of influence on environment

Point immediately short of the juncture of the side ditch near the tank and the drainage channel C (X-1)

Gross β : 15,000Bq/L

Cesium-134: 120Bq/L

Cesium-137: 310Bq/L

Seawater near the south water outlet (the drainage channel box) (T-2)

Gross β : ND (The detection limit value: 20Bq/L)

Cesium-134: ND (The detection limit value: 1.5Bq/L)

Cesium-137: ND (The detection limit value: 1.2Bq/L)

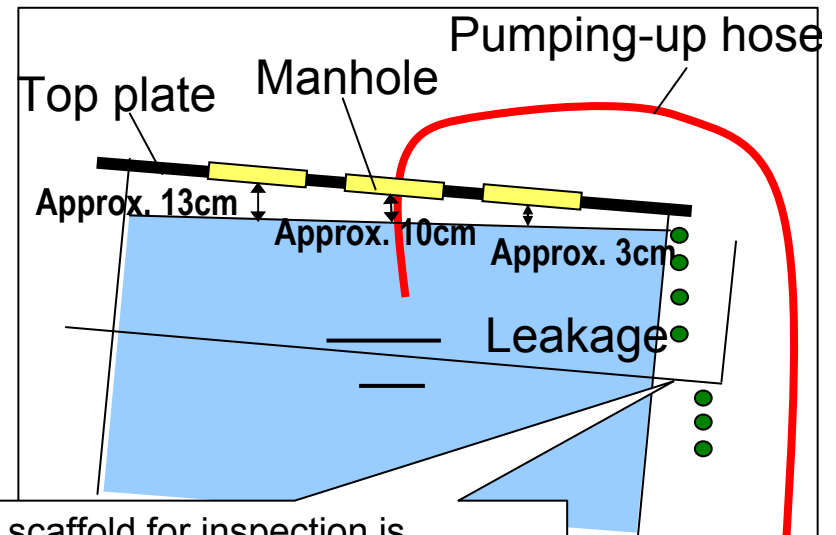
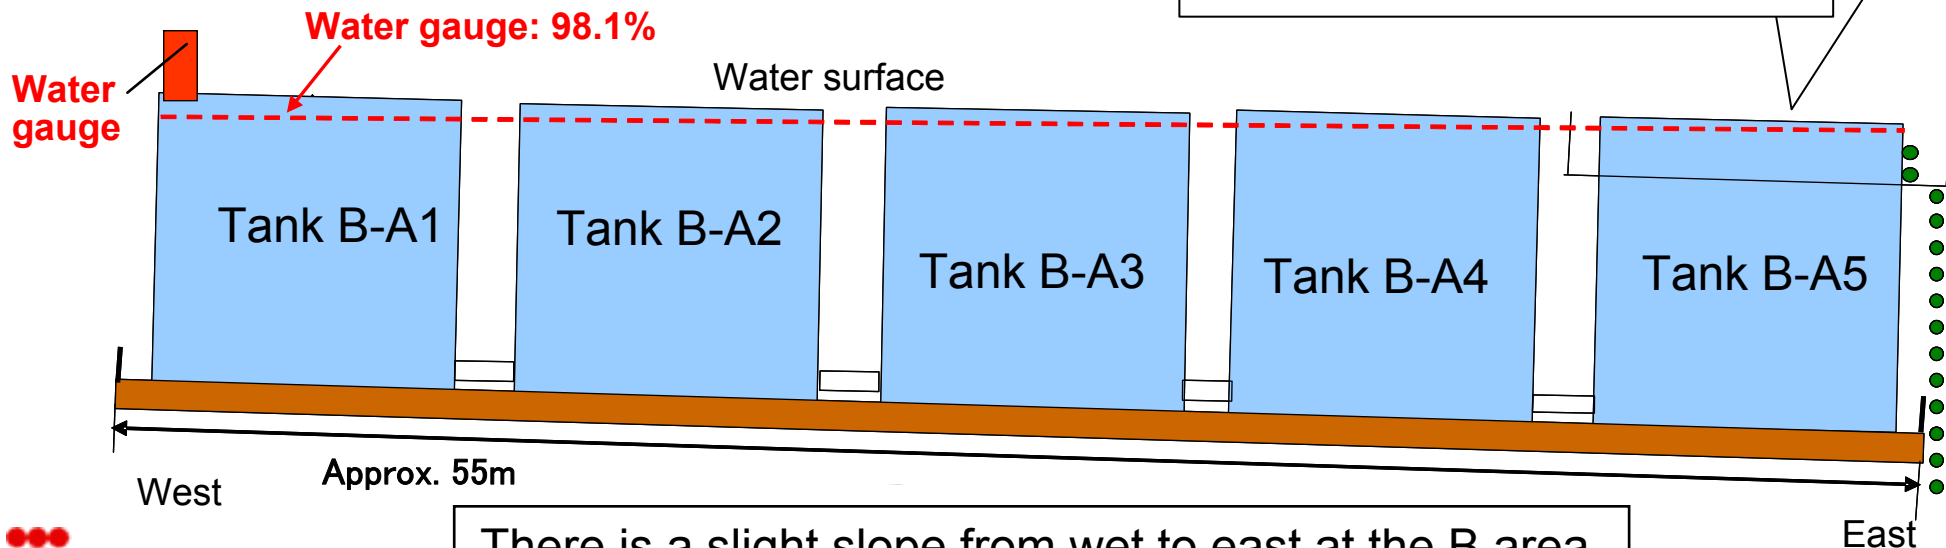
Tanks established at B south area

- In order to prevent rainwater from entering the tanks, the top plate and the flange part are fastened with bolts. (Approx. one bolt hole per 4 to 5 bolt holes is screwed.)
- The tanks have no packing on their top plates, and is not very good at water stopping. They are not supposed to be operated fully filled with water. The water gauge installed at the tank B-A1 watches the water level of tanks.
- The tanks are operated with the maximum amount of water capacity, 99% (approx. 40 cm from the top plate).
- Due to the slight slope on the ground, the water reached the top plate at the east-end tank (B-A5), and leaked, when the water gauge at the tank (B-A1) indicated 98.1%.
- Most of the leaked water dropped inside the dike, but some leaked outside the dike via the drainage hole on the scaffold for inspection.

There is a slight slope from west to east at the B area.
