Leakage from Plastic Tank on Side of H5 Tank Area of Fukushima Daiichi NPS (Updated at 17:30 on April 14)

<Reference>
April 14, 2014
Tokyo Electric Power Company

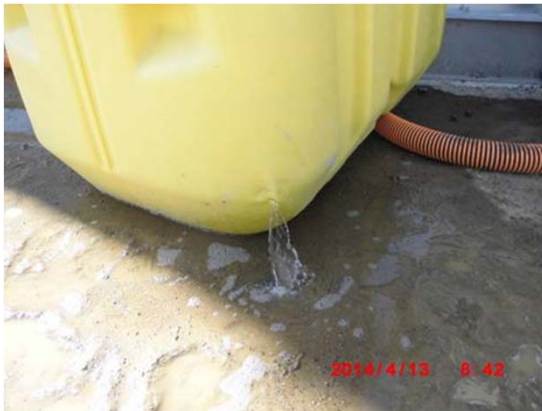
- Cooperative company workers discovered water leakage from the plastic tank which was installed on the side of H5 tank area (on the north side) on routine patrol around 8:40 on April 13.
- The leakage has occurred in the damaged part of the tank. The action has been taken by protecting the openings, attaching the crosstie on the bottom of the tank and having the damaged part upward.
- Soil collection in the peripheral areas of leakage has been completed. (Collected soil: Approx. 8m³)
- Capacity of the plastic tank: 1m³
- Leaked area: Peripheral area of the damaged tank (About 1/4 area of the approx. 15m x 3m)
- It is assumed there is no leakage to the sea as there is no side ditch around the tank.

Situation
as of discovery

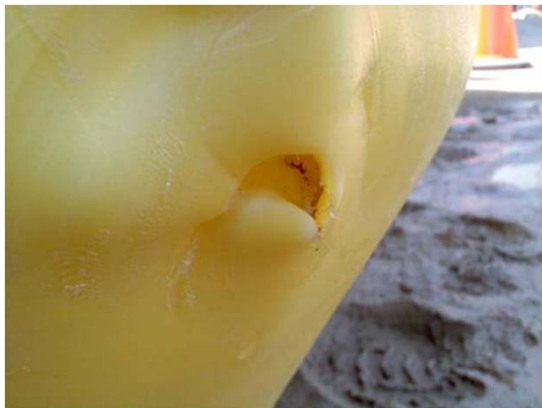
Damage status

<About the damaged tank>

- The above tank was used to store the collected water (including the dirt on the floor) from the dike with the accumulated rainwater during cleansing of the inside of the dike which was carried out prior to the painting operation for the inside of the dike at the end of 2013.
- After that, the tank still remained installed because it might be continuously used for cleansing of the inside of the dike.

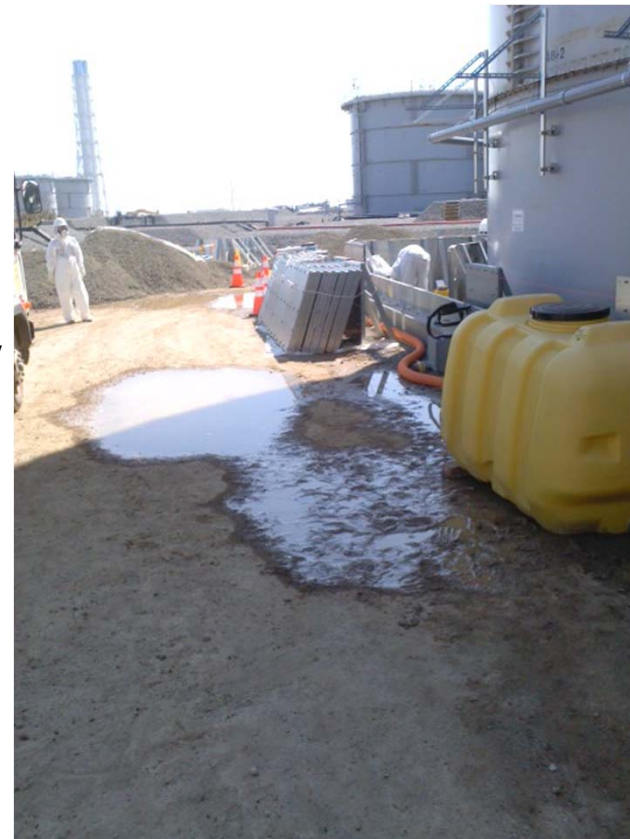
- Maximum 1m³
- Working on soil recovery in the leaked area
- It is assumed there is no leakage to the sea as there is no side ditch around the tank.

Leaked area
