**Mis-transportation of Accumulated Water to the Incinerator Workshop Building
in the Central Radioactive Waste Treatment Facility
of the Fukushima Daiichi Nuclear Power Station**

April 16, 2014

Tokyo Electric Power Company

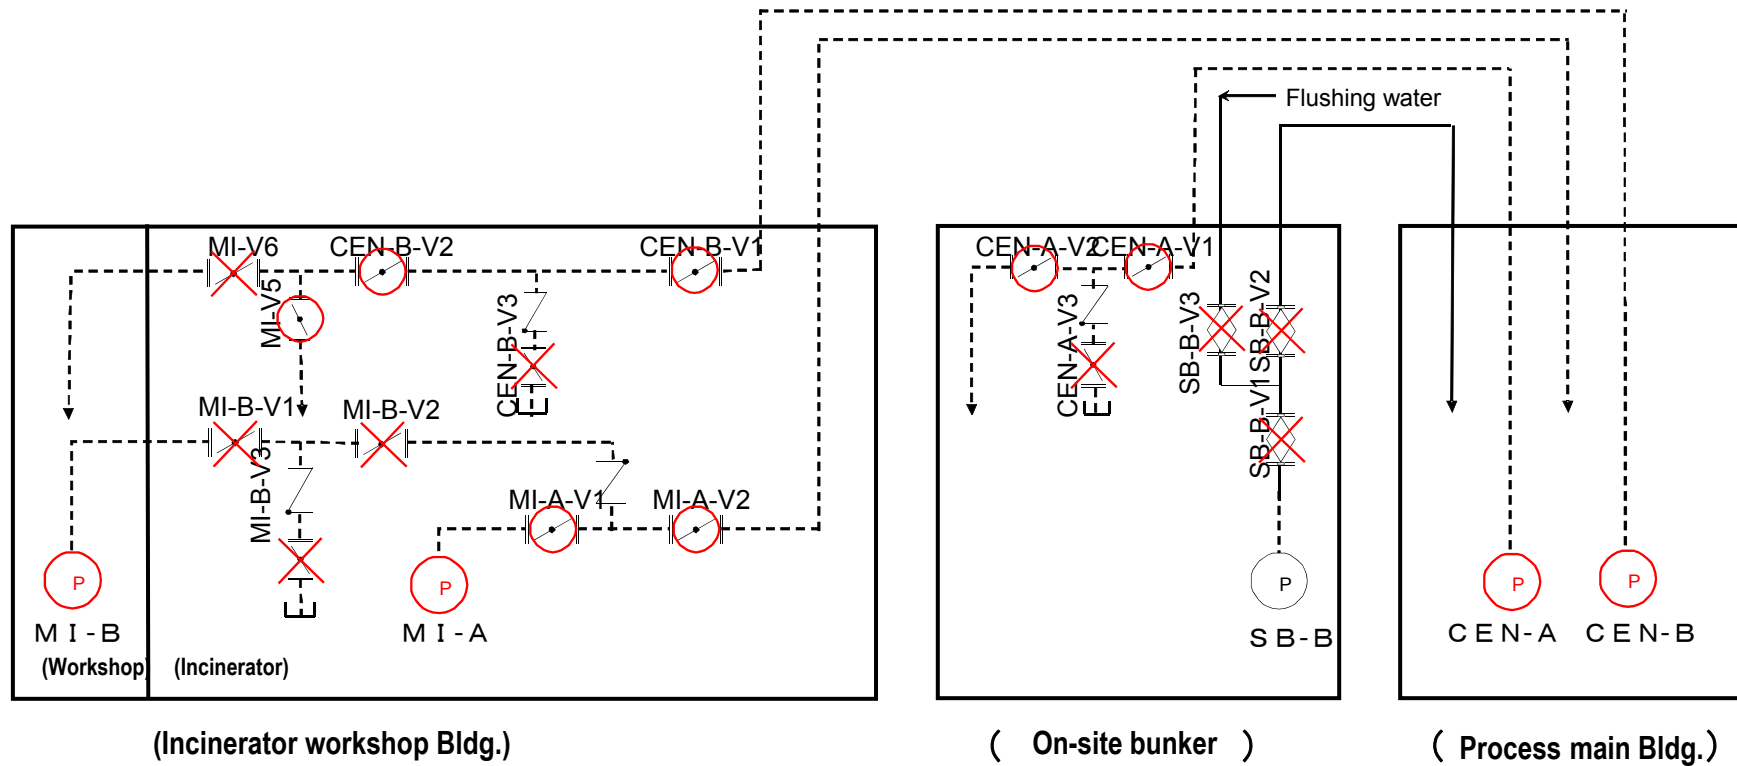
[Reference 2] On-site status (Pump start/stop status and Valve open/close status)

- A rising trend in water level in the On-site bunker building and a lowering trend in water level in the Process main building were found on April. 10, 2014. Accordingly, on-site investigation was carried out from April 12, and the next day on April 13, it was found that the temporary pumps^{*1} (four pumps) which were not in use on a regular basis were turned on.

- ◆ Process building → On-site bunker building (1 pump)
 - ◆ Process building → Incinerator workshop building (1 pump)
 - ◆ Incinerator workshop building → Process main building (2 pumps)

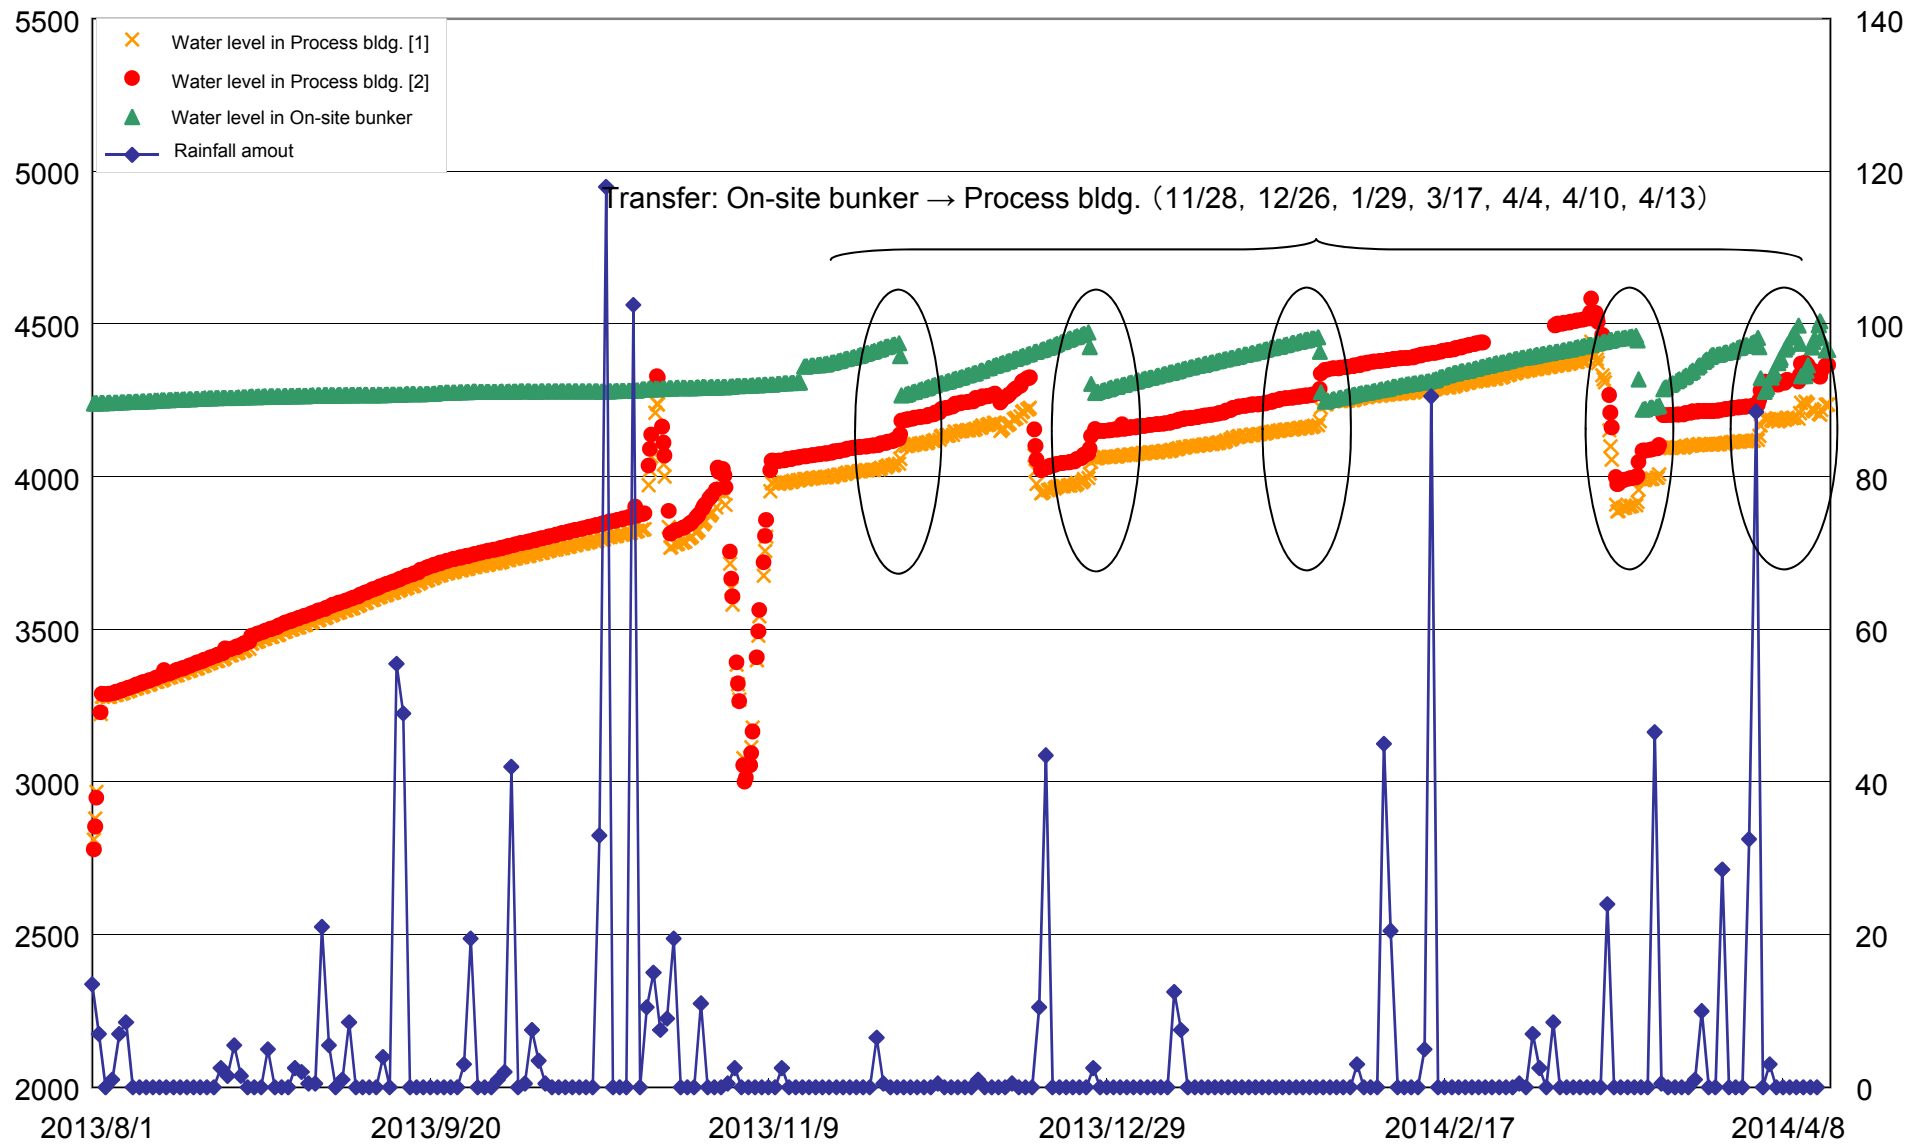
【Supplement 3】 Trend in water transfer (long-term)

- Currently, the analysis of each phenomenon is proceeding and has found a increase in the water level rising rate of the On-site bunker after April 4, and a decrease in that of the Process main building after April 10.

- Looking at a long term trend, a rise of the water level in the On-site bunker has been observed since last November, and therefore, a possibility whether the pumps in question were turned on during the period mentioned above will be evaluated with a comparison to the amount of water level to be increased after turning off the temporary pumps.

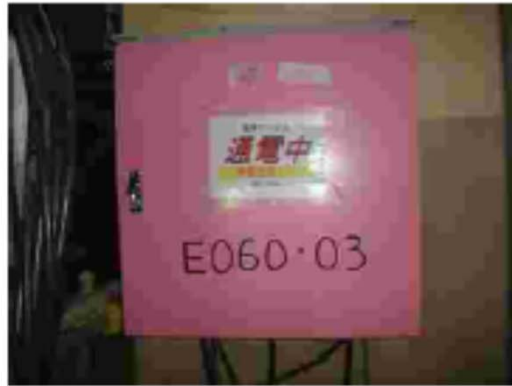
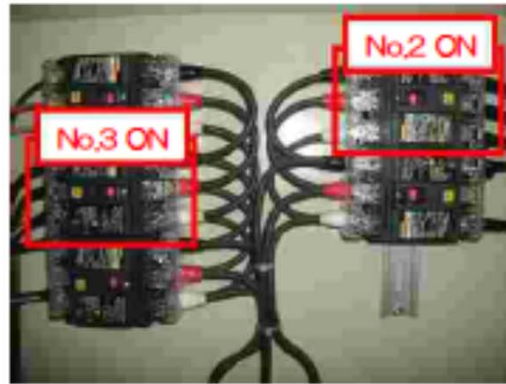
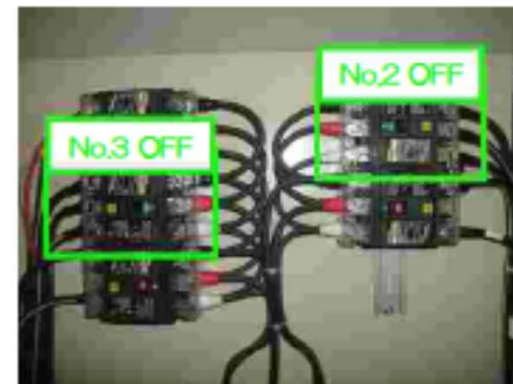
Temporary distribution board
(2F, Process main bldg.)

On/off operation of the temporary pumps is carried out with switches of the control board, but it was not controlled by locking. (The locking control of the control board in question has been started.)

In addition, although the switches of the control board were handled with number controls, there were no names displayed on them which makes it hard to deny the possibility of human error. Consequently, the improvement of identification of any temporary items in the highly-important facilities will be studied and addressed.

No.2 Discharge pump of Process main bldg. (CEN-A)
No.3 Discharge pump of Process main bldg. (CEN-B)

Label with description to each switch on the images is given for easy grasping of the situation , but the actual switches in the boards were handled with number controls only.

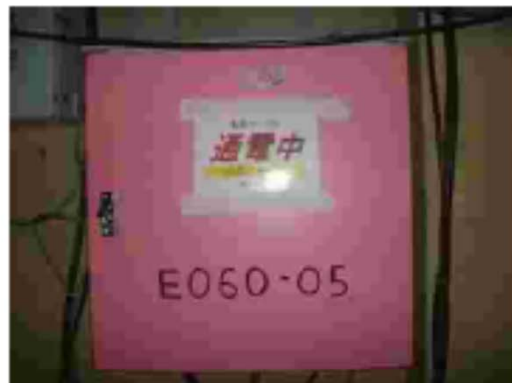
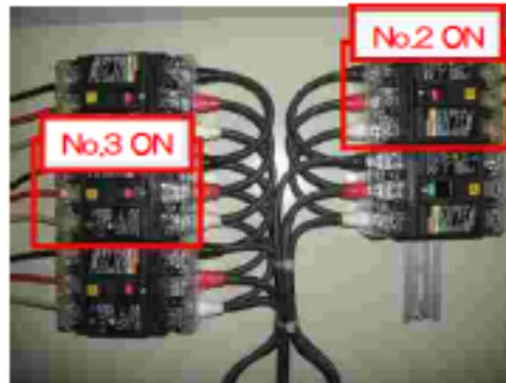
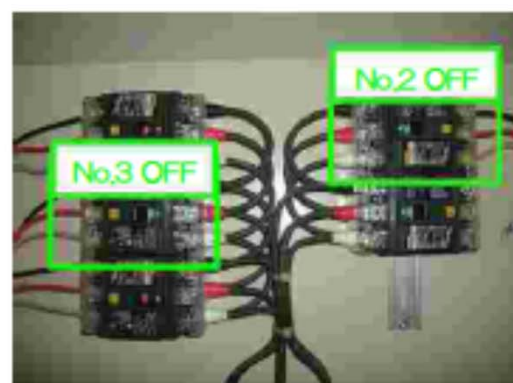
Temporary distribution board
(1F, Incinerator workshop bldg.)

No.2 Discharge pump of Incinerator workshop bldg. (Incinerator bldg.) (MI-A)
No.3 Discharge pump of Process main bldg. (Workshop bldg.) (MI-B)

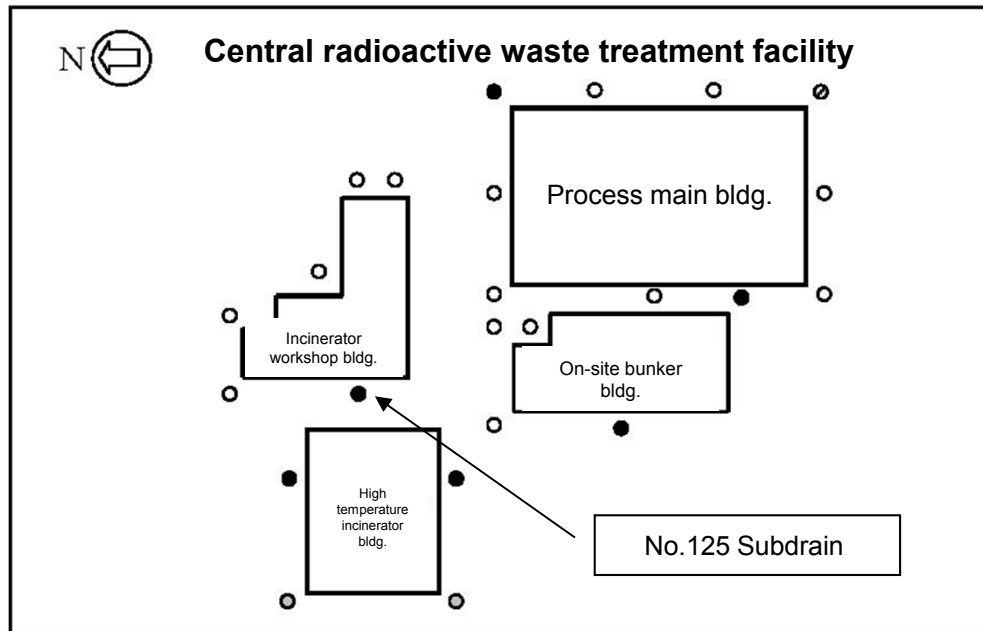
Estimated amount of accumulated water in the Incinerator workshop building (1st basement)

Total: approx. 203 m³ (= [1] + [2])

[1] Incinerator equipment bldg.: approx. 165 m³ (approx. 918 m² × 18 cm*)

[2] Workshop & machinery equipment bldg.: approx. 38 m³ (approx. 759 m² × 5 cm*)
