**External Visual Inspection Results
of the Fuels Removed from the Spent Fuel Pool
at Unit 4 in the Fukushima Daiichi Nuclear Power Station**

April 30, 2014

Tokyo Electric Power Company

Outlines of External Visual Inspection Results

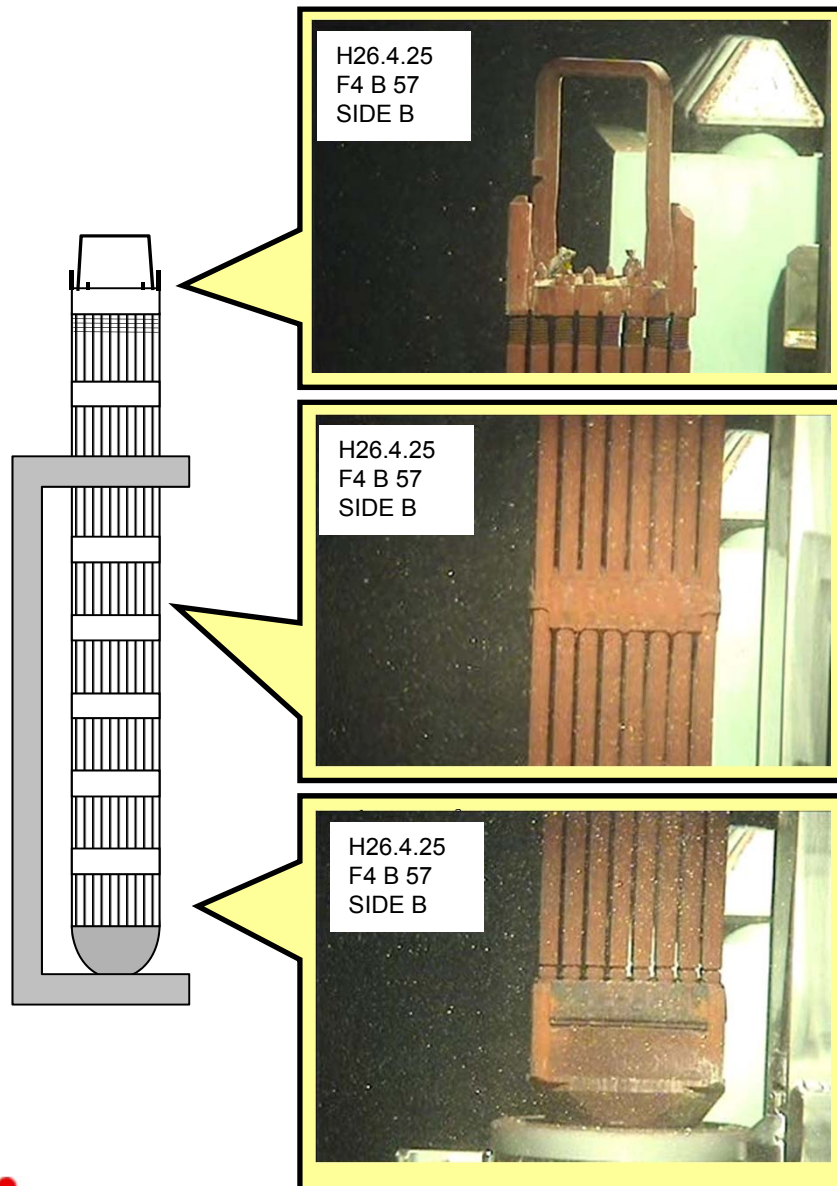
Inspection results (fuel type: 8 X 8 fuel (1))

Found no corrosion or damages with the fuel cladding tubes or load transfer spots (tie rod and tie plate of upper/ lower parts) of the nuclear fuel assembly.

Found no deformation, etc with fuel rods or problems in space between fuel rods.

Found no damages to the fuel cladding tube, although a few millimeter rubbles are identified in the fuel assembly.

→ Through the exterior visual inspection, it is verified that there is no remarkable corrosion or damage which causes a problem in terms of fuel soundness and fuel handling.

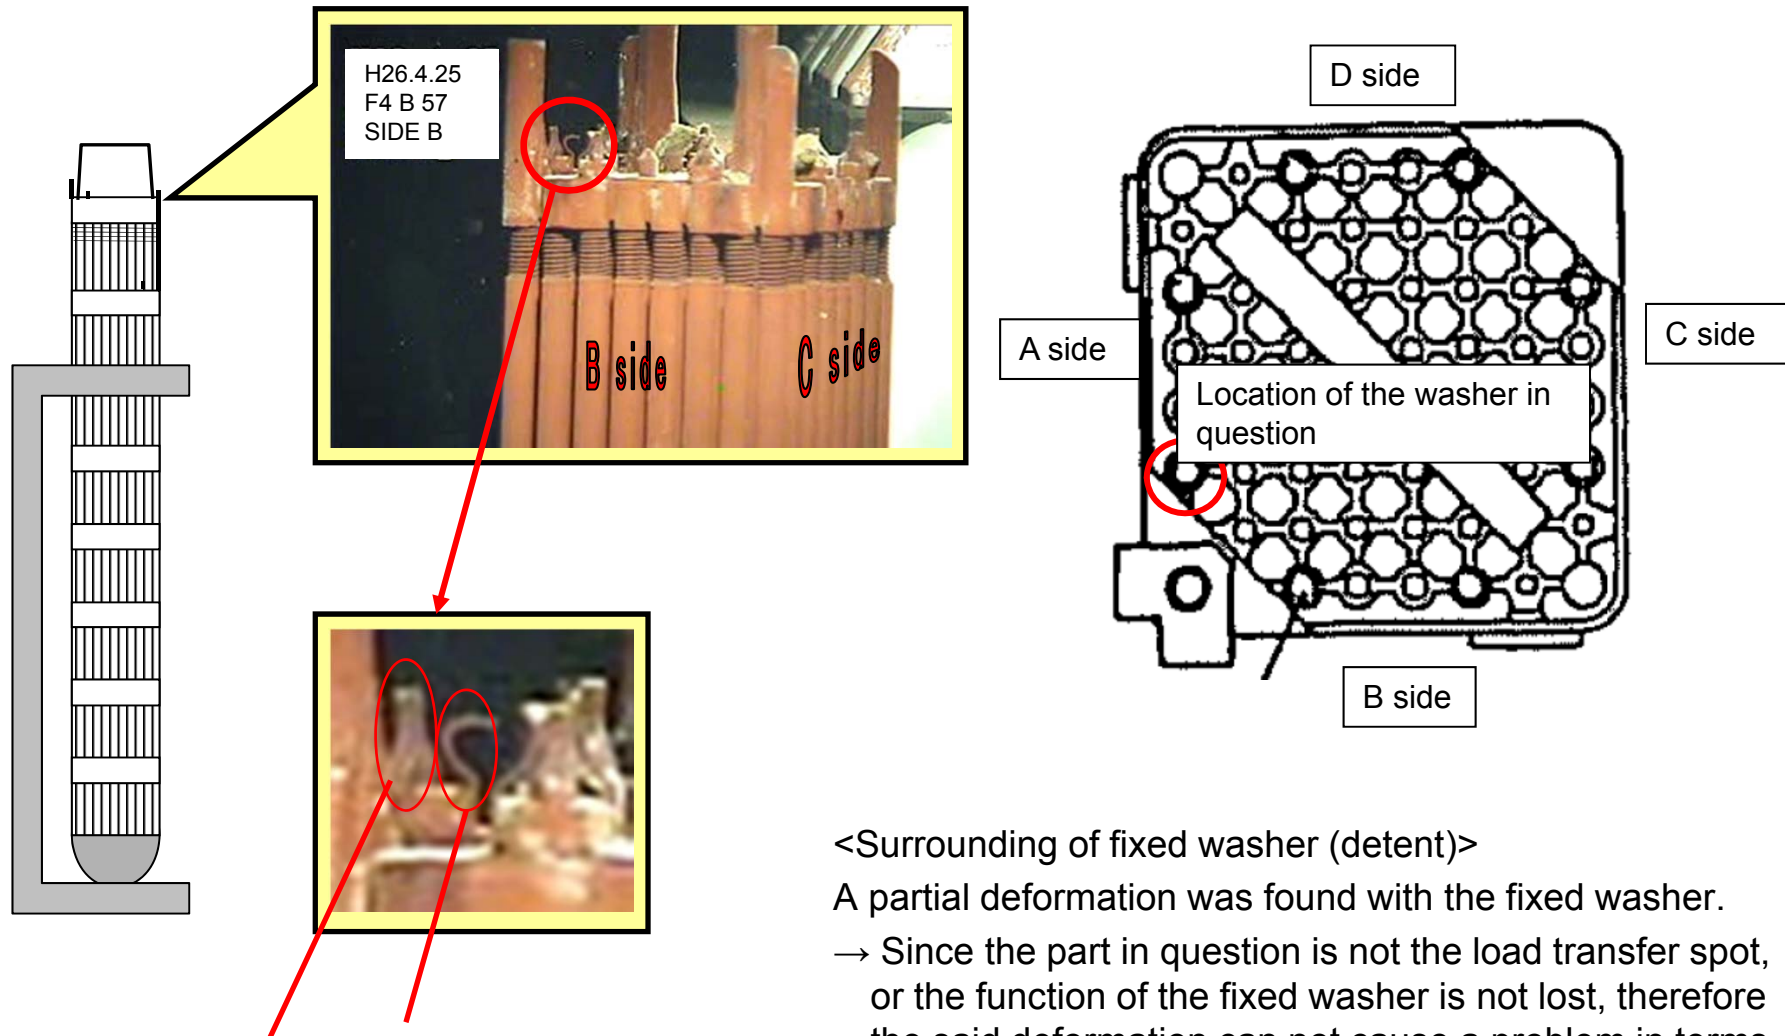
Inspection results (Fuel type: 8 X 8 fuel [2])

A partial deformation was found with the fixed washer.

→ Since the part in question is not the load transfer spot, or the function of the fixed washer is not lost, therefore the said deformation can not cause a problem in terms of fuel soundness and fuel handling.

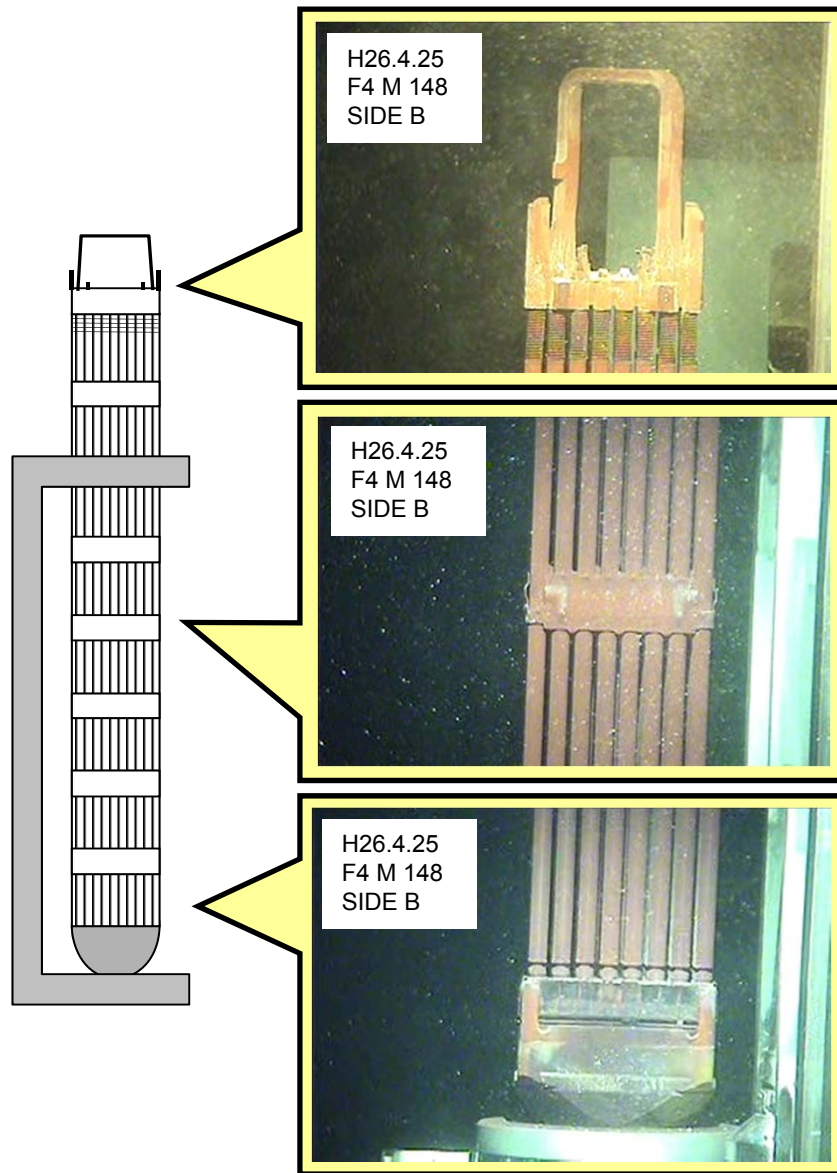
Inspection results (Fuel type: New type 8 X 8 zirconium liner-fuel)

Found no corrosion or damages with the fuel cladding tubes or load transfer spots (tie rod and tie plate of upper/ lower parts) of the nuclear fuel assembly.

Found no deformation, etc with fuel rods or problems in space between fuel rods.

Found no damages to the fuel cladding tube, although a few millimeter rubbles are identified in the fuel assembly.

→ Through the exterior visual inspection, it is verified that there is no remarkable corrosion or damage which causes a problem in terms of fuel soundness and fuel handling.

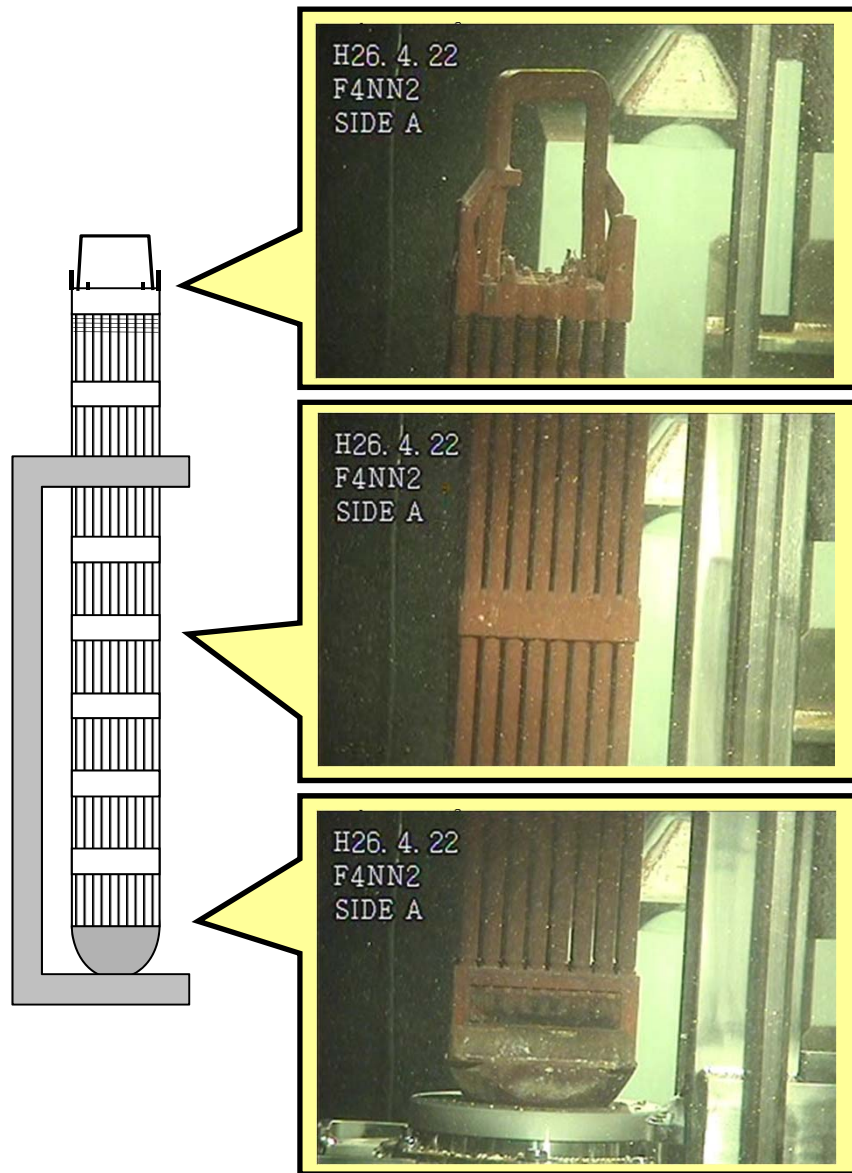
Inspection results (Fuel type: High burnup 8X8 fuel)

Found no corrosion or damages with the fuel cladding tubes or load transfer spots (tie rod and tie plate of upper/ lower parts) of the nuclear fuel assembly.

Found no deformation, etc with fuel rods or problems in space between fuel rods.

Found no damages to the fuel cladding tube, although a few millimeter rubbles are identified in the fuel assembly.

→ Through the exterior visual inspection, it is verified that there is no remarkable corrosion or damage which causes a problem in terms of fuel soundness and fuel handling.

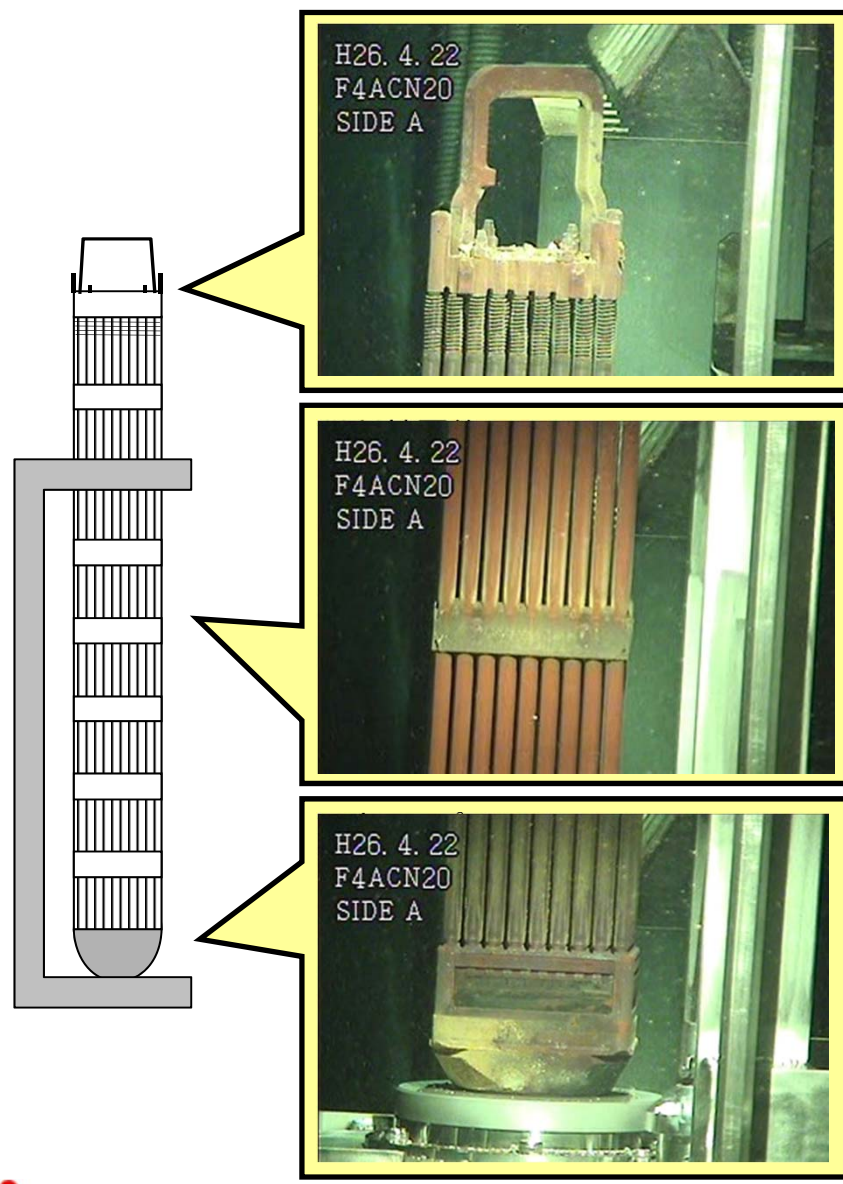
Inspection results (Fuel type: 9X9 fuel [B type])

Found no corrosion or damages with the fuel cladding tubes or load transfer spots (tie rod and tie plate of upper/ lower parts) of the nuclear fuel assembly.

Found no deformation, etc with fuel rods or problems in space between fuel rods.

Found no damages to the fuel cladding tube, although a few millimeters rubbles are identified in the fuel assembly.

→ Through the exterior visual inspection, it is verified that there is no remarkable corrosion or damage which causes a problem in terms of fuel soundness and fuel handling.
