Results of Investigation on Upper Parts of S/C (Suppression Chamber) of Unit 1 at Fukushima Daiichi NPS

May 27, 2014 Tokyo Electric Power Company

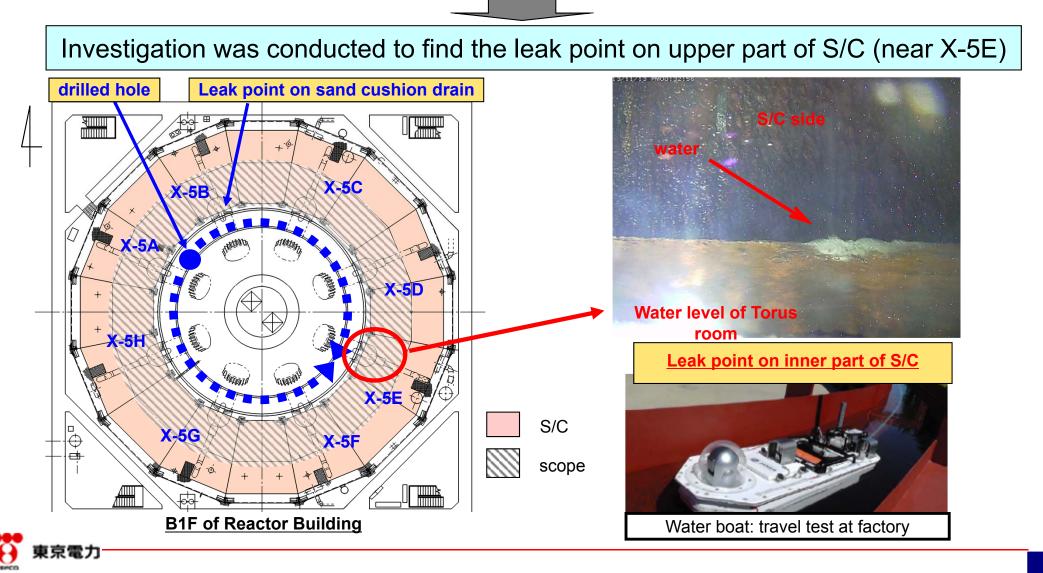
Investigation inside the S/C using a water boat (November, 2013)

- In November 2013, the presence of water leakage was checked at inner part of S/C as investigation around lower parts of vent pipes
 - Water leakage from upper part of S/C (near X-5E, southeast) was found.
 - Water leakage from sand cushion drain (near X-5B, northwest) was found.

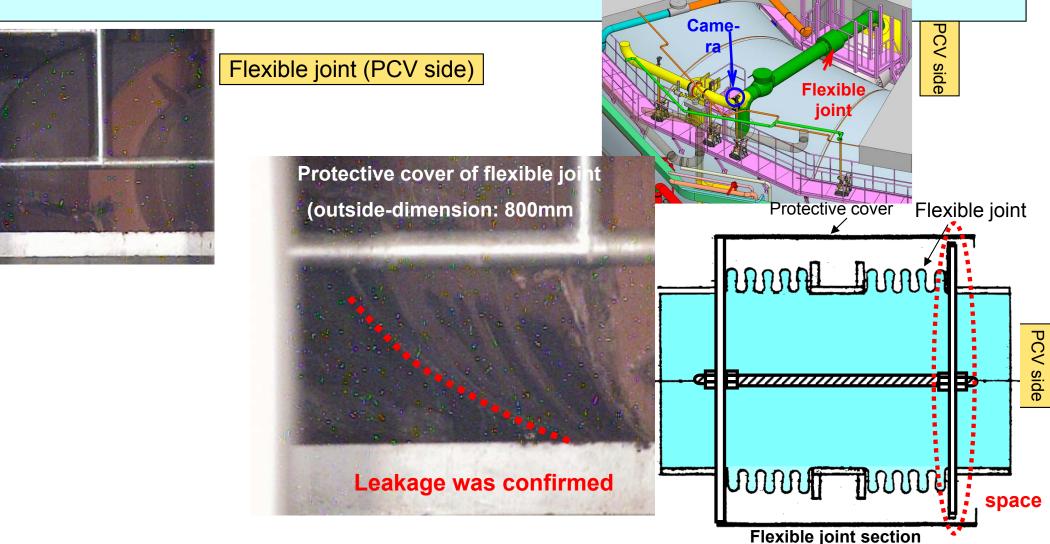
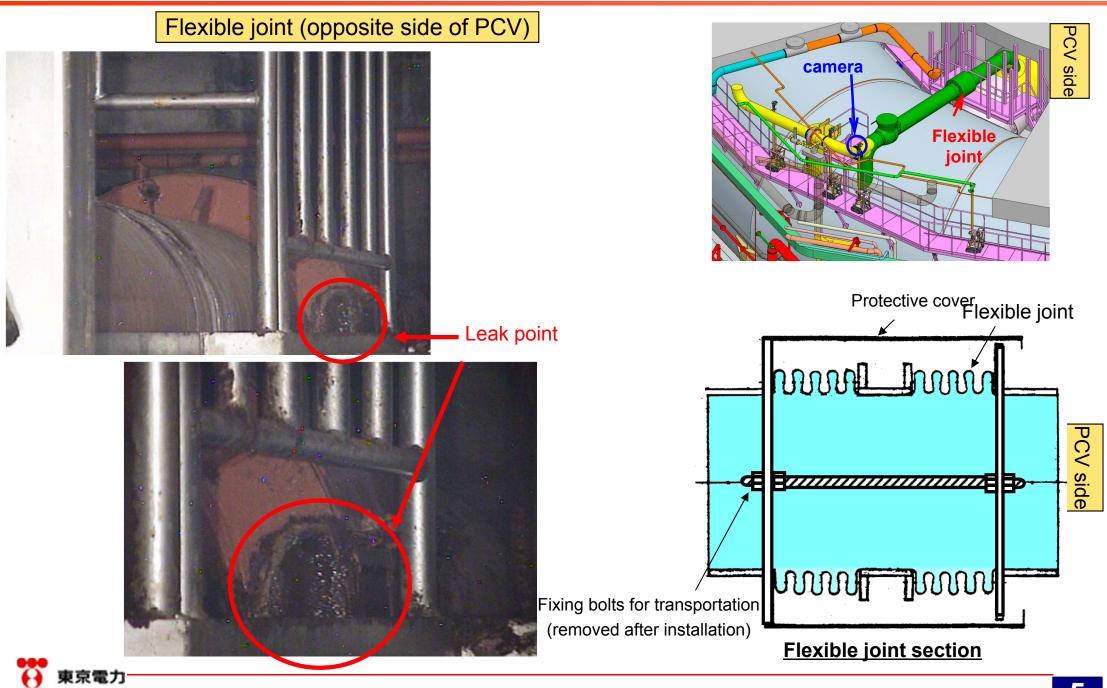
Situation of the upper part of S/C (near X-5E)

Leakage were found on both PCV side and opposite side of flexible joint cover of vacuum breaking line

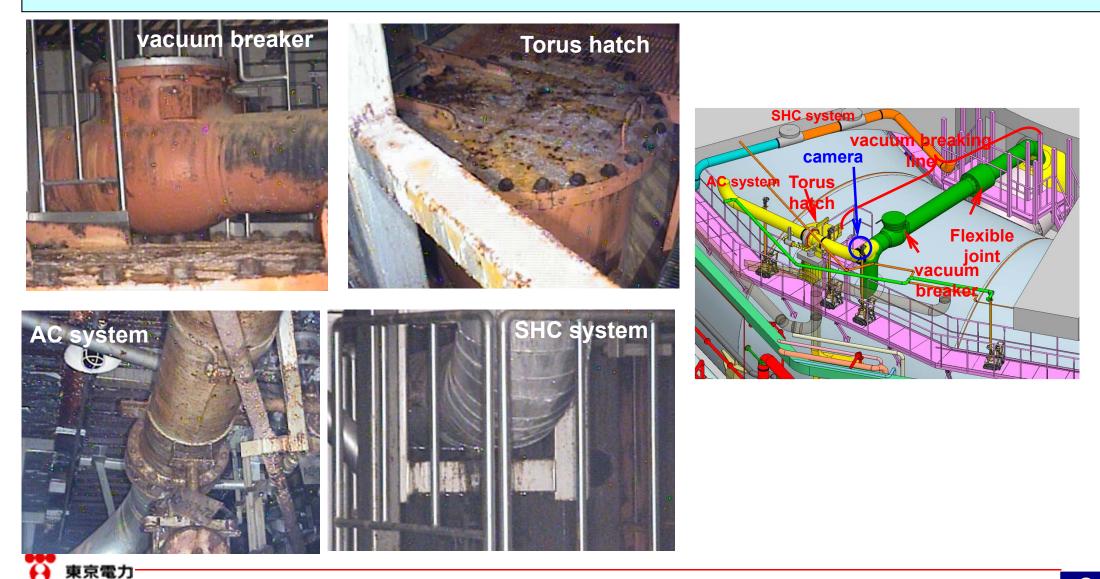
Situation of the upper part of S/C (near X-5E)

No leakage was found on vacuum breaker, torus hatch, SHC system pipe, and AC system pipe.

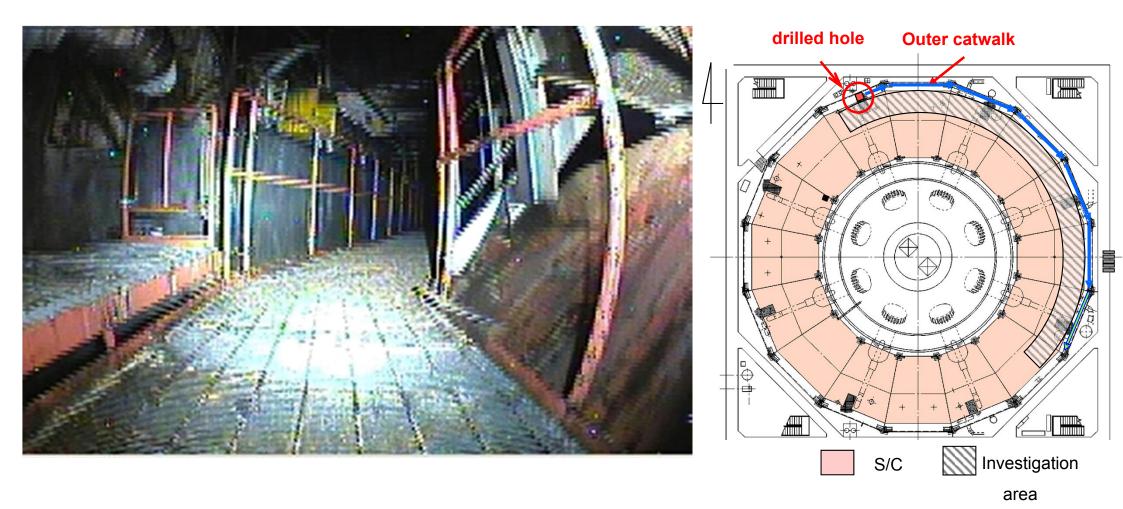
Situation of outside of the upper part of S/C (North)

No leakage/serious damage on systems was found
