**Results of Investigation on Upper Part of S/C  
(Suppression Chamber) of Unit 1 at  
Fukushima Daiichi NPS  
(outside around west/south side)**

**May 30, 2014**

**Tokyo Electric Power Company**

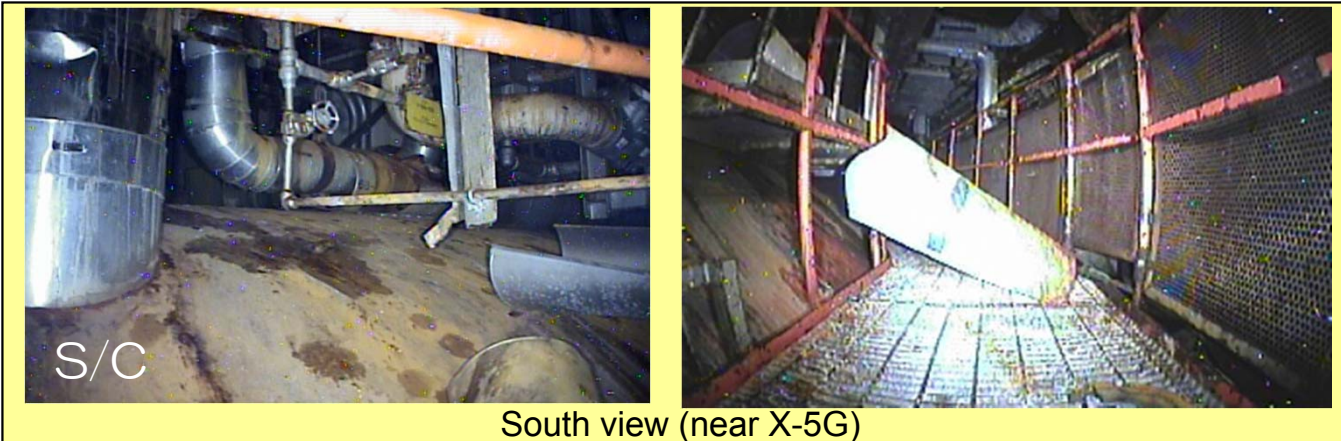
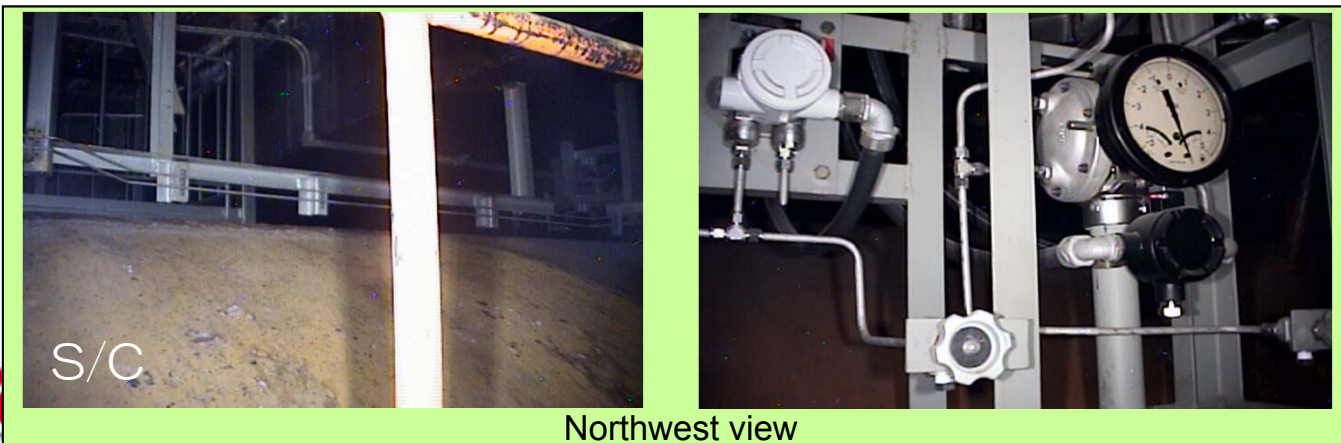
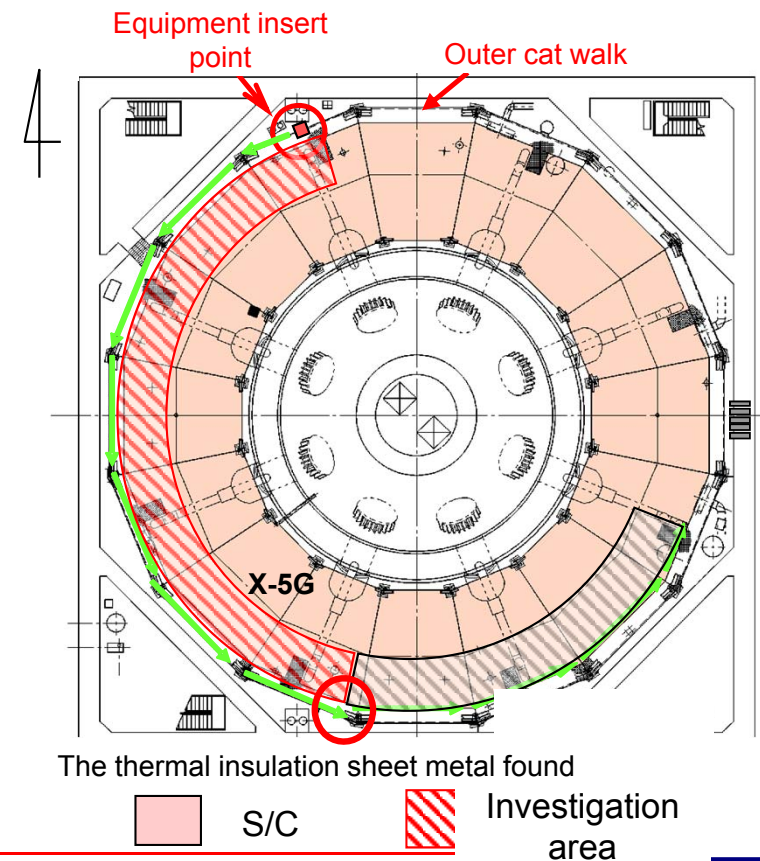
- As thermal insulation sheet metal was dropped and occupied the south cat walk (near X-5G), we investigated on from northwest to south.

- No leakage was found in the area from northwest to south.
- The pipes around X-5G were more dirty than the other area.
- Increase of radiation dose was confirmed near X-5G.
