1. Timeline

2. Leakage spot (scheme)

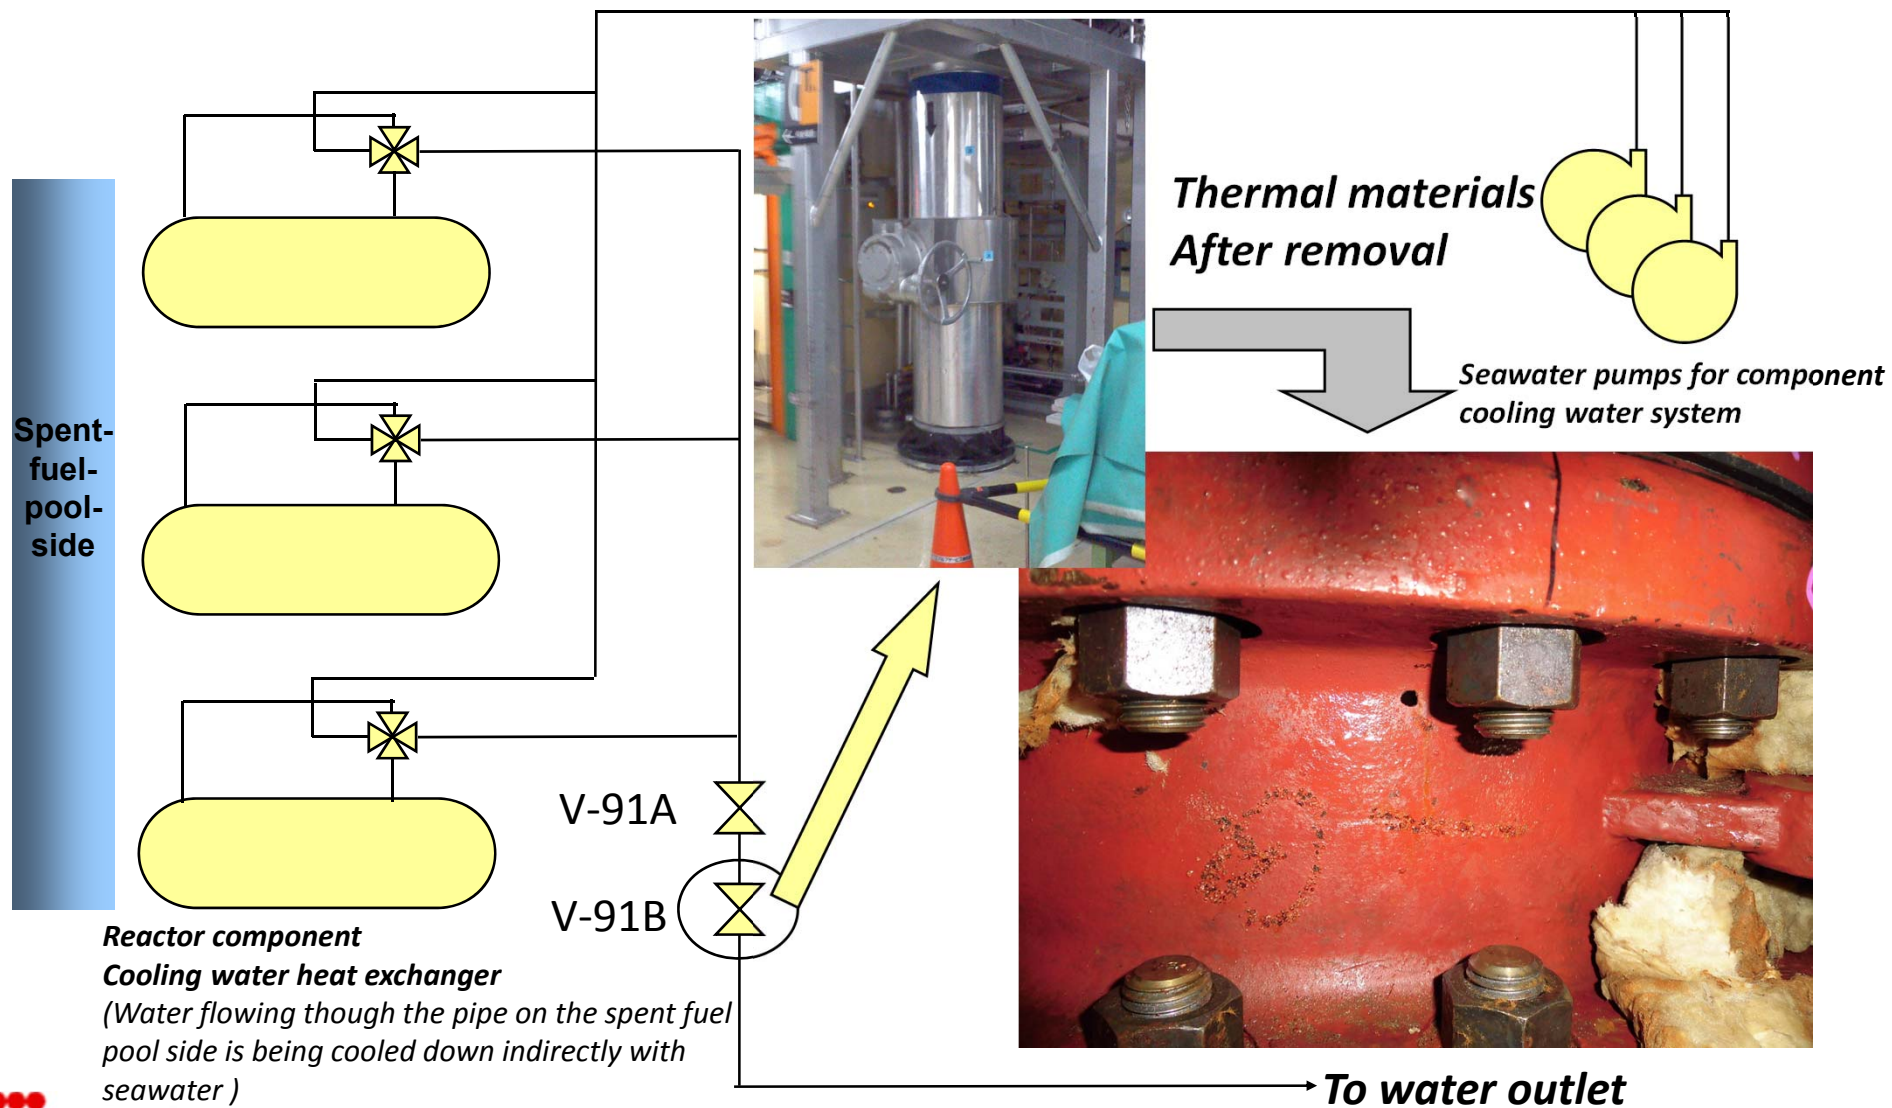
11:25 or around A leakage in the size of one finger thickness was discovered by TEPCO employees (on duty) on patrol, which is made from the thermal insulator installed nearby the outlet adjustment valve (V-37-91B) of the heat exchanger for the thermal materials seawater system and reactor component cooling water system located on the northeast side of the 1st floor of the unit 5 reactor building.

13:10 Shutdown FPC Pump (A) [Pool water temp. at the shutdown: 23.0 °C/ Temp. rise rate: 0.193 °C/ h]
13:14 Shutdown RCW Pump (C)
13:17 Shutdown SW Pump (A)
13:26 "Closed" position on V-37-91A, 91 B
13:34 Confirmed that the leakage from the relevant spot has stopped.
14:00 Confirmed that there was a hole with 3 mm in diameter opened in the valve itself.
