# **“Development of a technology to investigate inside the Reactor Primary Containment Vessel (PCV)”**

**-- Site test “Investigation B1” on grating around the pedestal inside Unit 1 PCV -**

**April 13, 2015**

**Tokyo Electric Power Company**

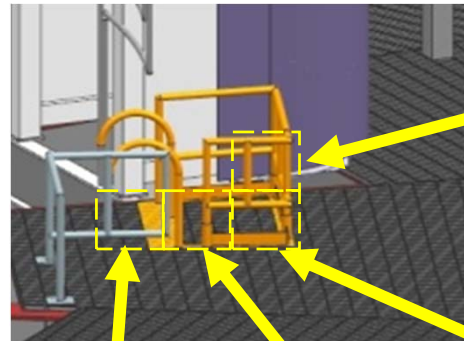
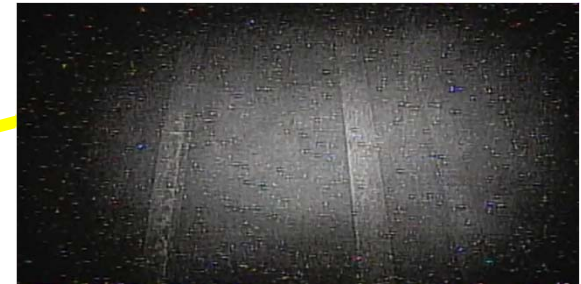
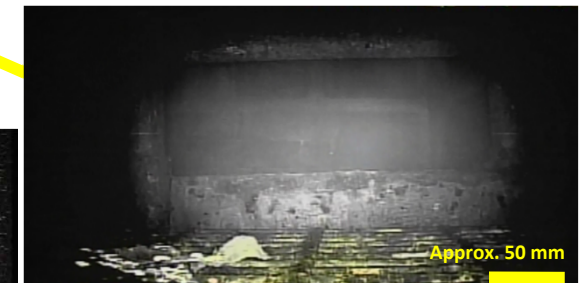
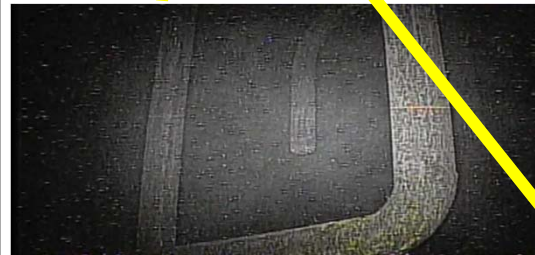
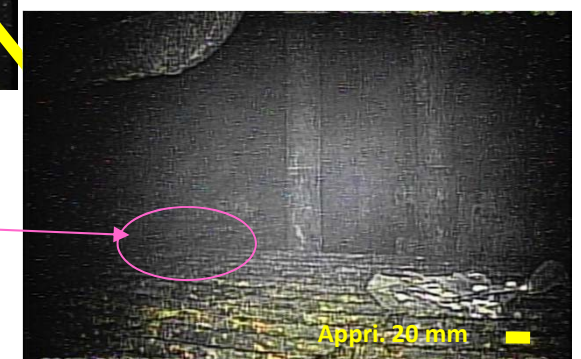
**B4**

With B2 investigation to be conducted next time, TEPCO confirmed there is an opening accessible to the basement as well as no obstacles around it.

Spot where the robot can be inserted.

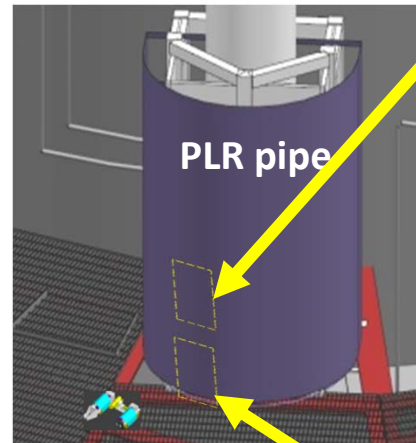
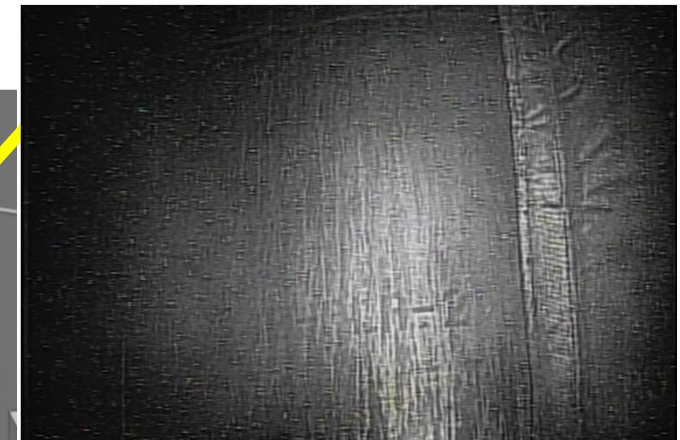
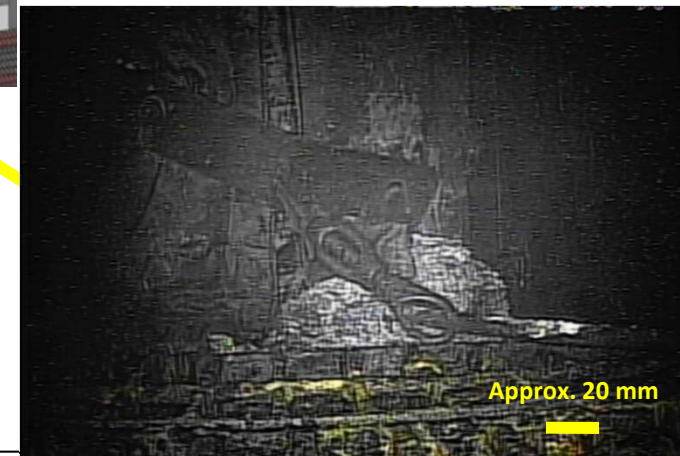
**B7**

- No significant damages were found on the PLR pipe (for heat retention).
- It was found that a part of the shield has been fallen off.

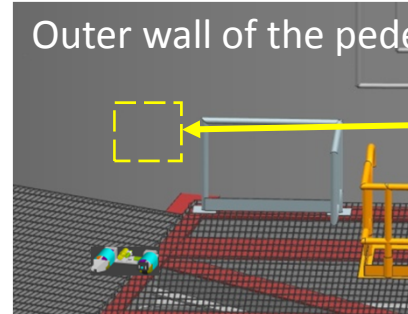
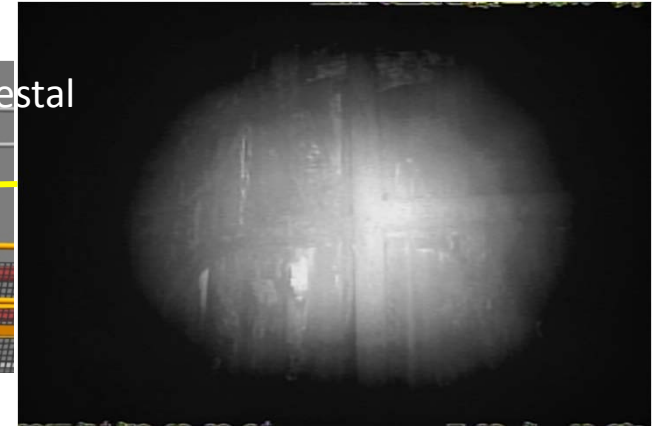
### B3 Exterior of the outer wall of the pedestal

No significant damages were found on the outer wall of the pedestal.

Outer wall of the pedestal

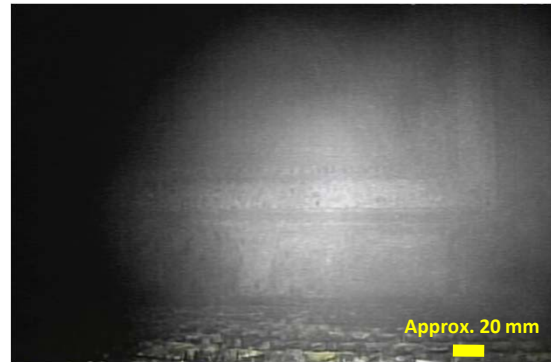
**B1**

No significant damages were found on HVH (D).

HVH (In the center at the bottom)

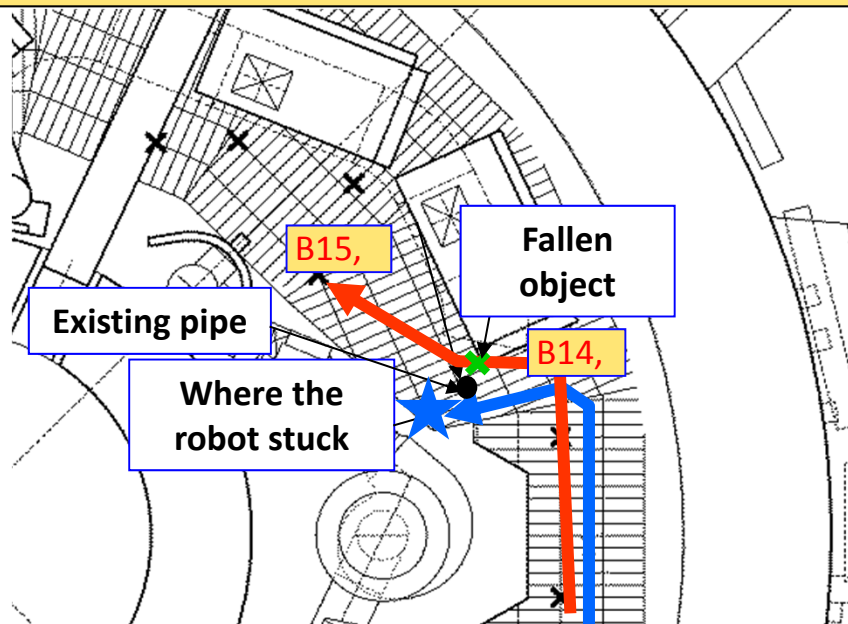
- Object was found to be fallen on the planned route between B 14 and B 15 where was the narrowest part of it.
- Following the procedures, the investigation continued by choosing an another route avoidable the objects.

- After that, although the robot stuck at a narrow point, it captured some images facing to the direction of CRD rail. (currently the images are under evaluation)

The robot got stuck with an existing pipe and some shut parts of the grating or uneven part at the joint, which resulted in making the route hard to run on.

Measures to be taken are under study.

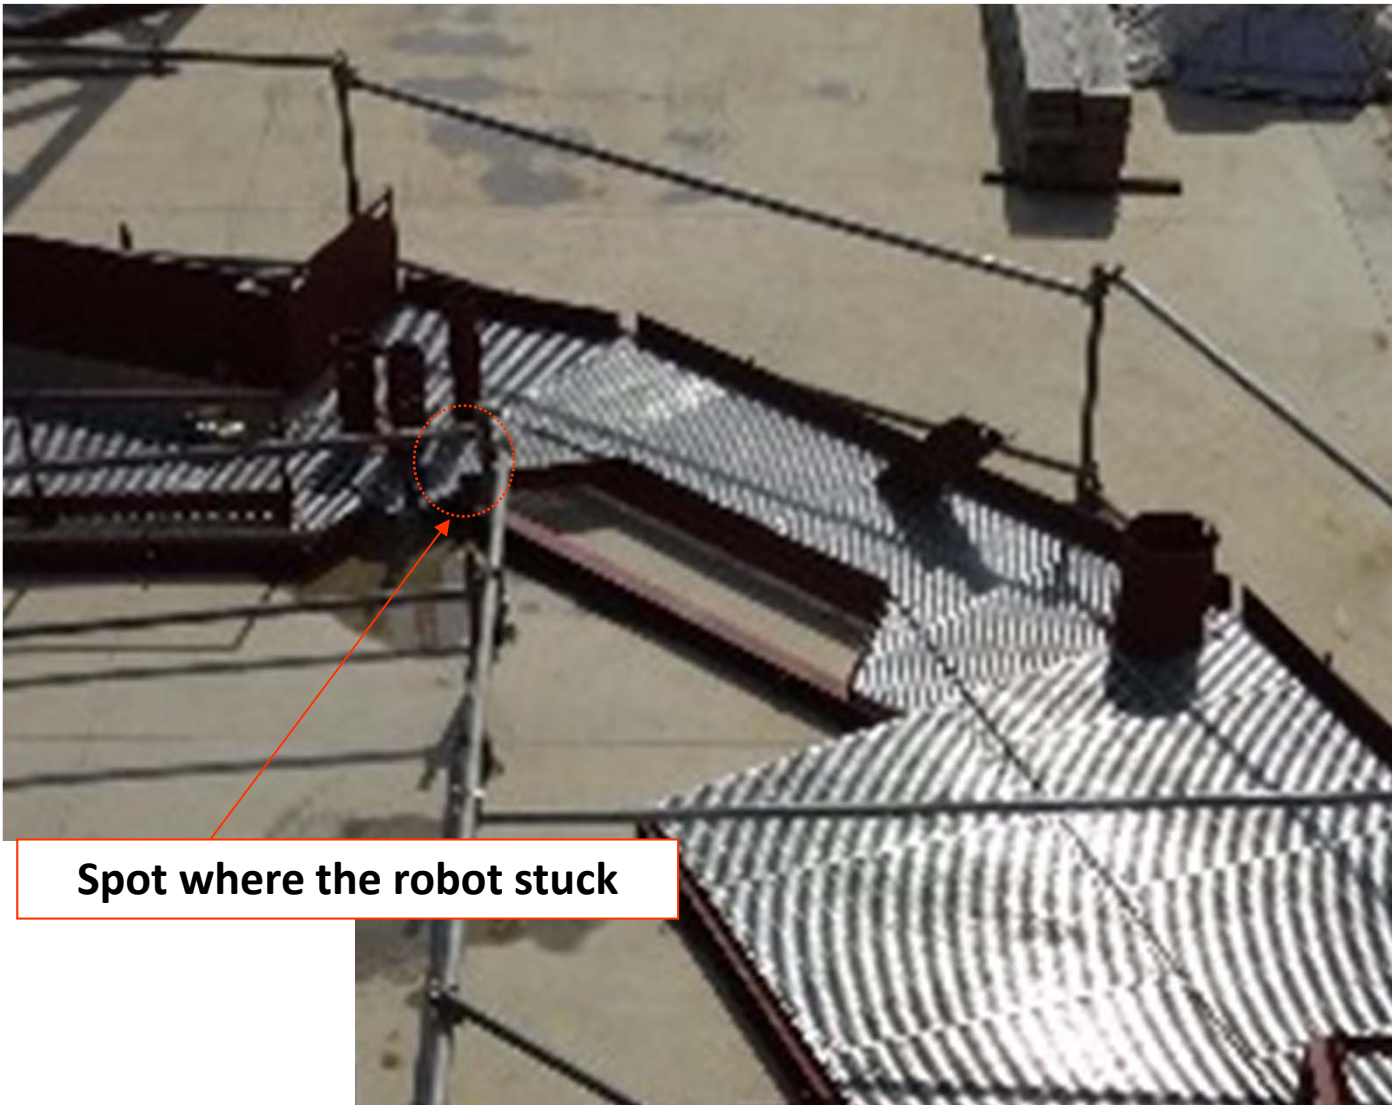
**Spot where the robot stuck**
