# **“Development of a technology to investigate inside the Reactor Primary Containment Vessel (PCV)”**

**- Results of follow up check after the site test -**

**[For April 18 and 19, 2015]**

**Tokyo Electric Power Company**

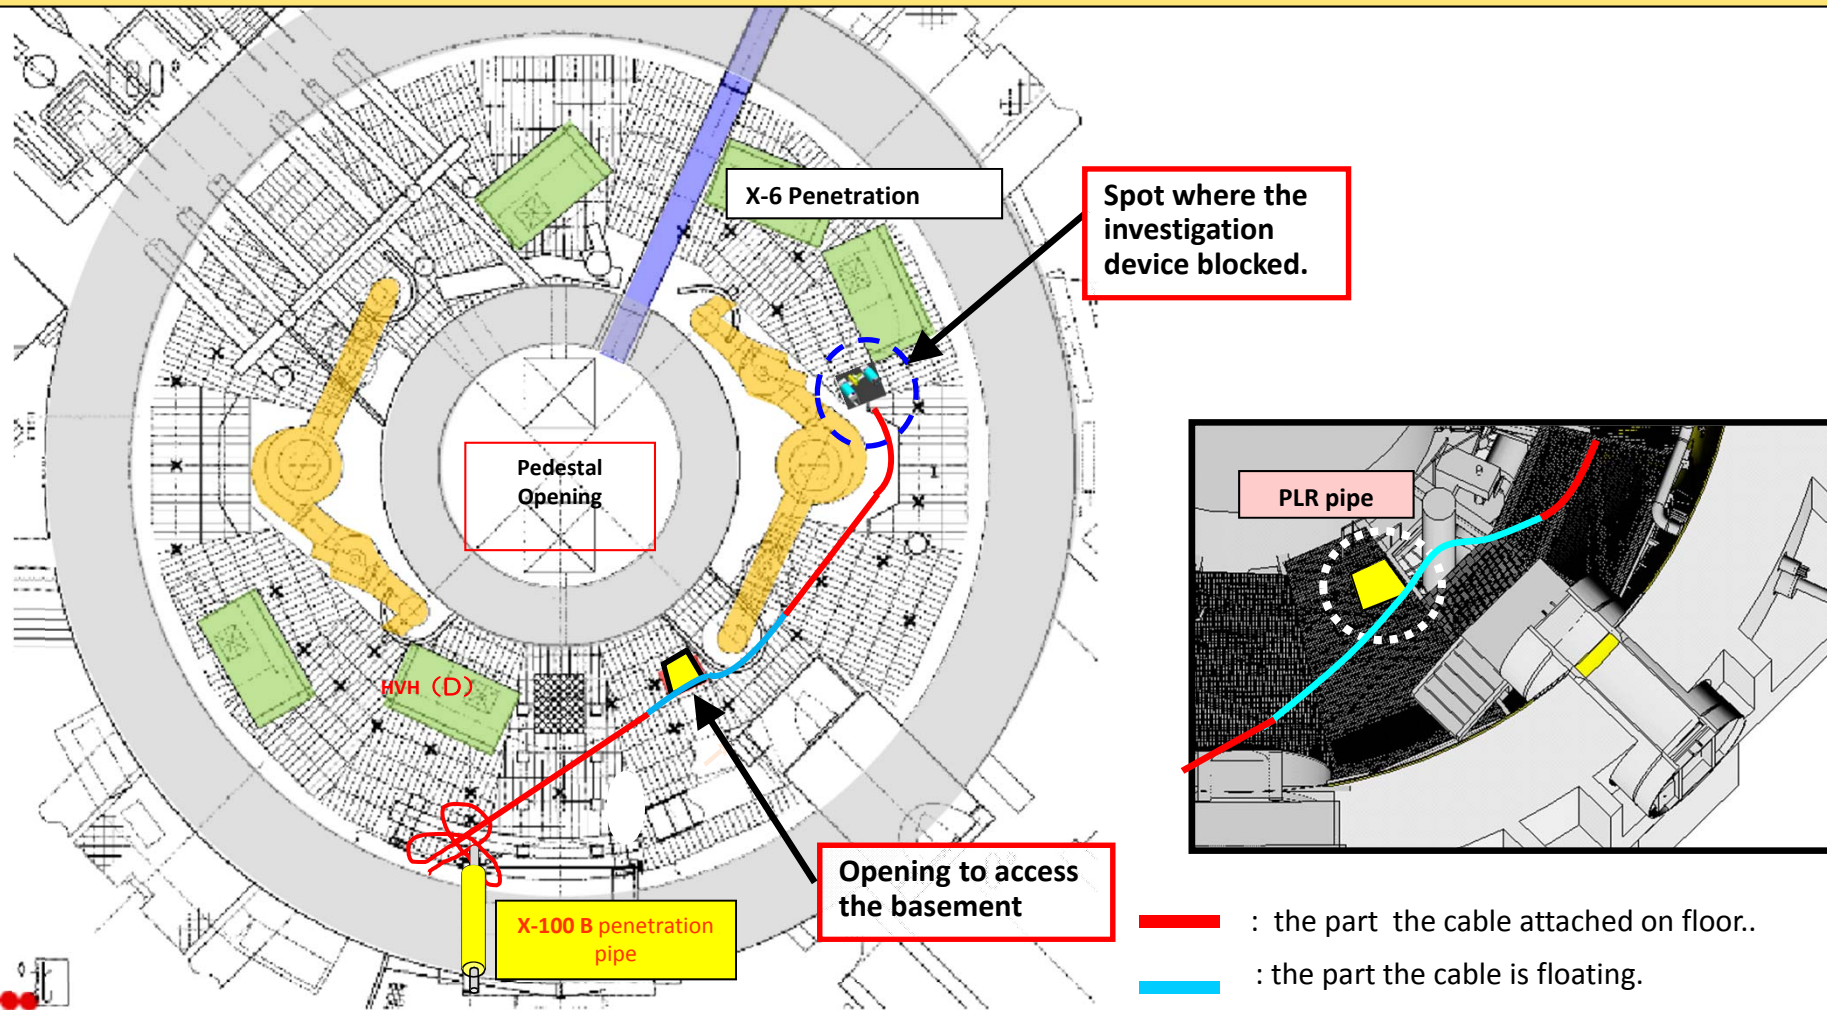
- The route of remaining cables is shown as below.
- **It was confirmed that** the remaining cable around the opening to access the basement **will be no obstacle to B2 investigation.**

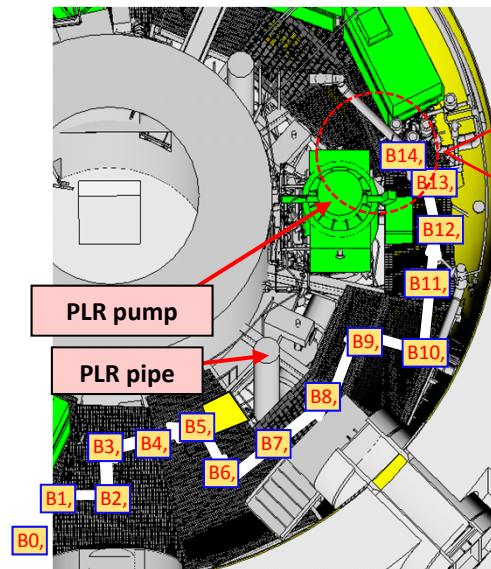
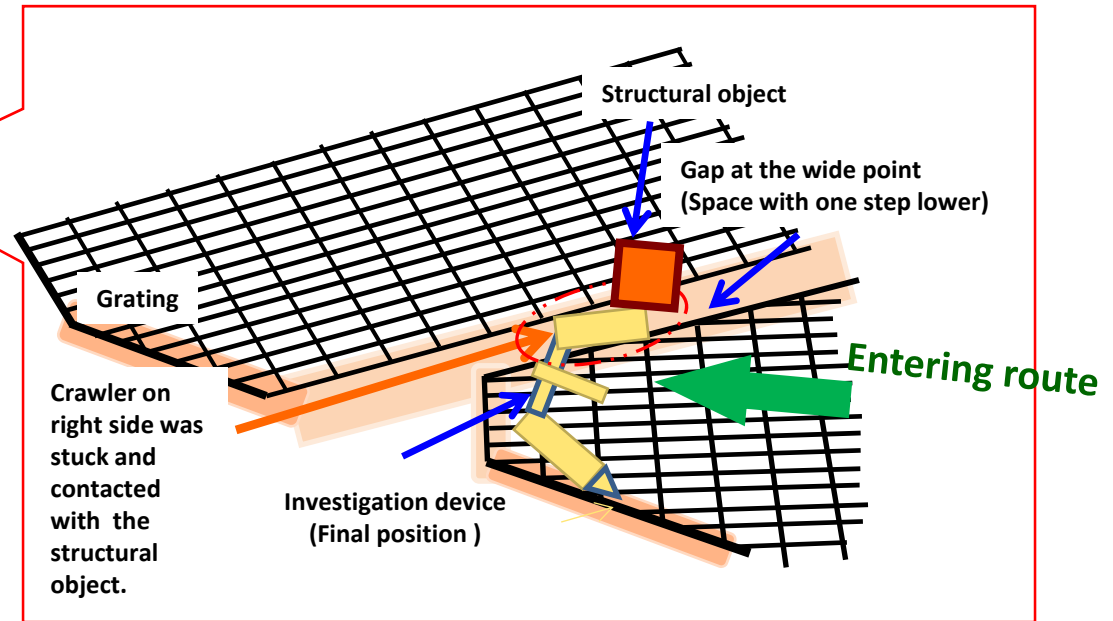
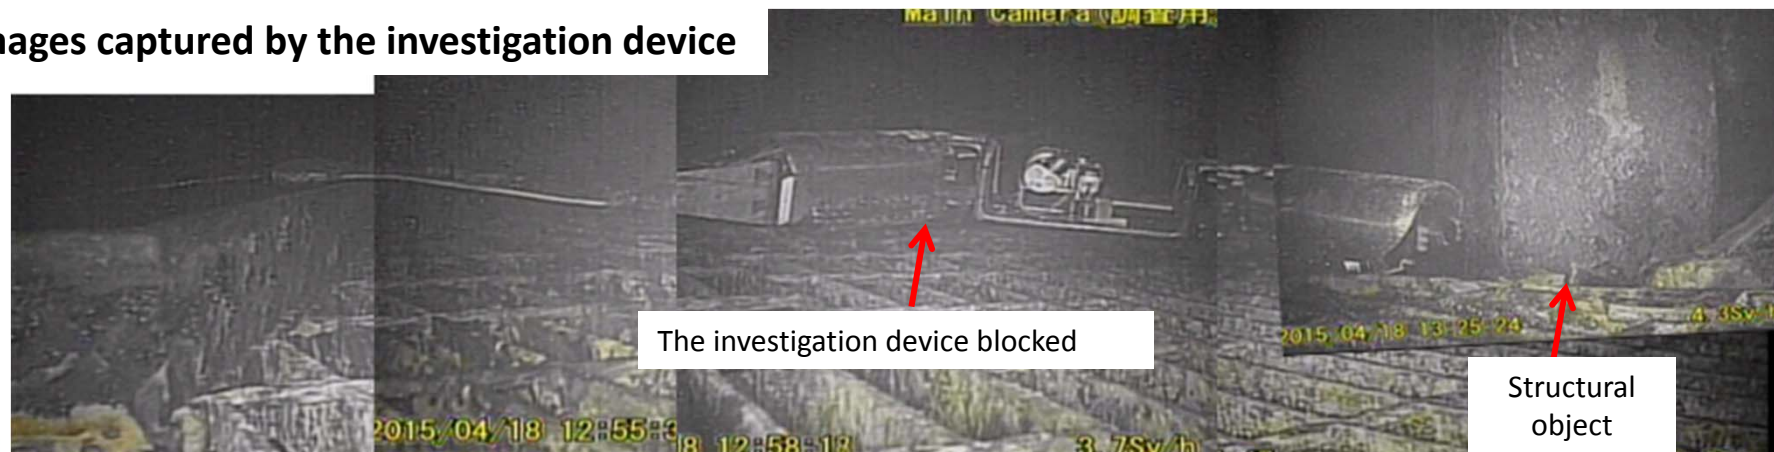
Images captured by the investigation device

The situation of the investigation device blocked is shown as below, which is almost compatible with what has been assumed.

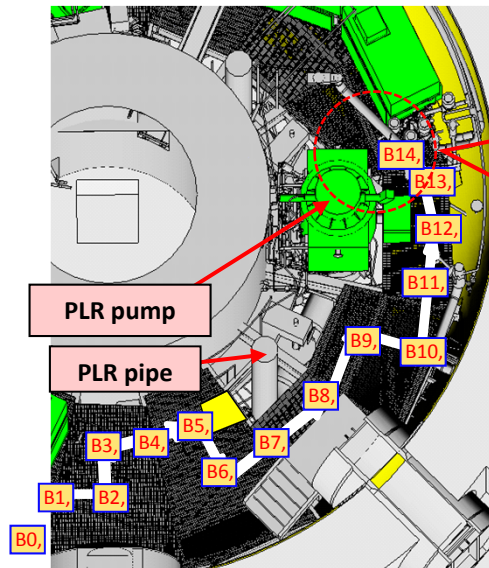
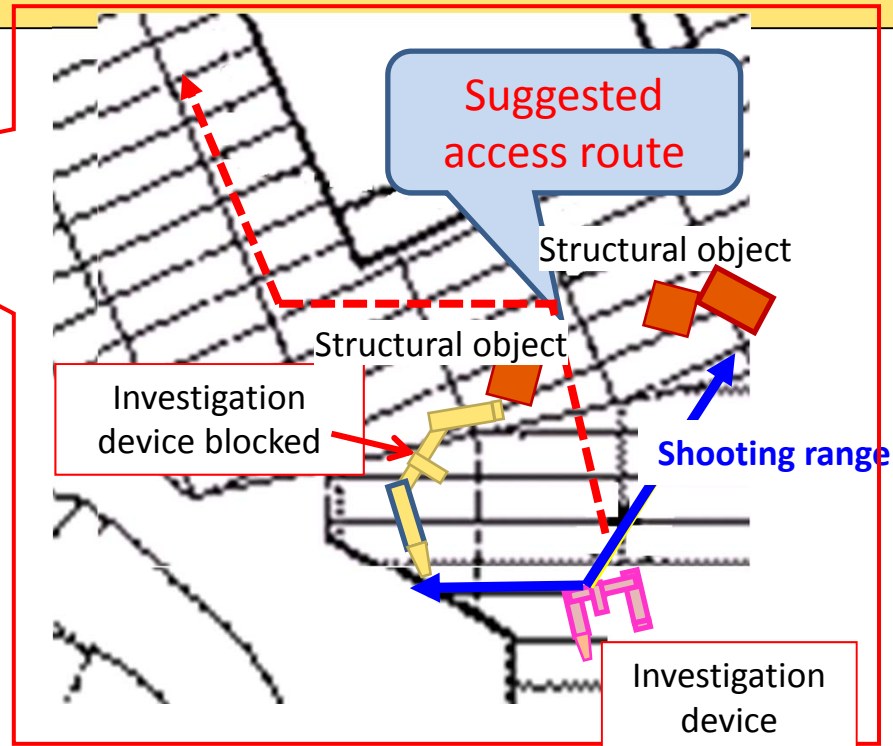
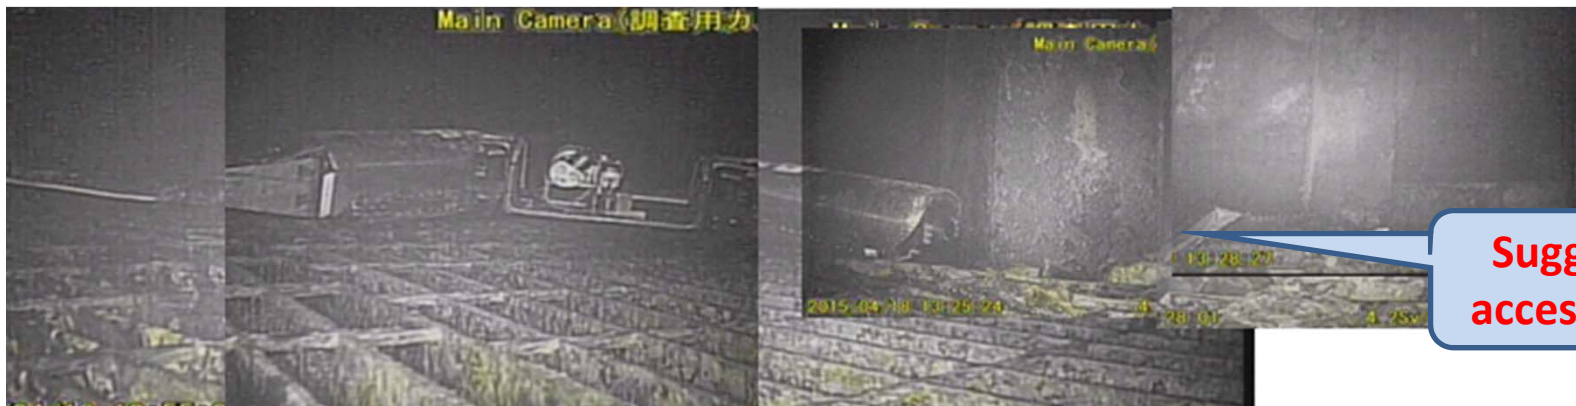
Suggested access route

It was judged that the suggested access route to CRD rail would be **too narrow to get the device pass through between the two structural objects.**

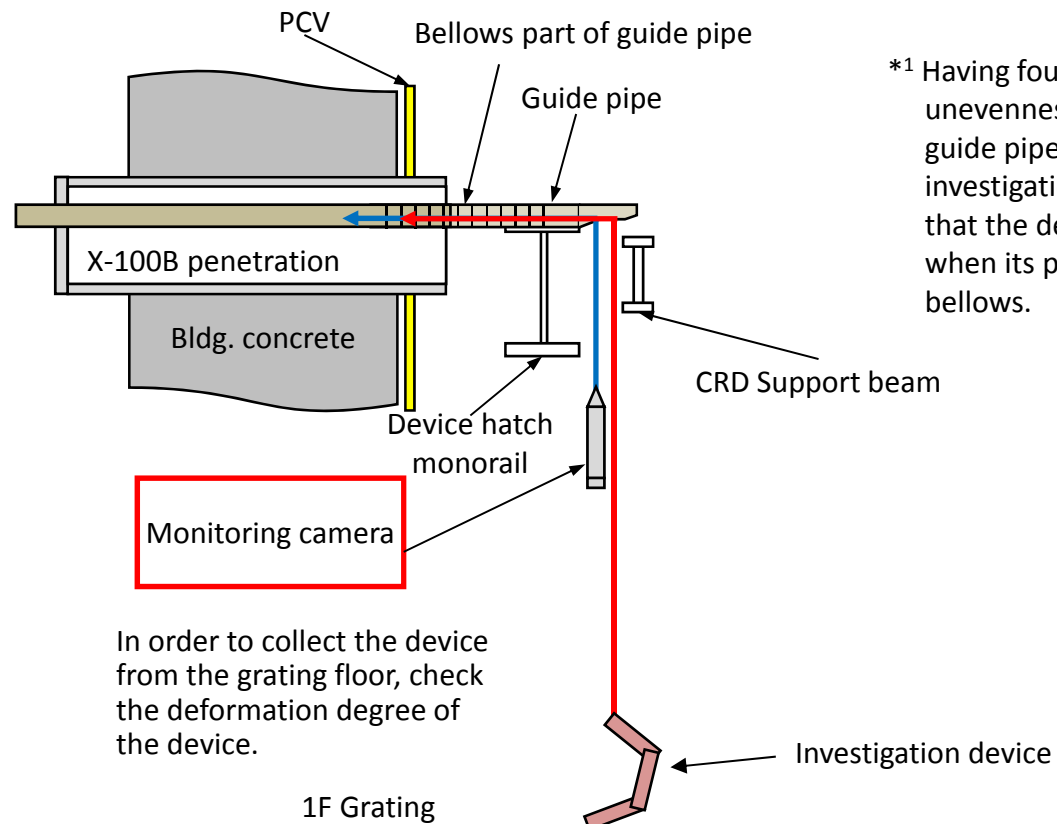
- Earning information inside the reactor primary containment vessel, which is the main purpose of this investigation, has been achieved.
- Due to the deterioration of the monitoring camera with radiation, it became disabled to perform a deformation check on the device. Accordingly, the collection of the device to outside the reactor primary containment vessel has been judged as risky. (\*1)

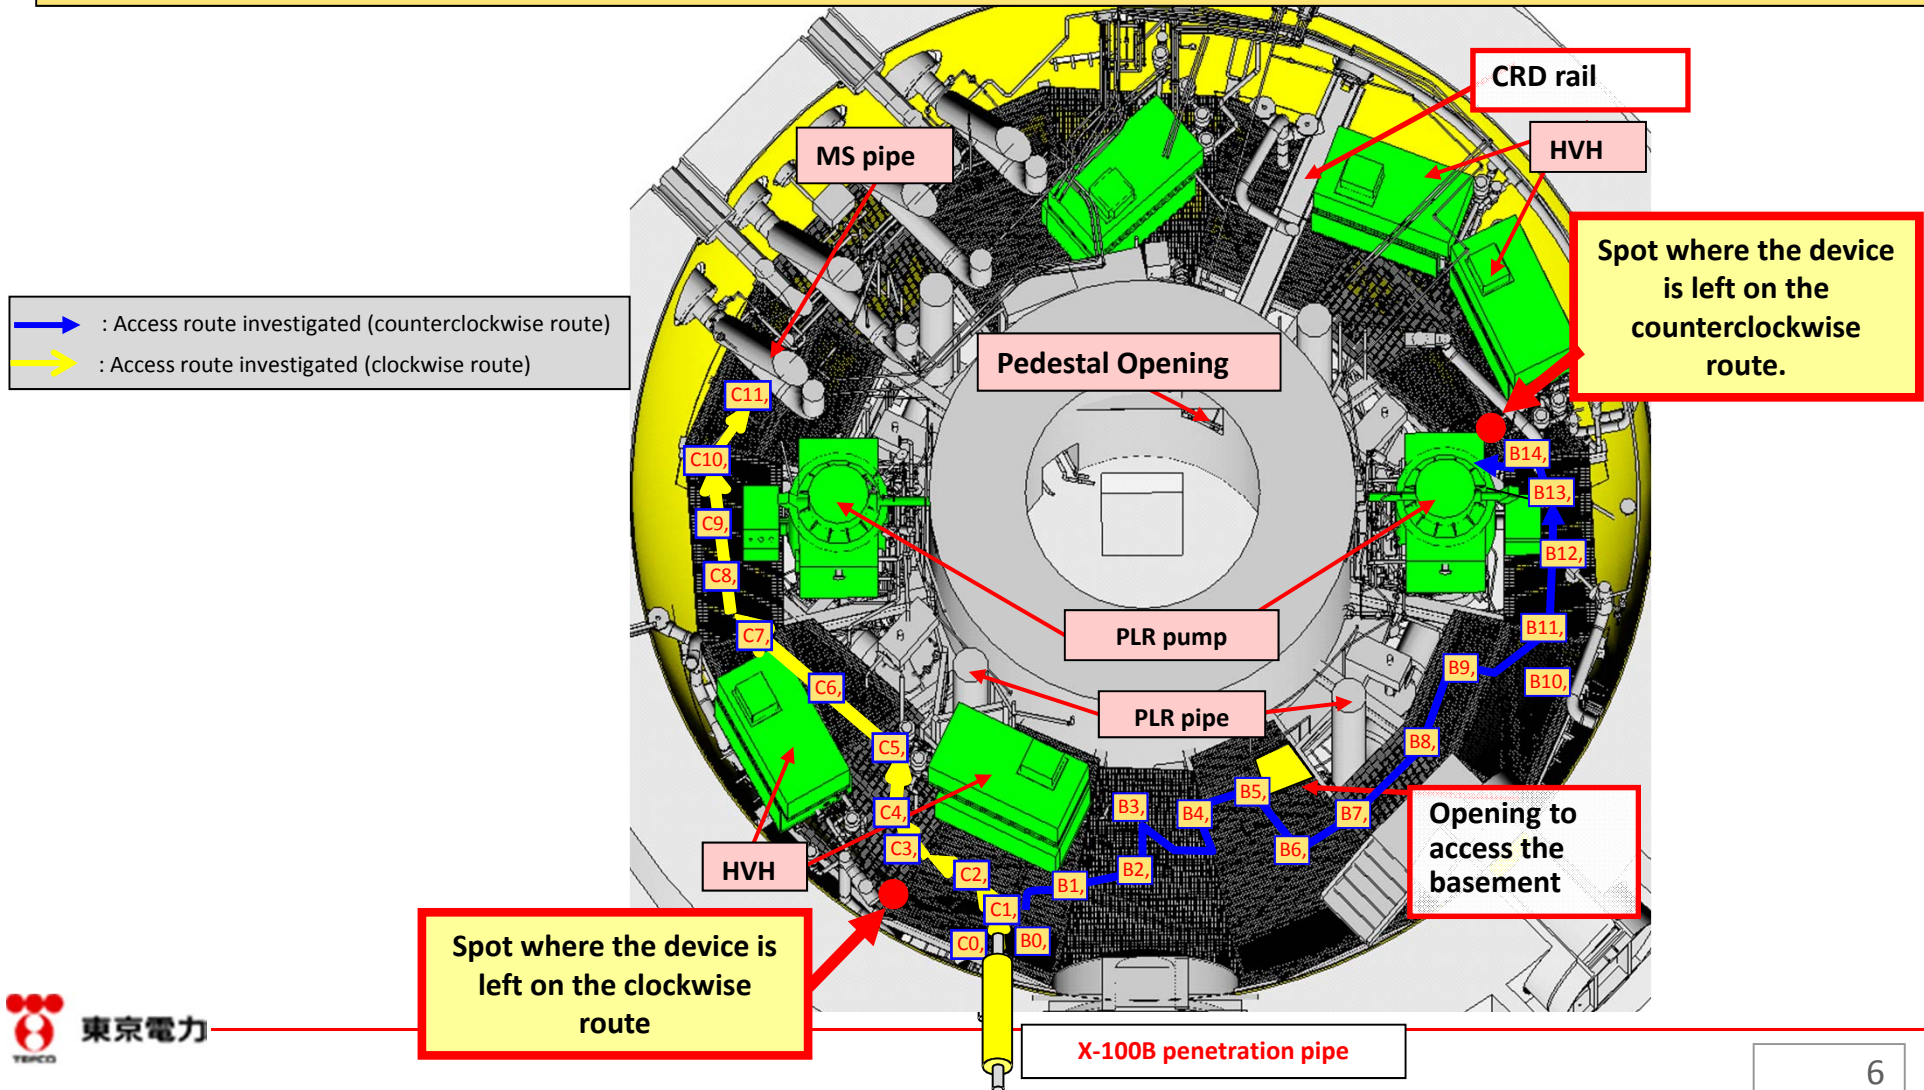
- Locations where the devices are left are shown as below. Those are places that are able to retain the devices in a stable state.
- The remaining devices will be no obstacle to B2 investigation.

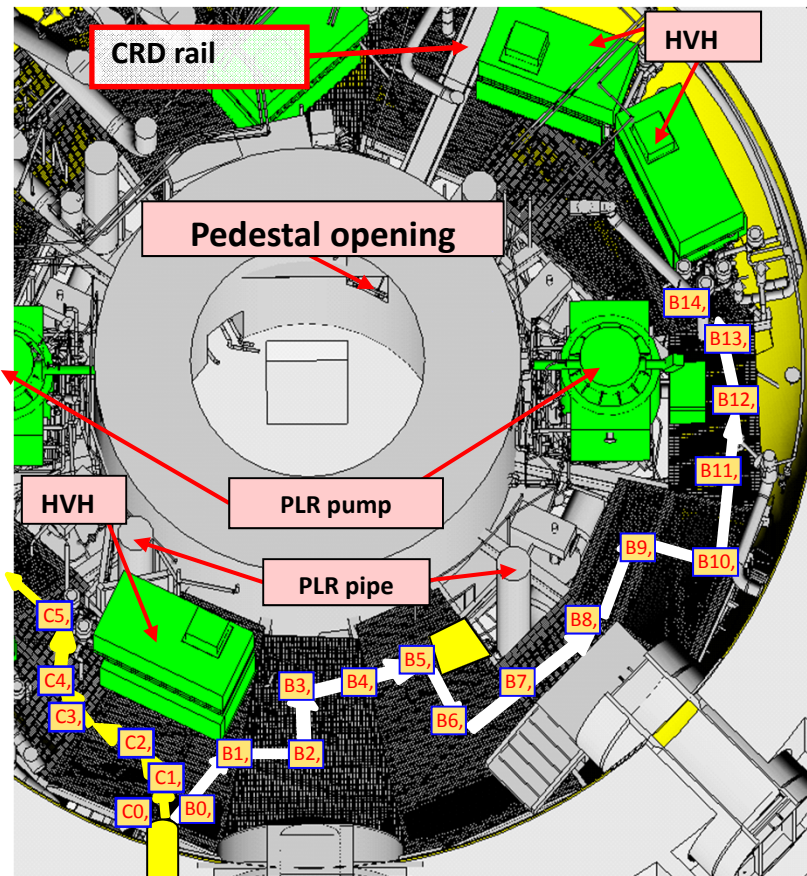
Temperature and dose rate were measured at the following points.

Dose rate (Sv/h)	Temperature (°C)
Around B14	<b>4.4</b>	<b>17.9</b>
Around B11	<b>5.7</b>	<b>18.7</b>
Around B7	<b>5.9</b>	<b>19.1</b>
Final point (around C3)	<b>4.1</b>	<b>20.4</b>
