**Comprehensive Risk Review of all the possible risks
which might have an impact outside the site
boundary of the Fukushima Daiichi Nuclear Power
Station**

～ Result of Comprehensive Risk Review ～

April 28, 2015

Tokyo Electric Power Company

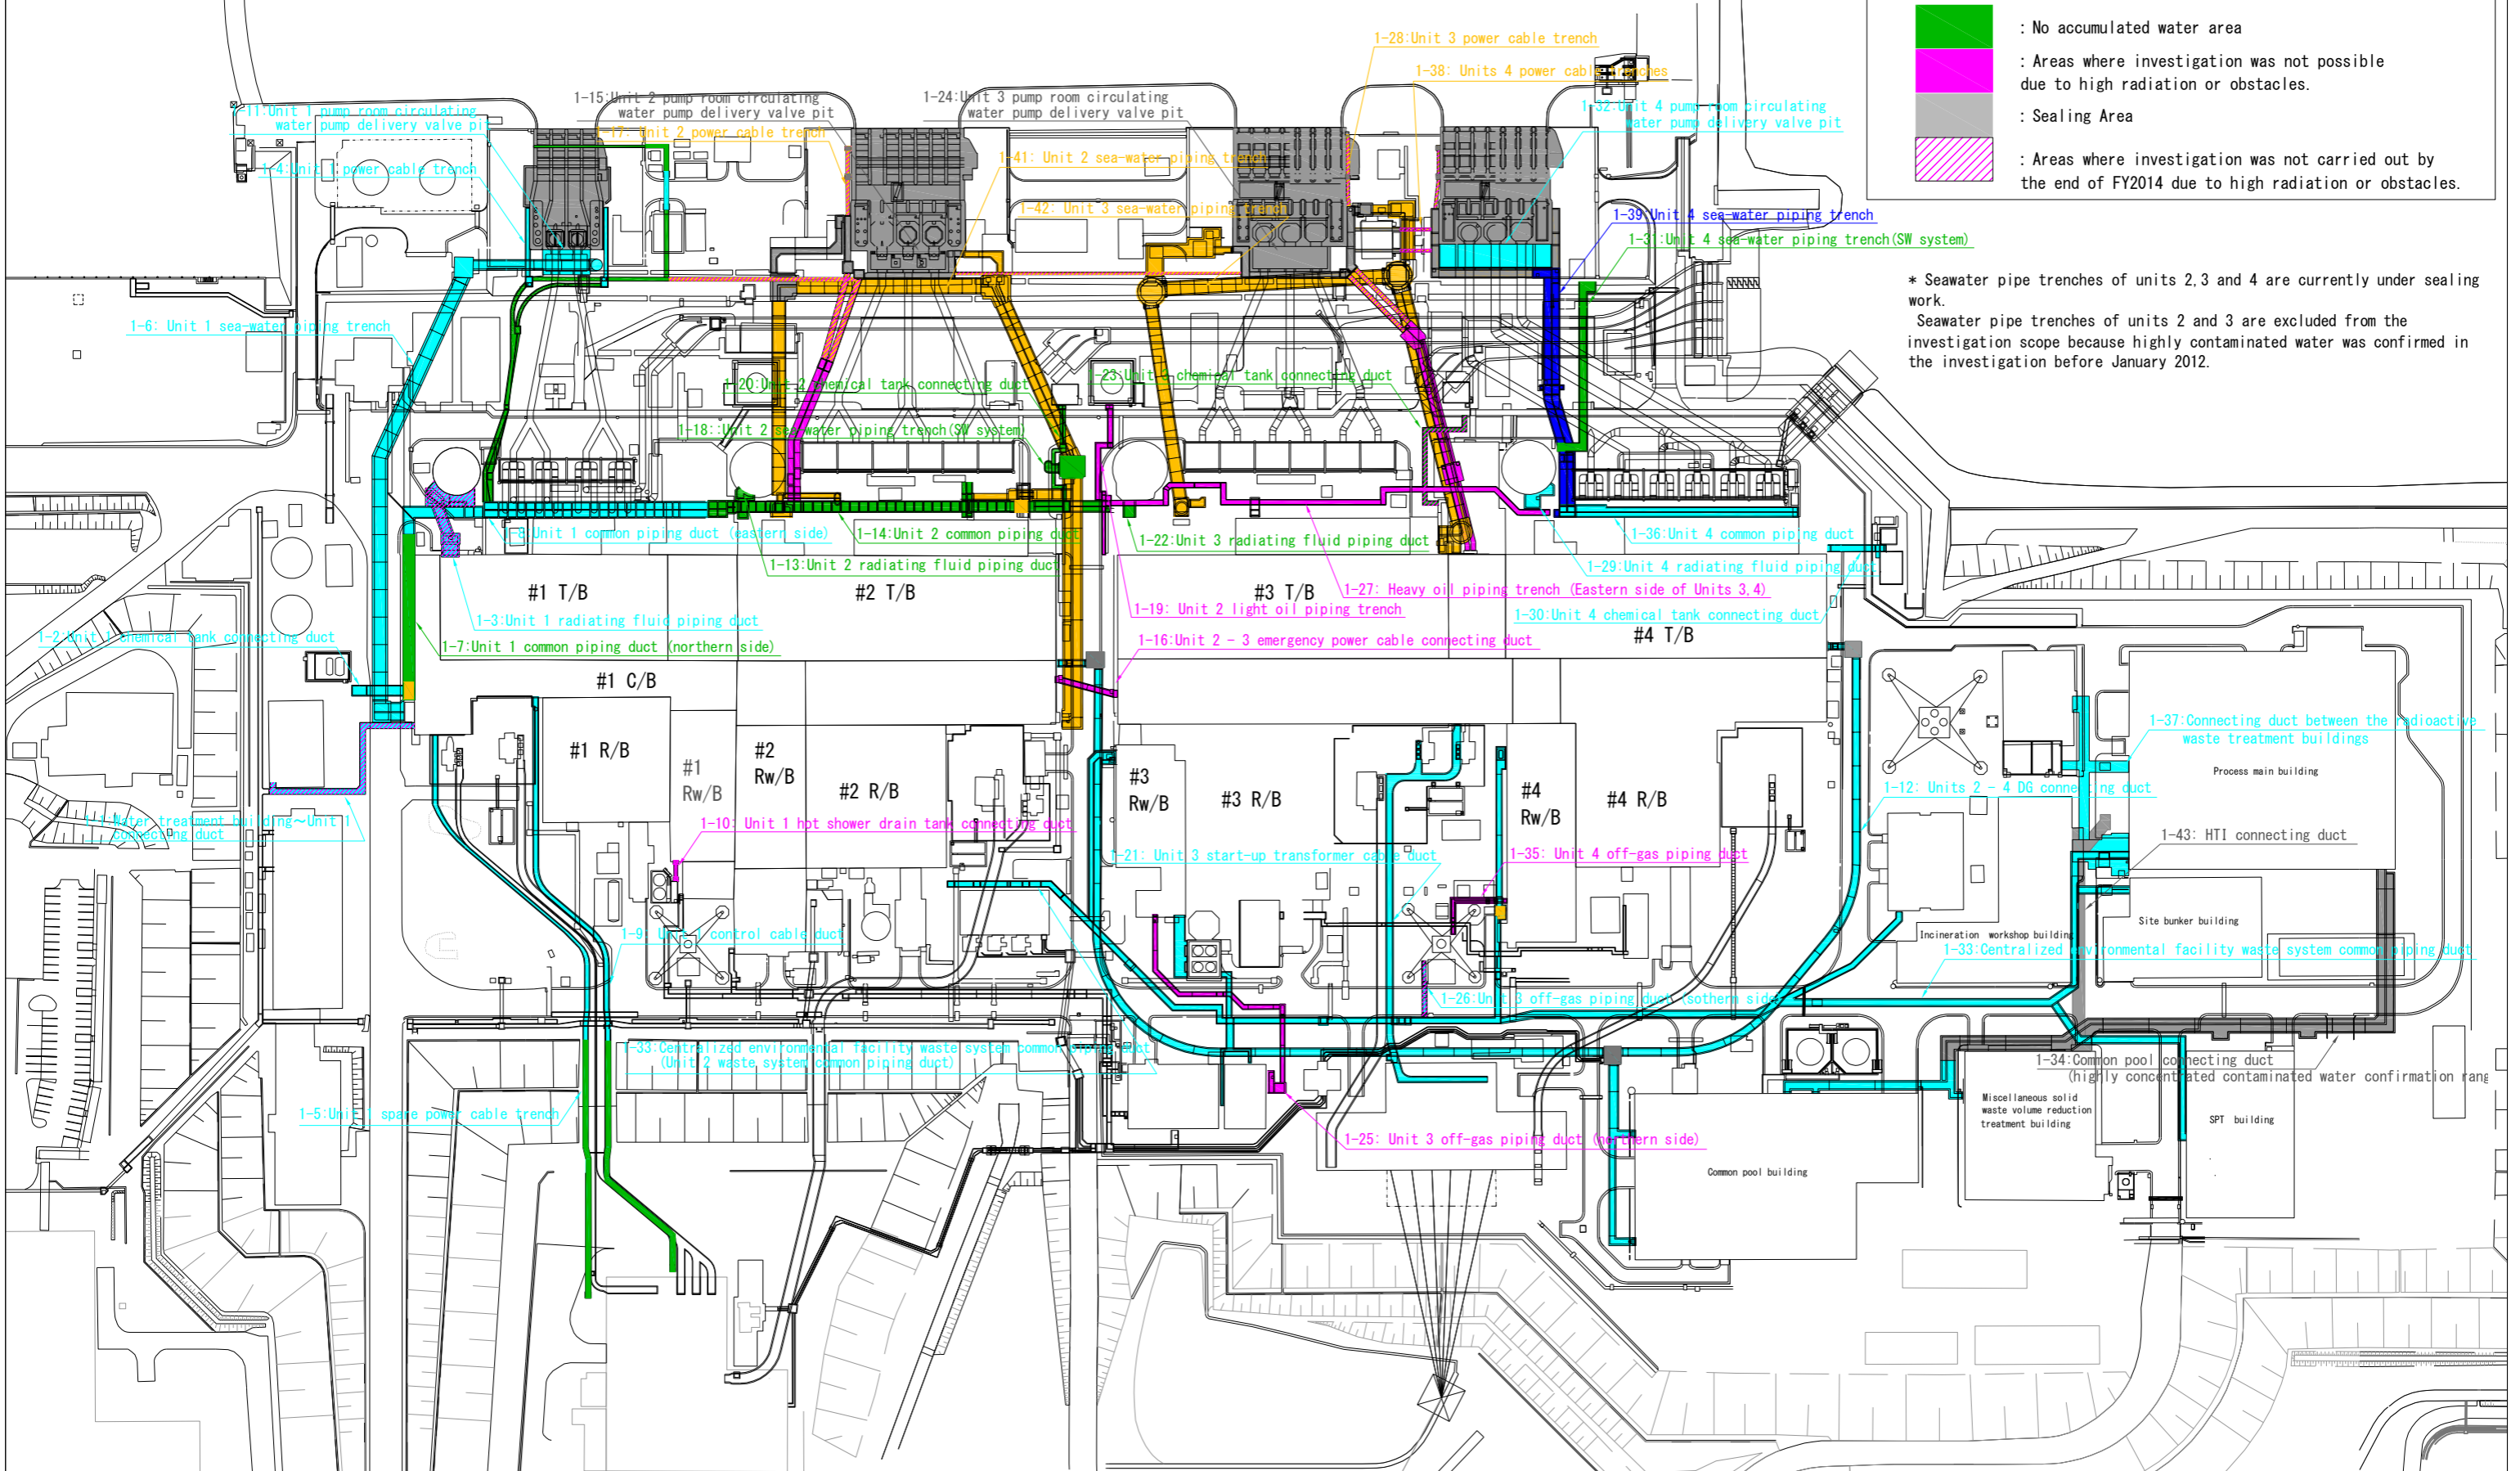
: Areas where investigation was not carried out by the end of FY2014 due to high radiation or obstacles.

* Seawater pipe trenches of units 2,3 and 4 are currently under sealing work.
Seawater pipe trenches of units 2 and 3 are excluded from the investigation scope because highly contaminated water was confirmed in the investigation before January 2012.

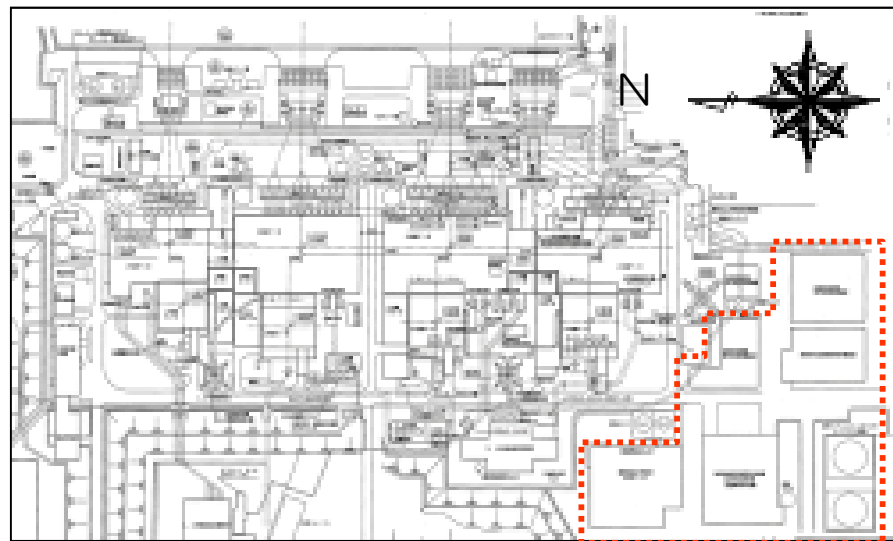
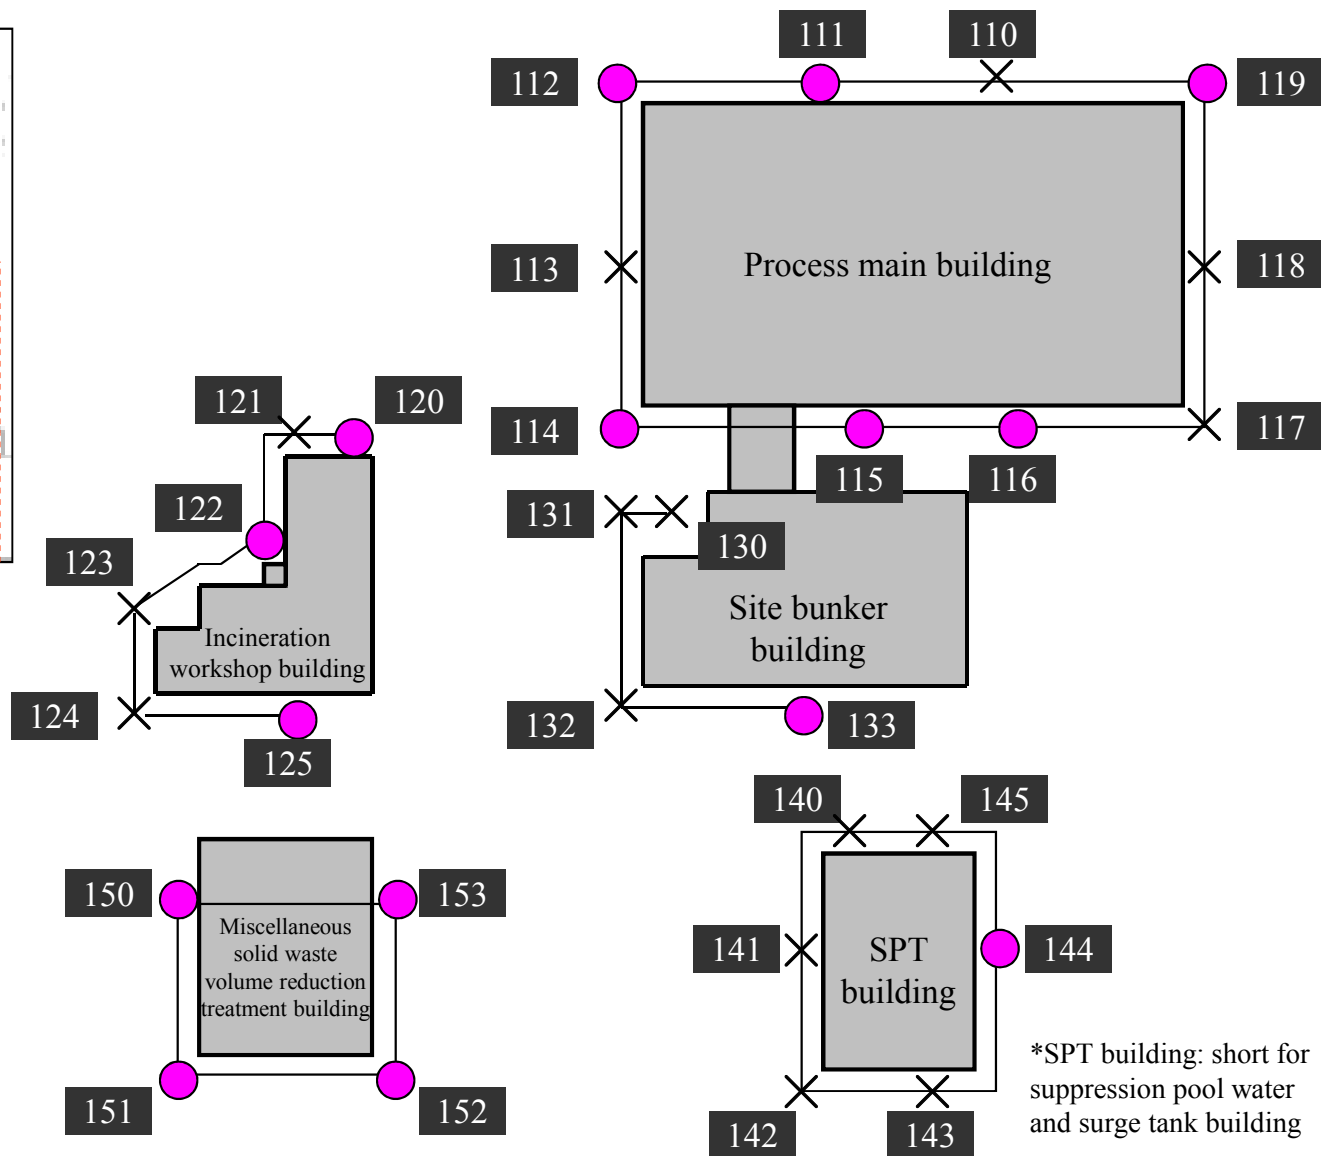
【Reference】 Regarding water quality investigation of each building's sub-drain pit

- Conducted water quality investigation of water accumulated in the 17 existing sub-drain pits from December 12 to draft a method for restoring the sub-drains in each building.

● : Investigated [17 units]

✕ : Unable to investigate [18 units]
