# **Investigation Results of the Inside of Unit 3's Primary Containment Vessel (PCV)**

**(Prompt report as of October 20)**

October 20, 2015

Tokyo Electric Power Company

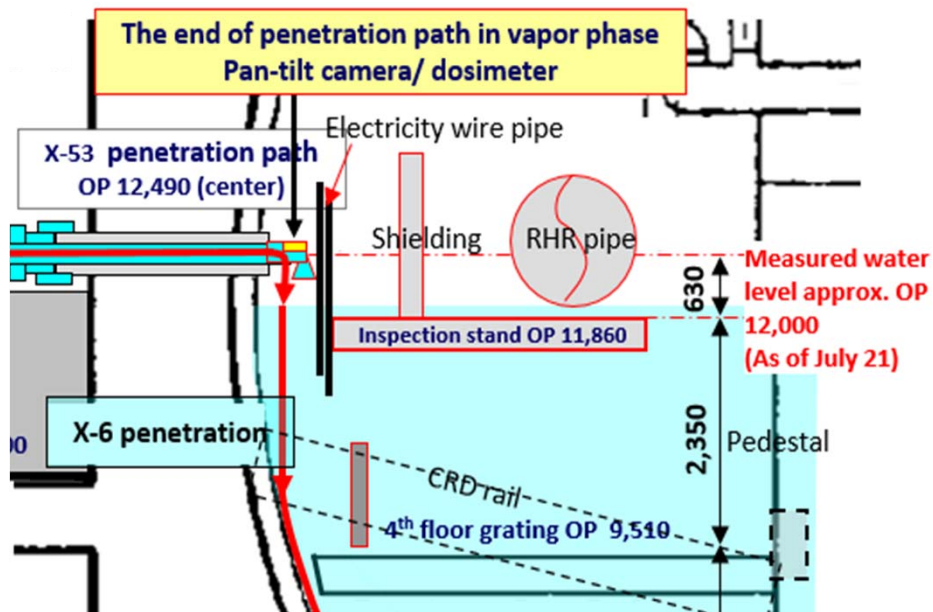
- No damage of the structures inside the PCV (RHR pipe, D/W spray sparger, interior lights) and the PCV's inner wall was found within the investigation range.
- The most radiation dose measured in vapor phase inside the PCV was approximately 1 Sv/h.

No.	Measurement Points	Measurement Values
①	In the vicinity of the PCV's inner wall	Approx. 1 Sv/h
②	550mm away from the end of penetration path	Approx. 0.75 Sv/h

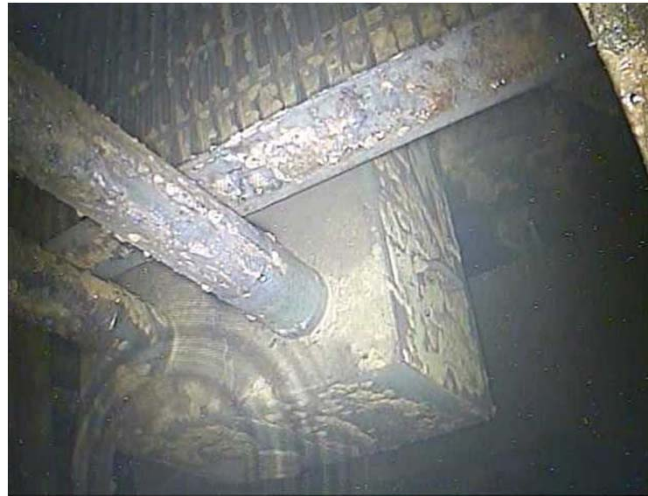
The bottom of inspection stand (with water surface)

- The water level inside the PCV mostly agreed with the estimated level\*, by investigating the water surface inside of the PCV in the vicinity of the upper surface of inspection stand (under evaluation). (\*OP: approx. 12,000)
- The temperatures inside the PCV were approx. 26~27°C in vapor phase and approx. 33~35°C underwater.

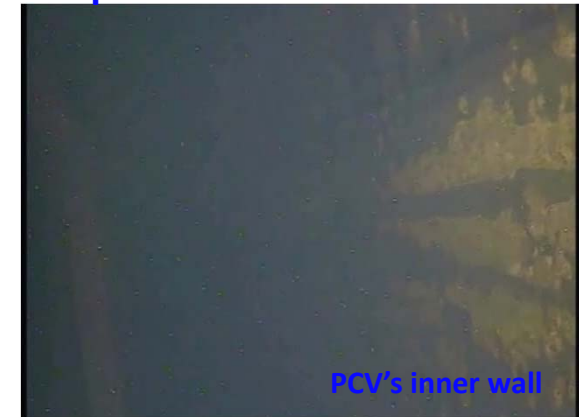
"a" part

- The investigation was conducted from the X-53 penetration path to the 1<sup>st</sup> floor grating because the space between the 1<sup>st</sup> floor grating and the PCV's inner wall was narrow and filled with sediments.
- No damage on the PCV's inner wall was found within the investigation range.

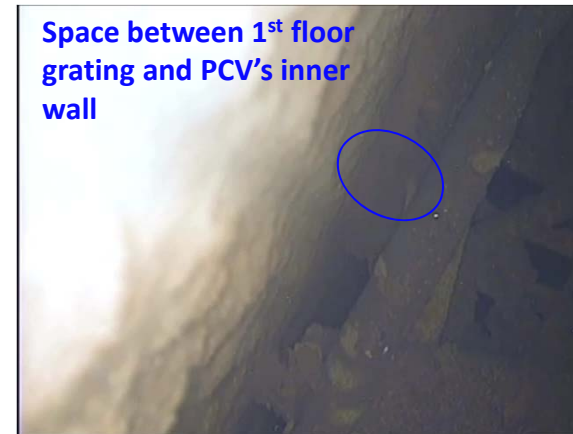
"b" part

Space between 1<sup>st</sup> floor grating and PCV's inner wall

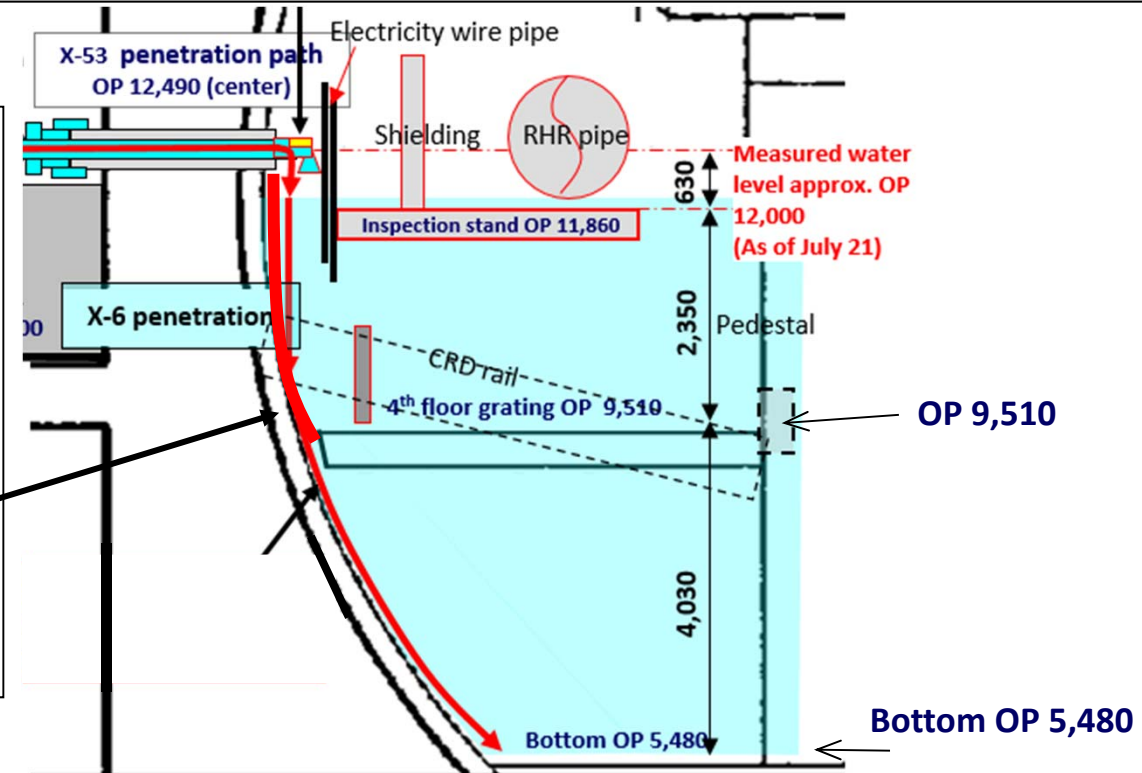
Temperature measurement points:  
7 measurement points at approx.  
500 mm intervals from the end of  
penetration path to the 1<sup>st</sup> floor  
grating\*

\*The measurements were conducted  
to the extent possible because the  
camera could not be inserted to the  
bottom of PCV.
