Unit 2 Primary Containment Vessel Investigation
at Fukushima Daiichi Nuclear Power Station
(By the self-propelled investigation device)

Tokyo Electric Power Company Holdings, Inc.

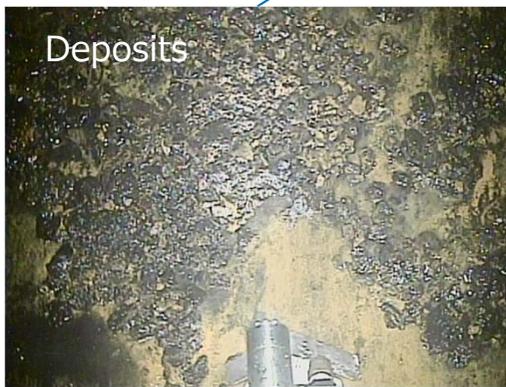
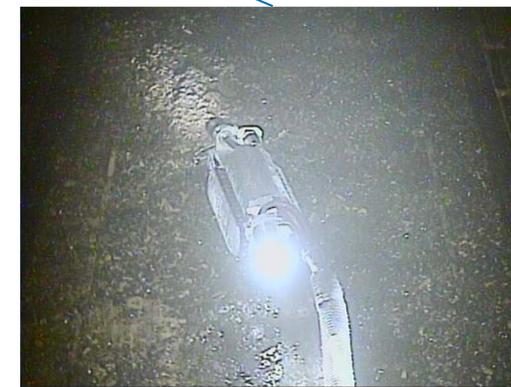
Images from guiding pipe camera

- The deposits on the CRD rail was the mixture of black paste and thin pieces of or gravel-sized materials.
- The deposits on the upper part of the CRD rail was soft but it adhered more to the lower part of the rail.
- The deposit removal device could get on the deposits but could not run on them for some parts.

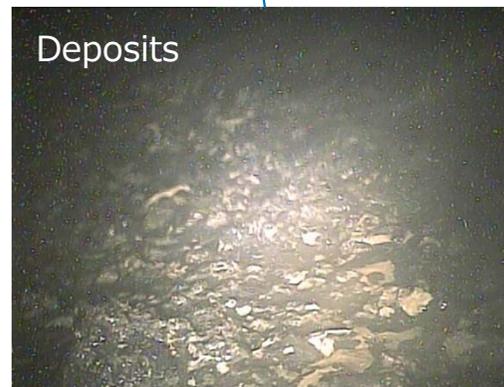
Images from front camera attached to the deposit removal device

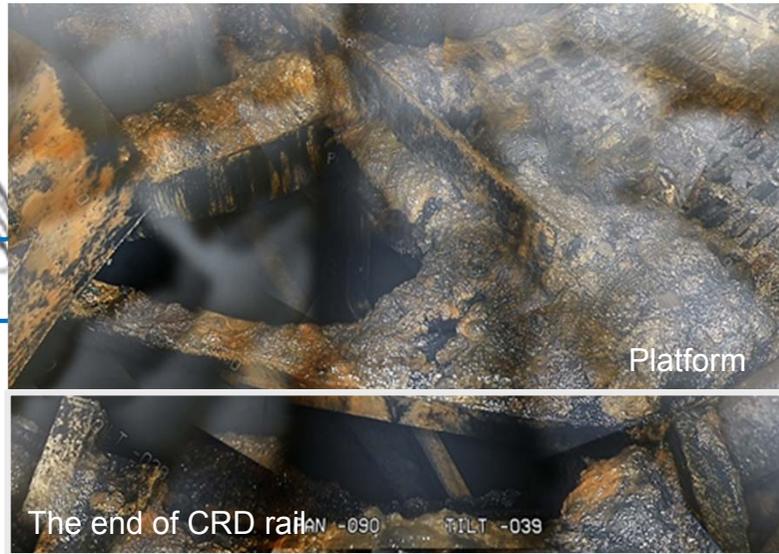
- There was a gap (about 150 to 40mm) between the CRD rail and platform as expected.
- There were some deposits on the platform.

The same part as the picture below

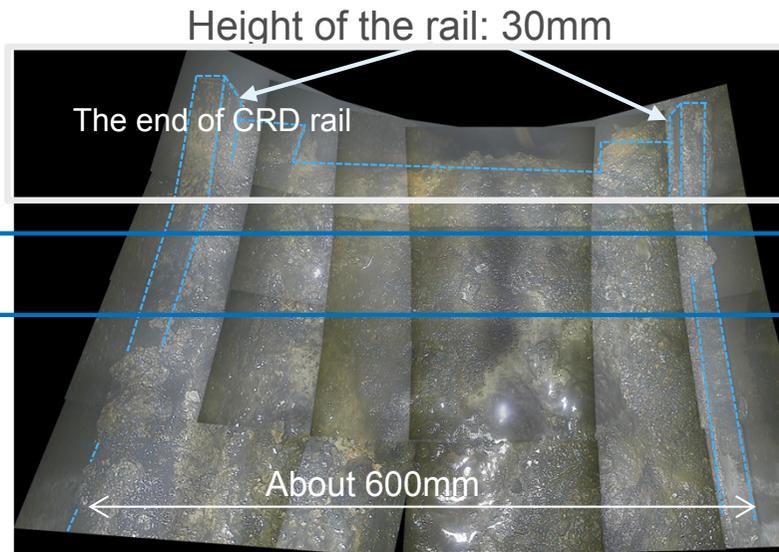
The same part as the above picture

- There were deposits all over the end of CRD rail.
- A part of the deposits was climbing over the edges of CRD rail.

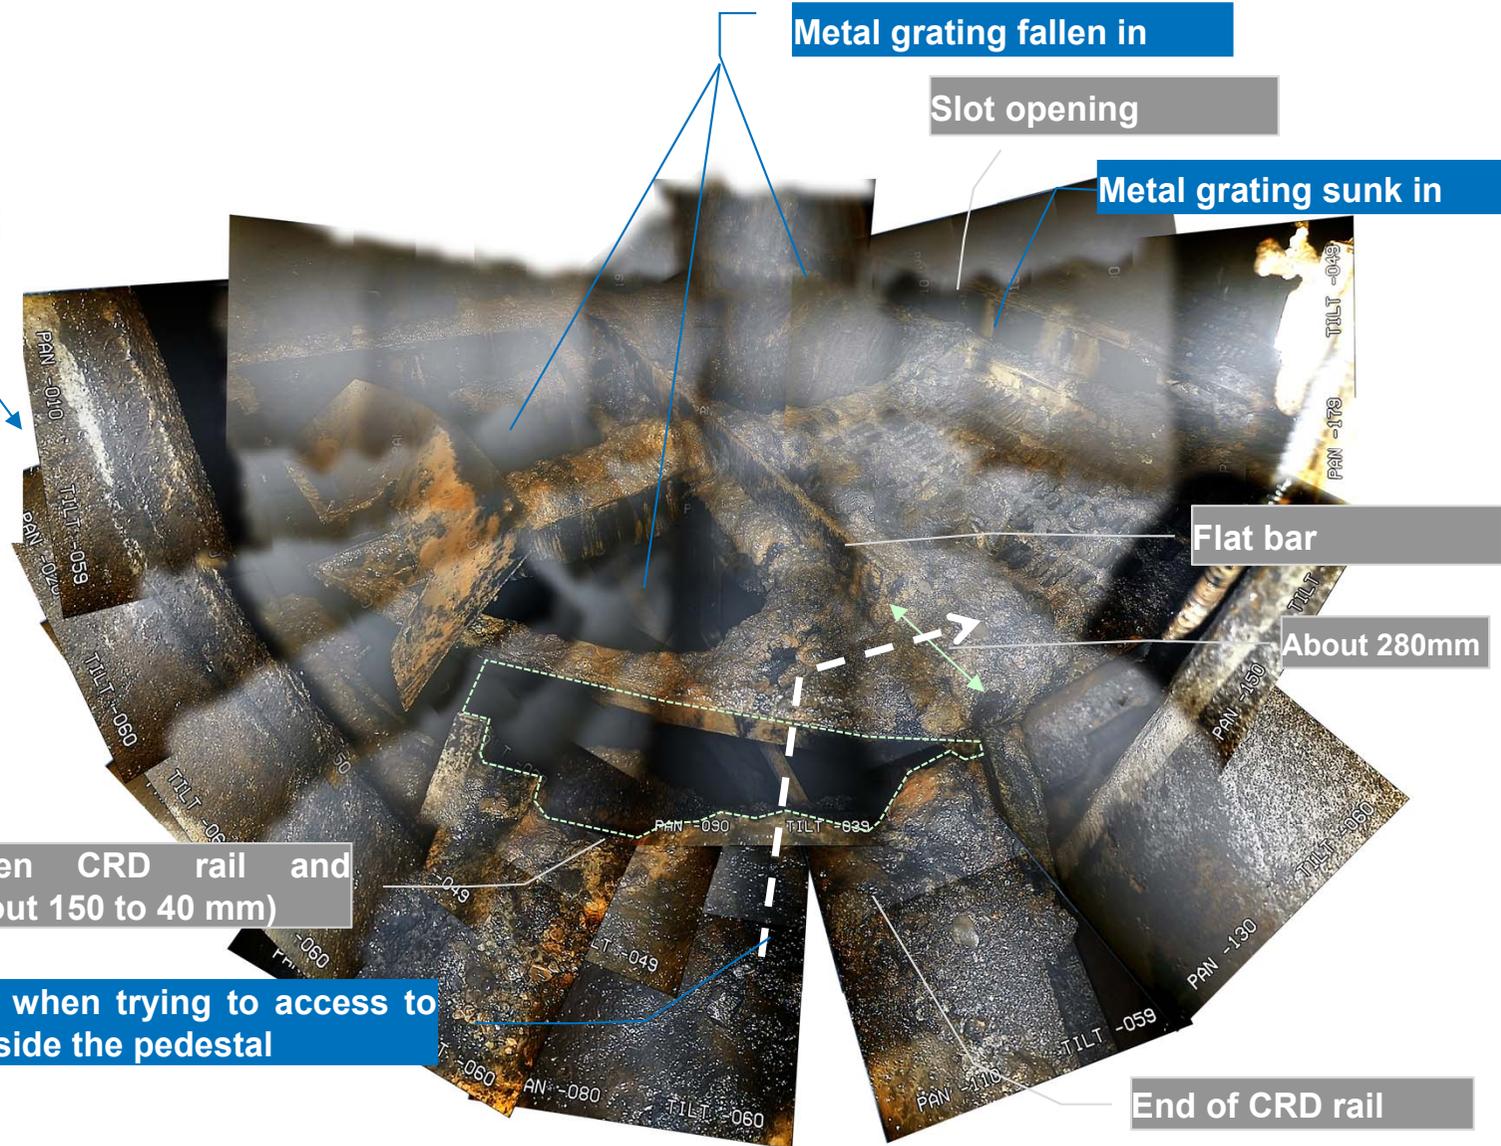
Digital image of Unit 2 pedestal area
obtained from preparatory investigations
