# 1. Progress of Unit 1 PCV internal investigation

(Preliminary report of March 19 investigation) 1/2

Reference  
March 21, 2017

Tokyo Electric Power Company Holdings, Inc.

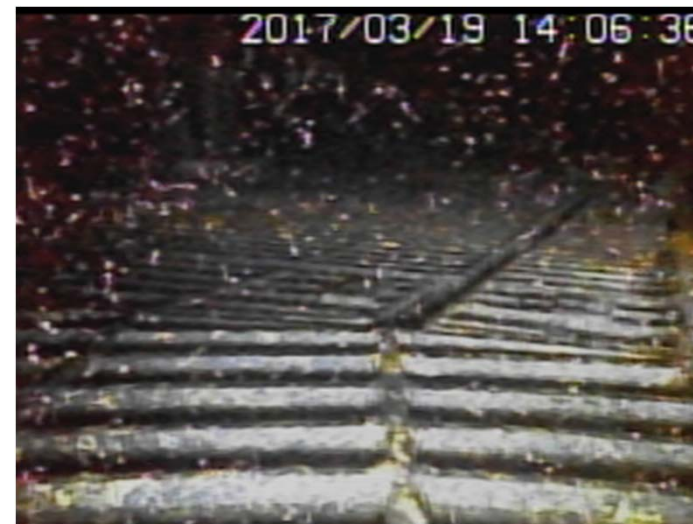
On the metal grating  
(Front left-side camera of the investigation device)

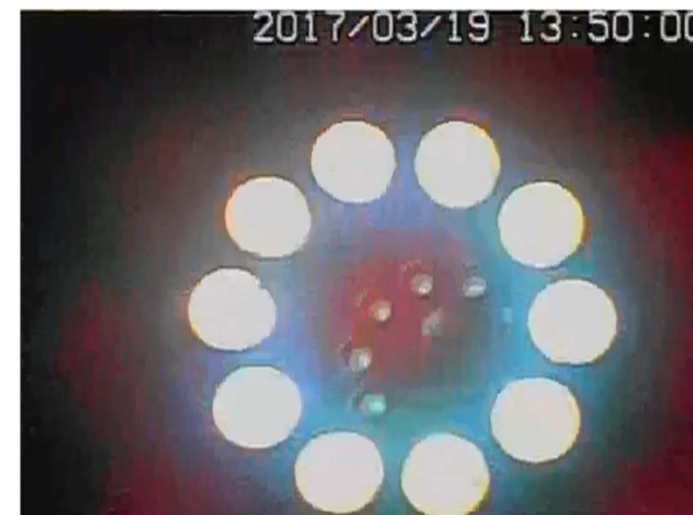
Measurement unit camera before inserted into the water

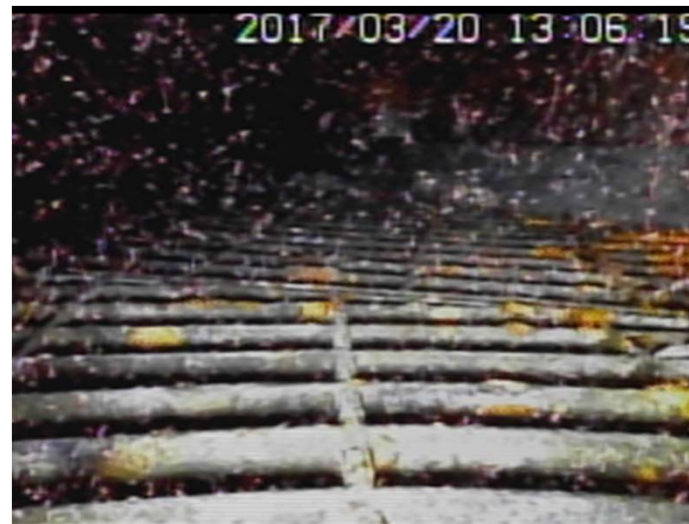
On the metal grating  
(Front left-side camera of the investigation device)

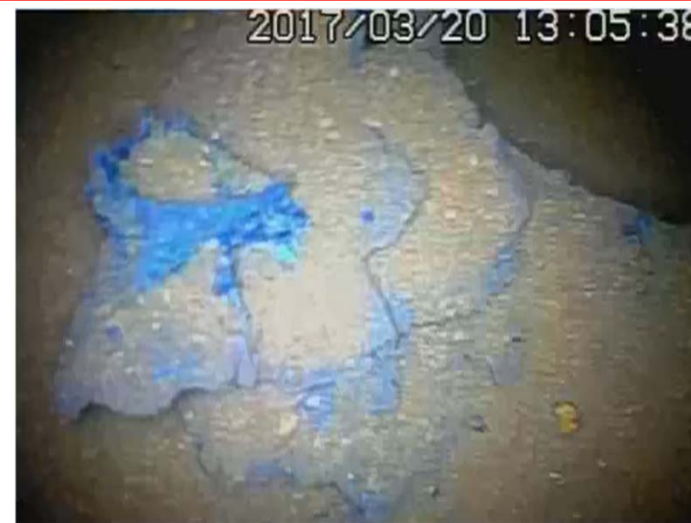
Underwater image at measuring point D2

Radiation dose at measurement point BG

(Provisional values)  
 • On metal grating: 12 Sv/h  
 • The lowest point: 6.3 Sv/h (About 1m above the PCV basement floor\*)

The conditions of PCV basement will be evaluated after organizing digital images and radiation data.

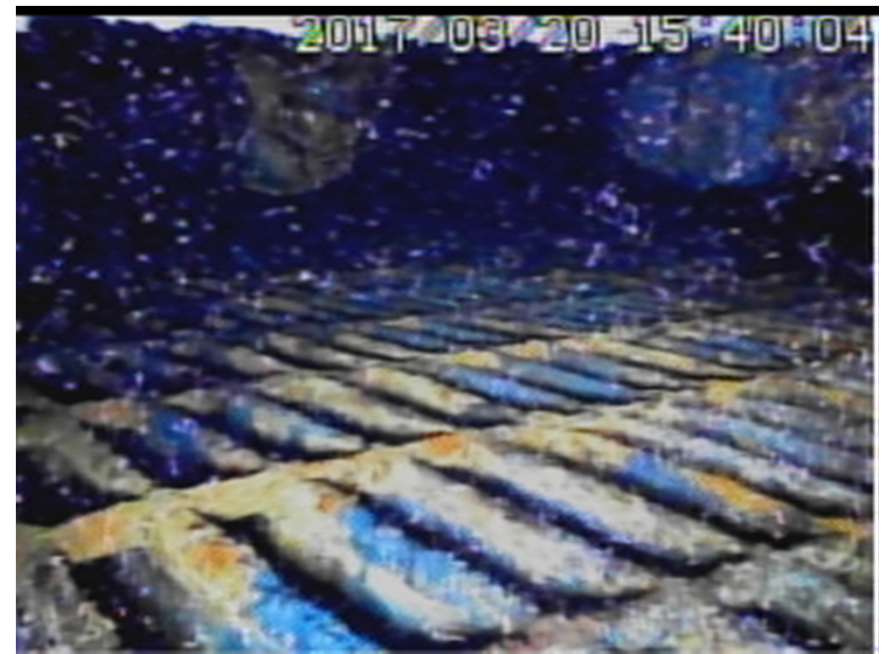
- The investigation device moved to the measurement point D1 because the access route between the measurement points D2 and D3 was narrow and there was a risk that the device cannot go through.
- The measurement point D3 will be prioritized on March 21 because it is close to the pedestal opening. The device will move to the measurement points D3 and then D1 to investigate those places.

On the metal grating  
between measurement points D2 and D3  
(Front left-side camera of the investigation device)
