# 1. Progress of Unit 1 PCV internal investigation

(Preliminary report of March 21 investigation) 1/4

Reference  
March 22, 2017

Tokyo Electric Power Company Holdings, Inc.

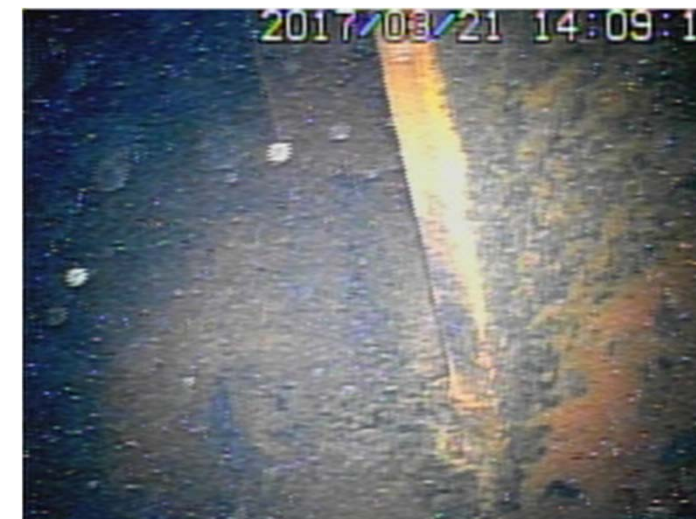
Underwater image at the measuring point D3

Radiation dose at the measurement point D3 (Provisional values)

- On metal grating: 10 Sv/h
- The lowest point: 3.0 Sv/h (About 1.6m above the PCV basement floor\*)

The conditions of PCV basement will be evaluated after organizing digital images and radiation data.

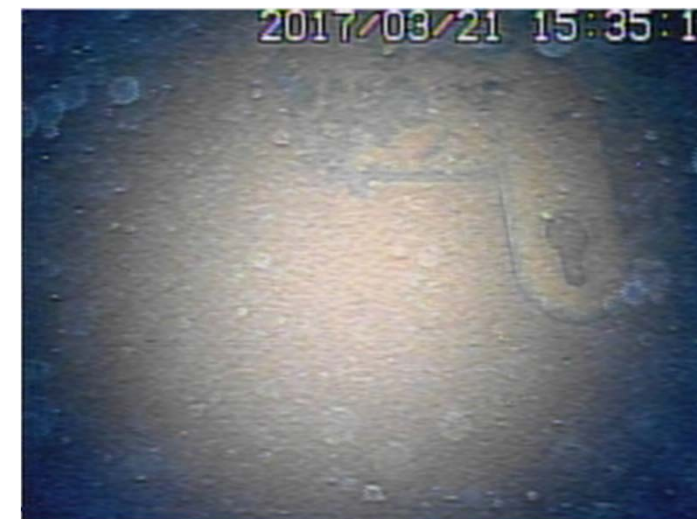
Underwater image between the measurement points D1 and D2

Radiation dose between the measurement points D1 and D2 (Provisional values)

- On metal grating: 8.4 Sv/h
- The lowest point: 6.3 Sv/h (About 0.9m above the PCV basement floor<sup>\*2</sup>)

The conditions of PCV basement will be evaluated after organizing digital images and radiation data.

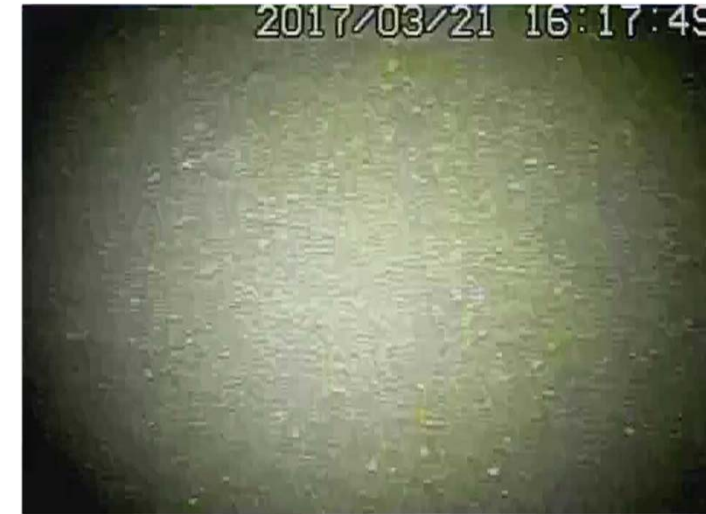
Underwater image between the measurement points D1 and D2

Radiation dose between the measurement points D1 and D2 (Provisional values)

- On metal grating: 8.2 Sv/h
- The lowest point: 5.9 Sv/h (About 0.9m above the PCV basement floor<sup>\*2</sup>)

The conditions of PCV basement will be evaluated after organizing digital images and radiation data.

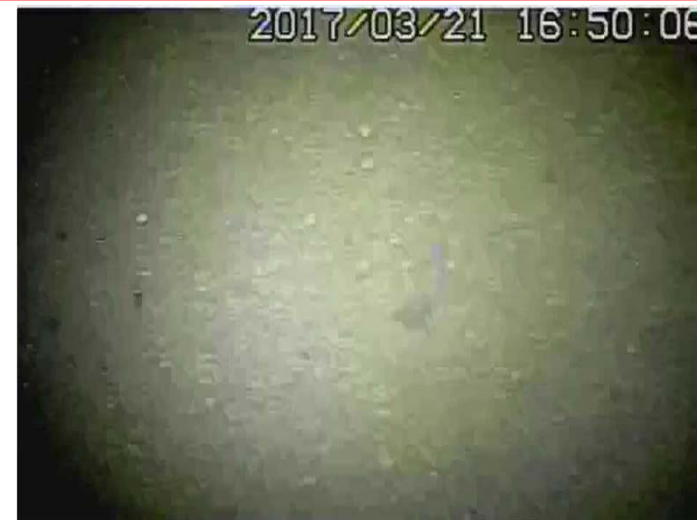
Underwater image between the measurement points D1 and D2
