# 1. Progress of Unit 1 PCV internal investigation

(Preliminary report of March 22 investigation) 1/3

Reference  
March 23, 2017

Tokyo Electric Power Company Holdings, Inc.

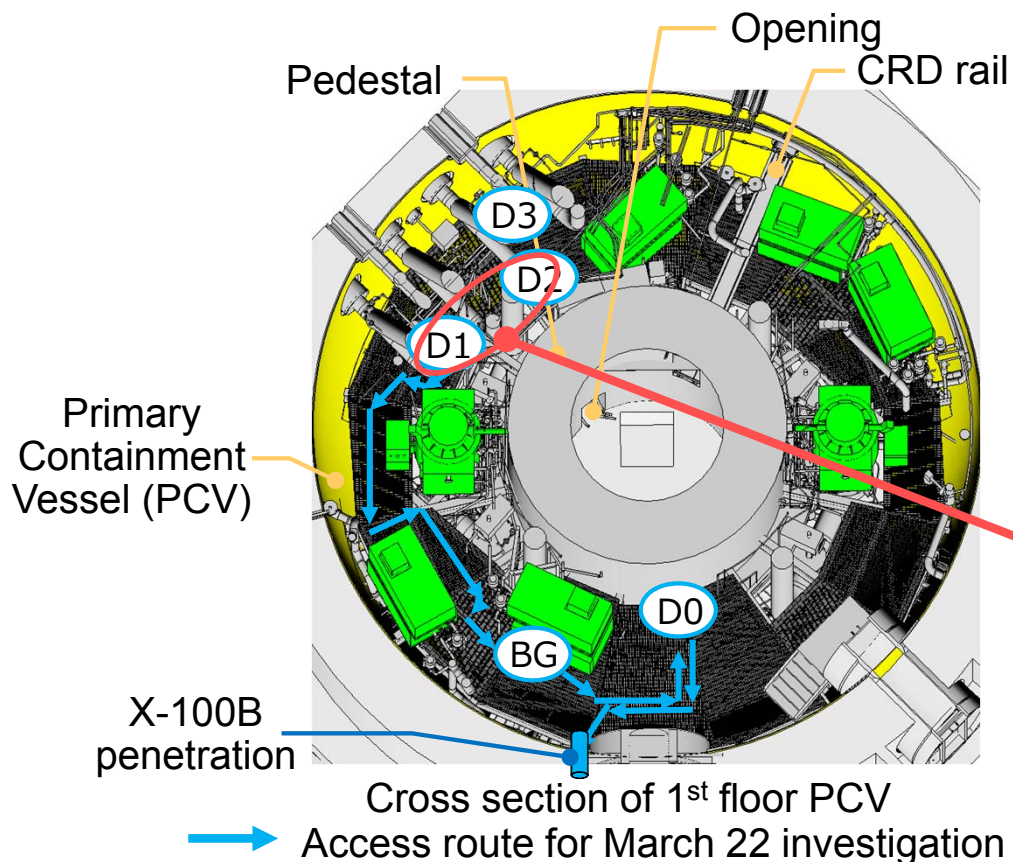
Underwater image at the vicinity of the measuring point D2

Radiation dose at the vicinity of the measurement point D2 (Provisional values)

- On metal grating: 9.3 Sv/h
- The lowest point: 9.4 Sv/h (About 0.9m above the PCV basement floor\*)

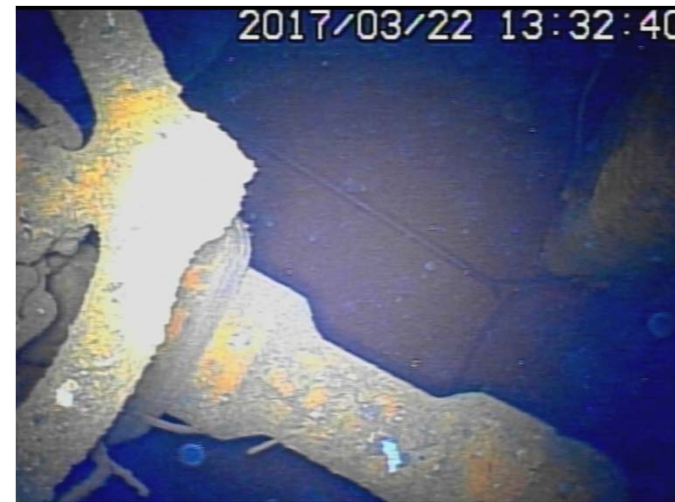
Underwater image at the measuring point D0

Radiation dose at the measurement point D0 (Provisional values)

- On metal grating: 6.7 Sv/h
- The lowest point: 1.6 Sv/h (About 0.6m above the PCV basement floor\*)

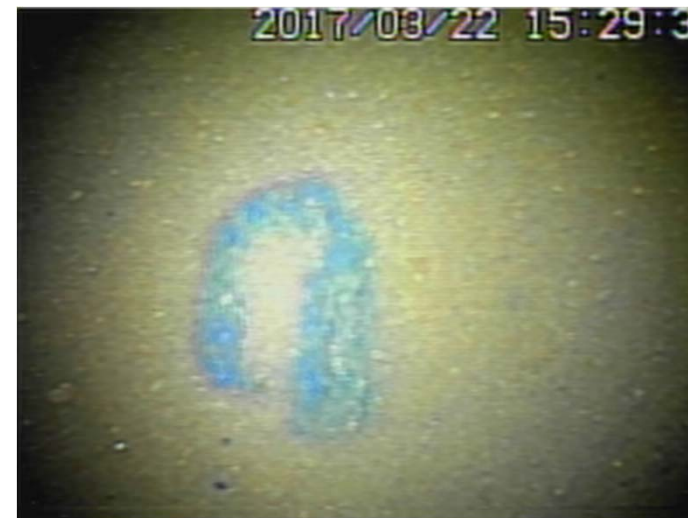
Underwater image at the measuring point D0

Radiation dose at the measurement point D0 (Provisional values)

- On metal grating: 3.6 Sv/h
- The lowest point: 5.4 Sv/h (About 0.3m above the PCV basement floor\*)

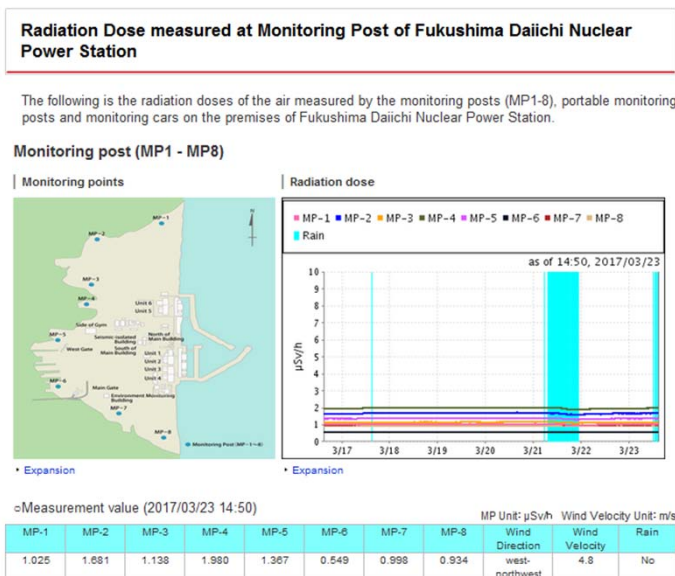
As of 1:50 p.m. on March 22, 2017: about 0.5-2.0  $\mu\text{Sv/h}$

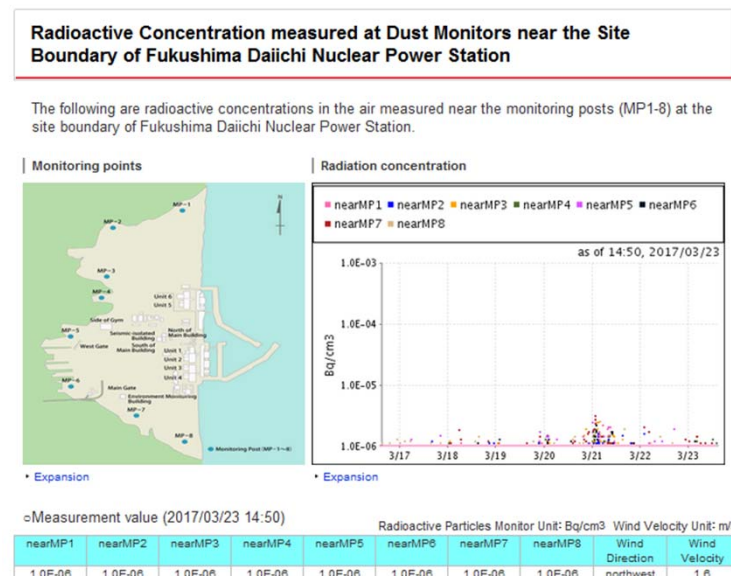
As of 10:50 a.m. on March 23, 2017: 1.0E-06 Bq/cm<sup>3</sup>

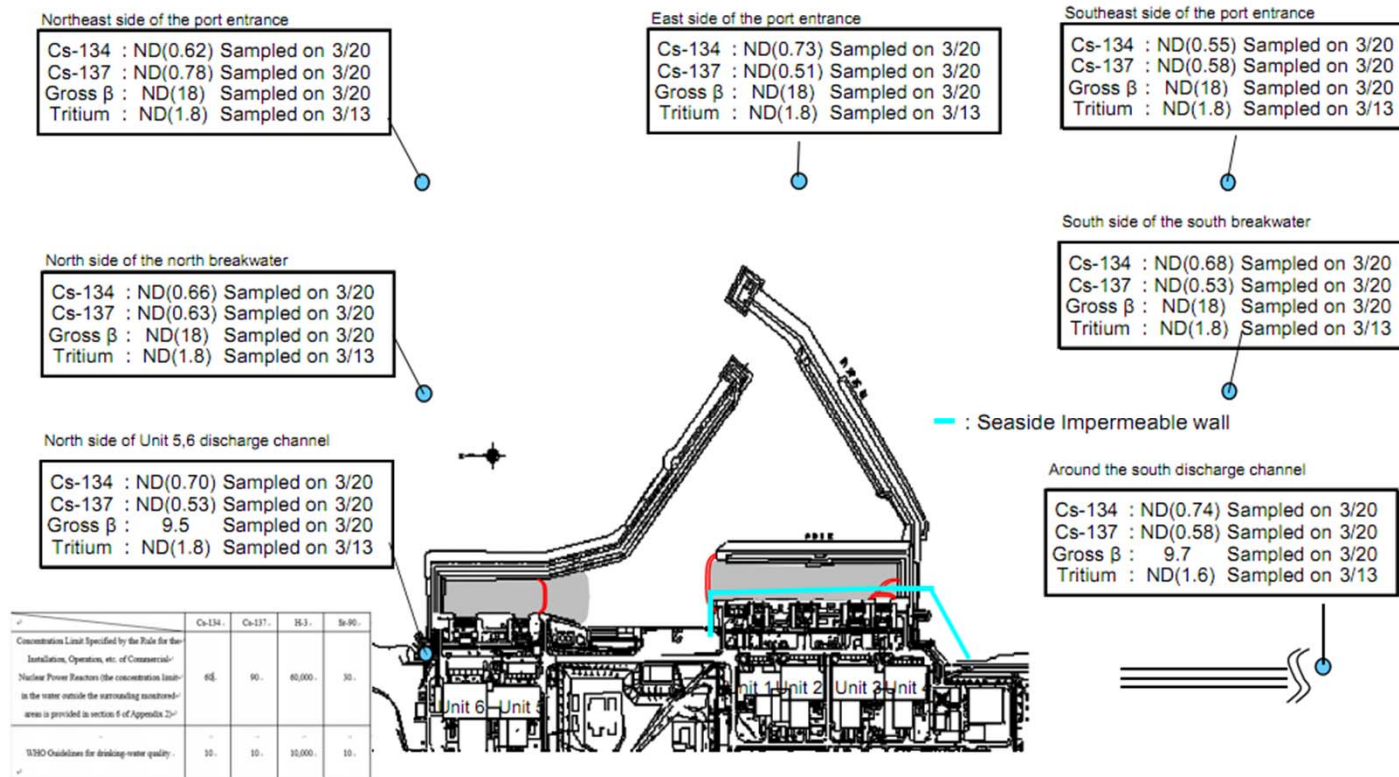
As of 12:00 a.m. on March 23, 2017: ND for Cesium134 and Cesium137, ND-9.7 Bq/L for Grossβ
