Unit 1 Primary Containment Vessel Internal Investigation

1. Overview of the Primary Containment Vessel (PCV) internal investigation

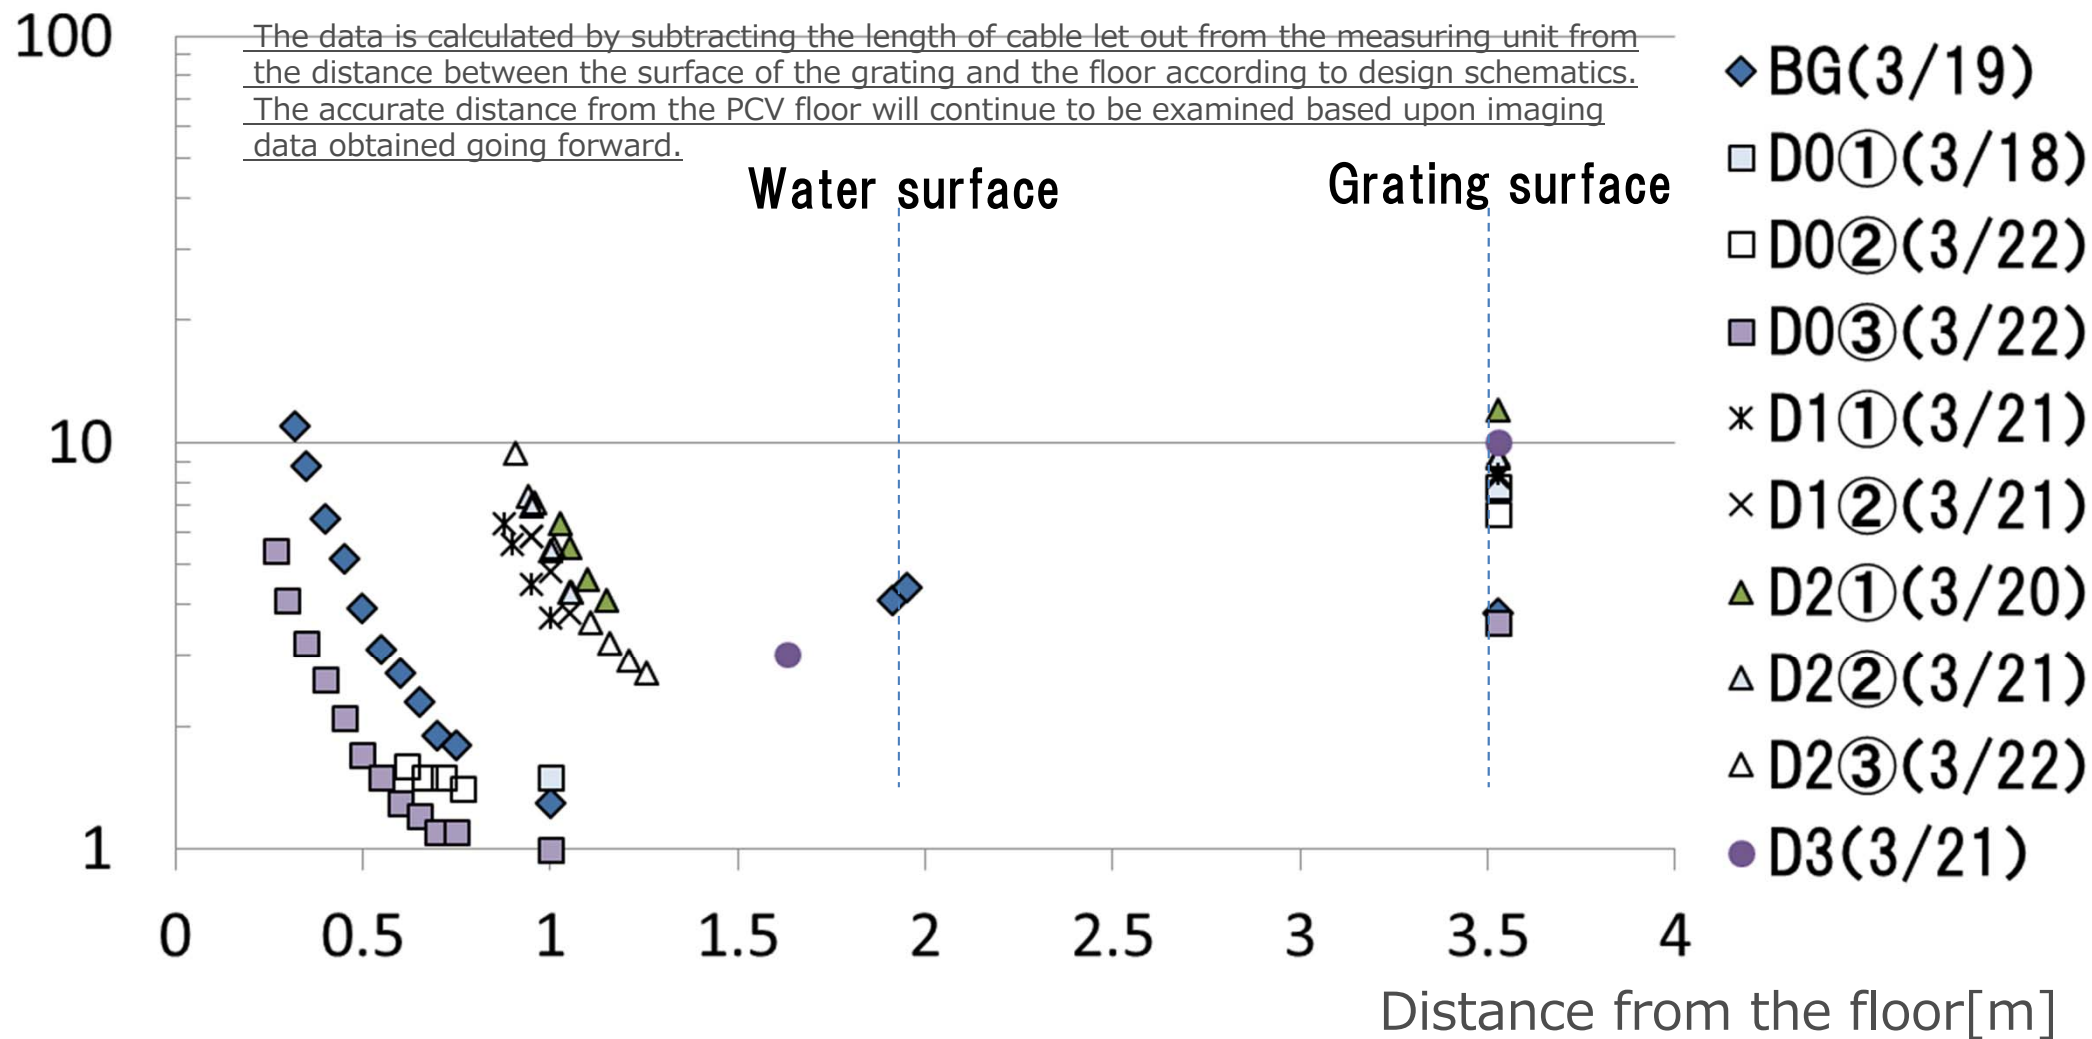
Dose rate[Sv/h]

- Dose levels decrease upon submerging into the water, but then rise again as the floor is approached.
- The height from the PCV floor at which dose levels begin to rise differs depending on the measurement point.(There are many possible causes for this. The deposits could be radiation sources, radiation sources under the deposits that have adhered to the underlying structures may be having an impact, or there may be melted fuel near the PCV floor, etc.)
