# 1. Progress of Unit 3 PCV internal investigation (1/2) (Preliminary report of July 19 investigation)

- ① Today, July 19, we conducted an exploration of the inside of the Unit 3 primary containment vessel (PCV) by inserting a submersible ROV through the X-53 penetration seal. The ROV took photographs of the conditions inside the PCV around the pedestal opening and enabled us to achieve the objective of the exploration, which was to examine conditions inside the pedestal.

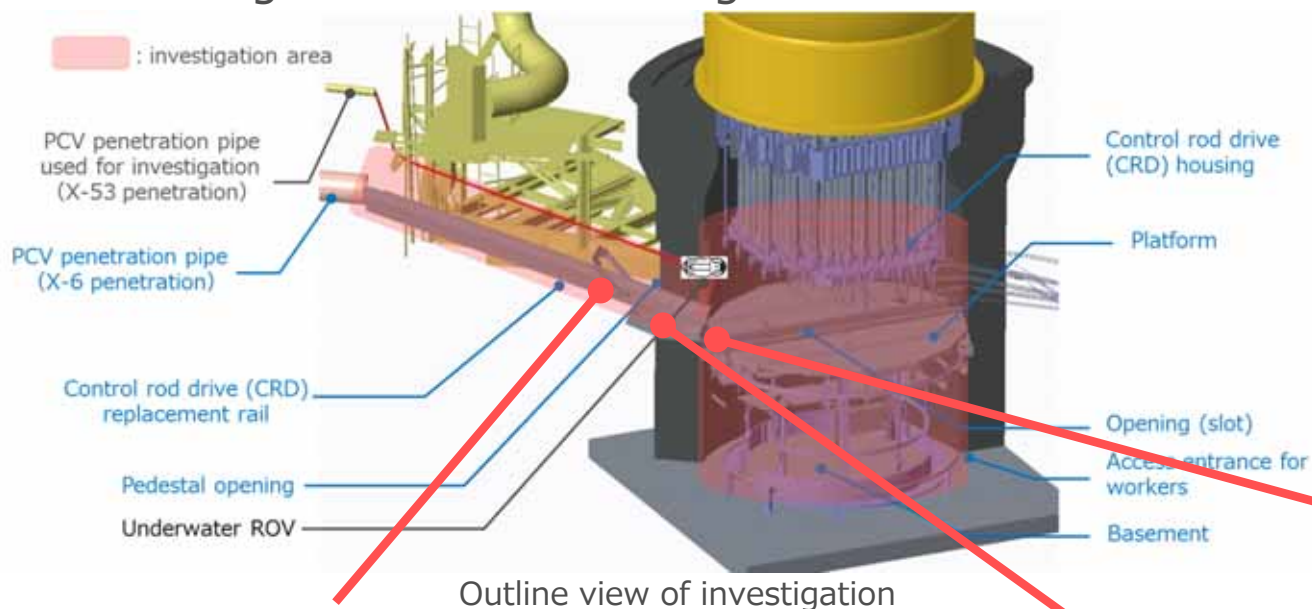
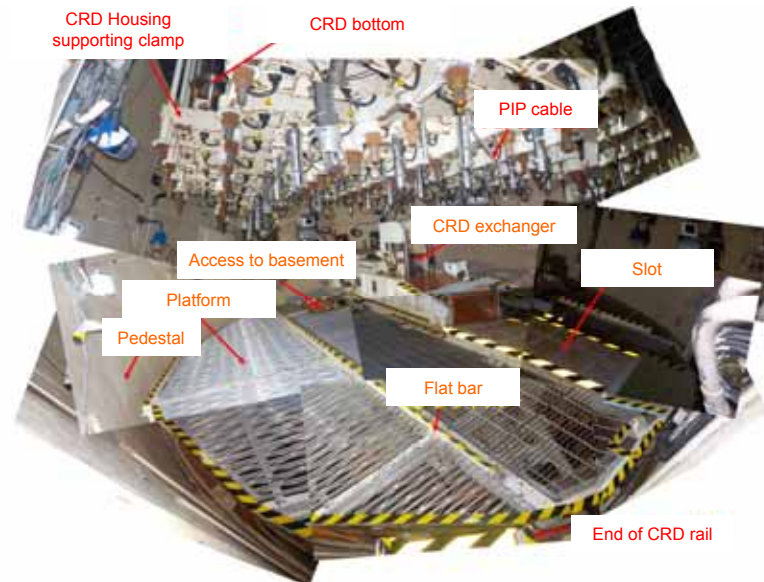
Showing the state of investigation below

- ② Today's exploration revealed damage to multiple structures inside the pedestal and also that some of the support fittings for the CRD housing have fallen. Due to the scope of today's exploration we were not able to examine the grating above the platform.

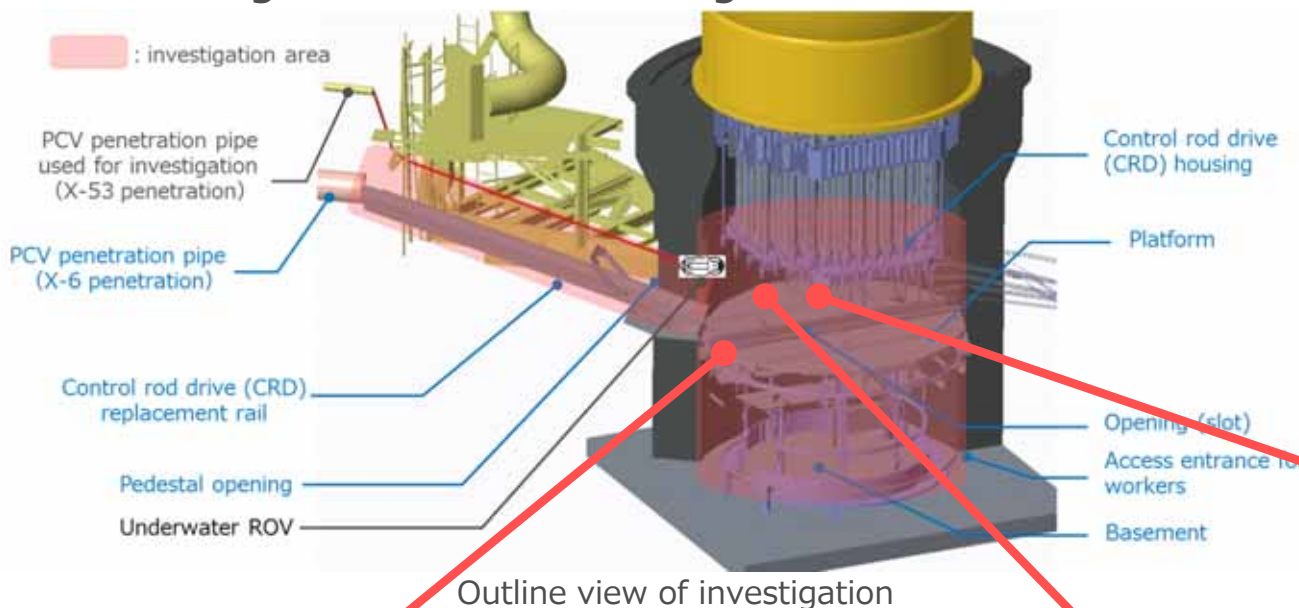
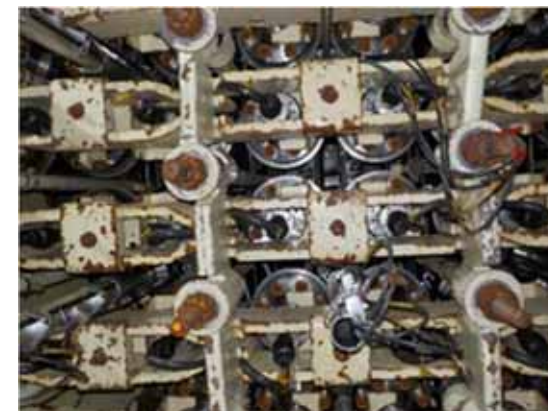
■ Showing the state of investigation below

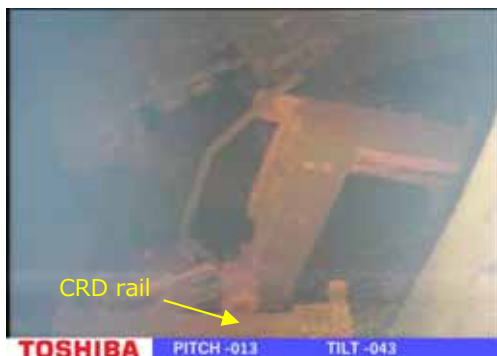
Platform condition

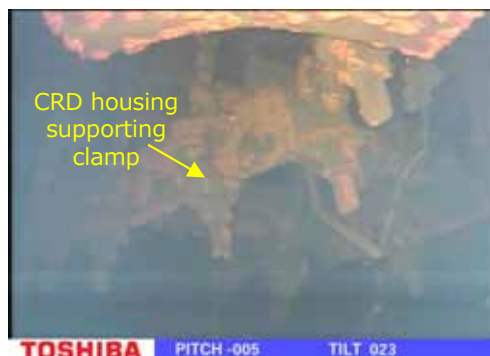
Bottom of the CRD housing

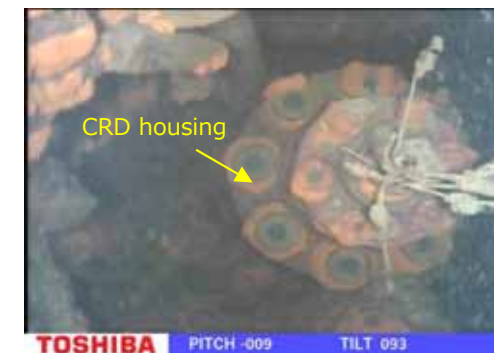
Bottom of the CRD housing
