1. Progress of Unit 3 PCV internal investigation (Preliminary report of July 21 investigation) (1/3)

July 21, 2017

Tokyo Electric Power Company
Holdings, Inc

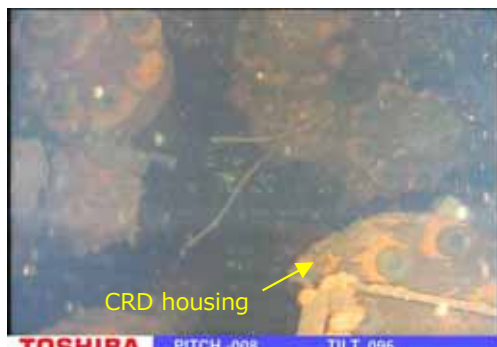
① Bottom of the CRD housing

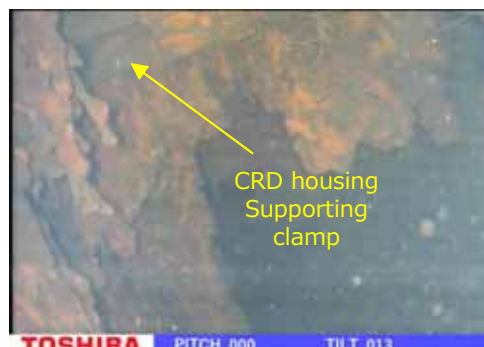
② Bottom of the CRD housing

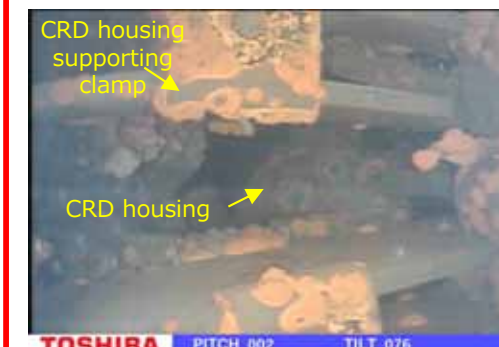
③ Bottom of the CRD housing

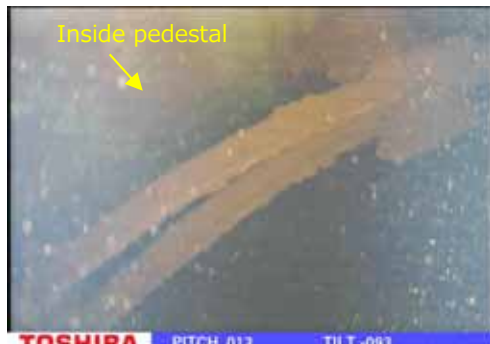
④ Nearby the platform

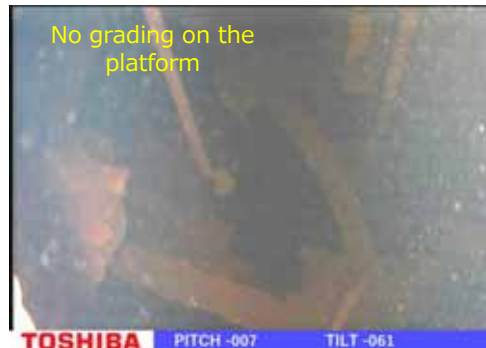
⑤ Nearby the platform

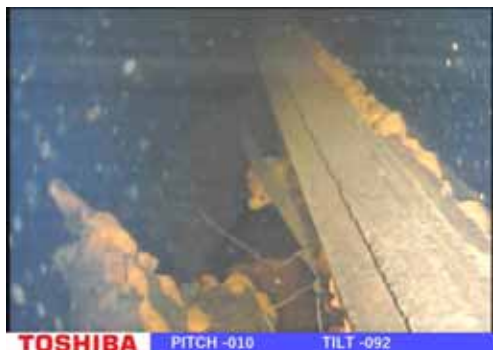
⑦ Nearby the platform

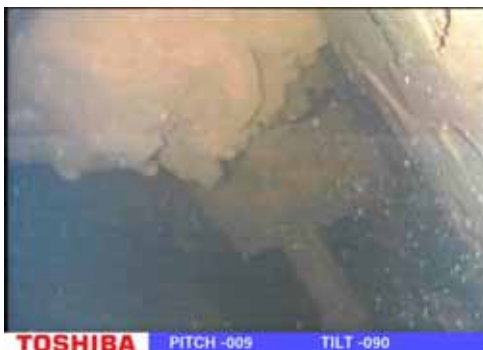
⑧ Nearby the wall of pedestal

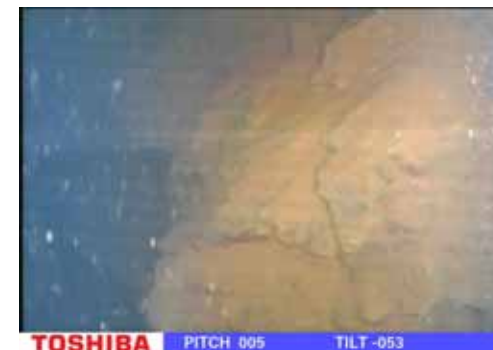
⑨ Nearby the wall of pedestal
