Unit 1 Primary Containment Vessel Internal Investigation ～ Analysis of image data and dose data ～

July 27, 2017

Tokyo Electric Power Company Holdings, Inc

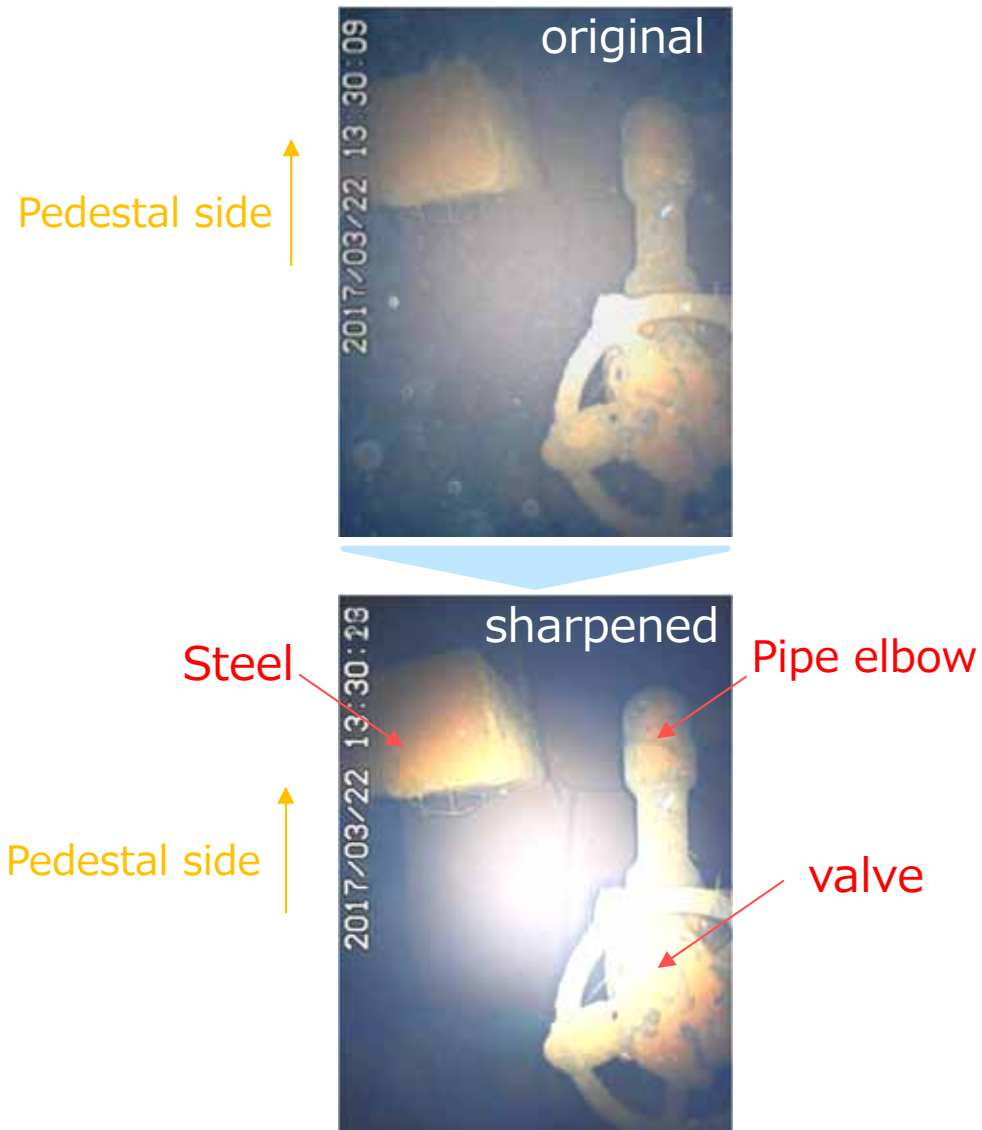
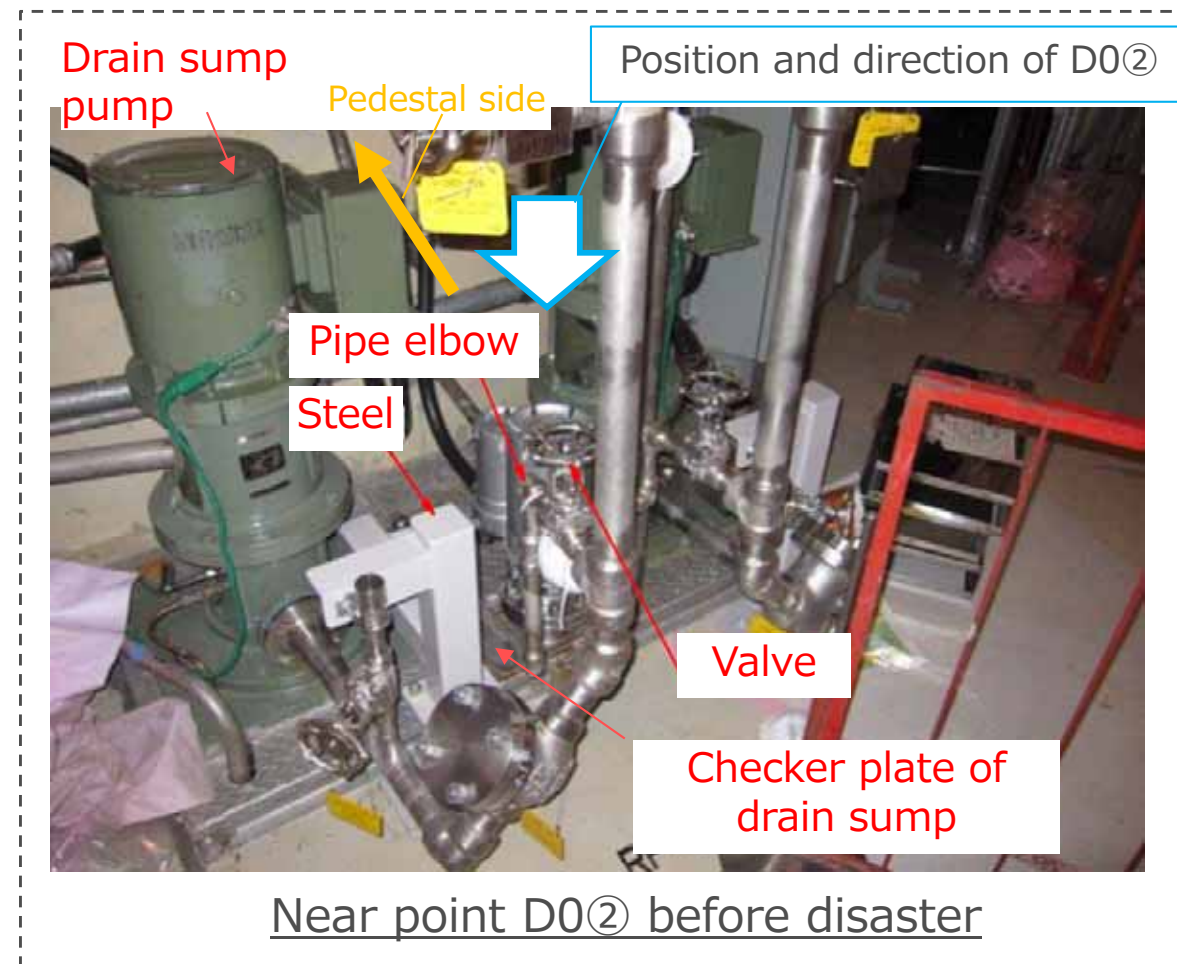
- Image data of the measurement points were sharpened.
- Sharpened image of the point D0② shows no extensive deformity and damage of existing structures including valves, pipes and steels. The checker plate of drain sump was not found due to deposits.

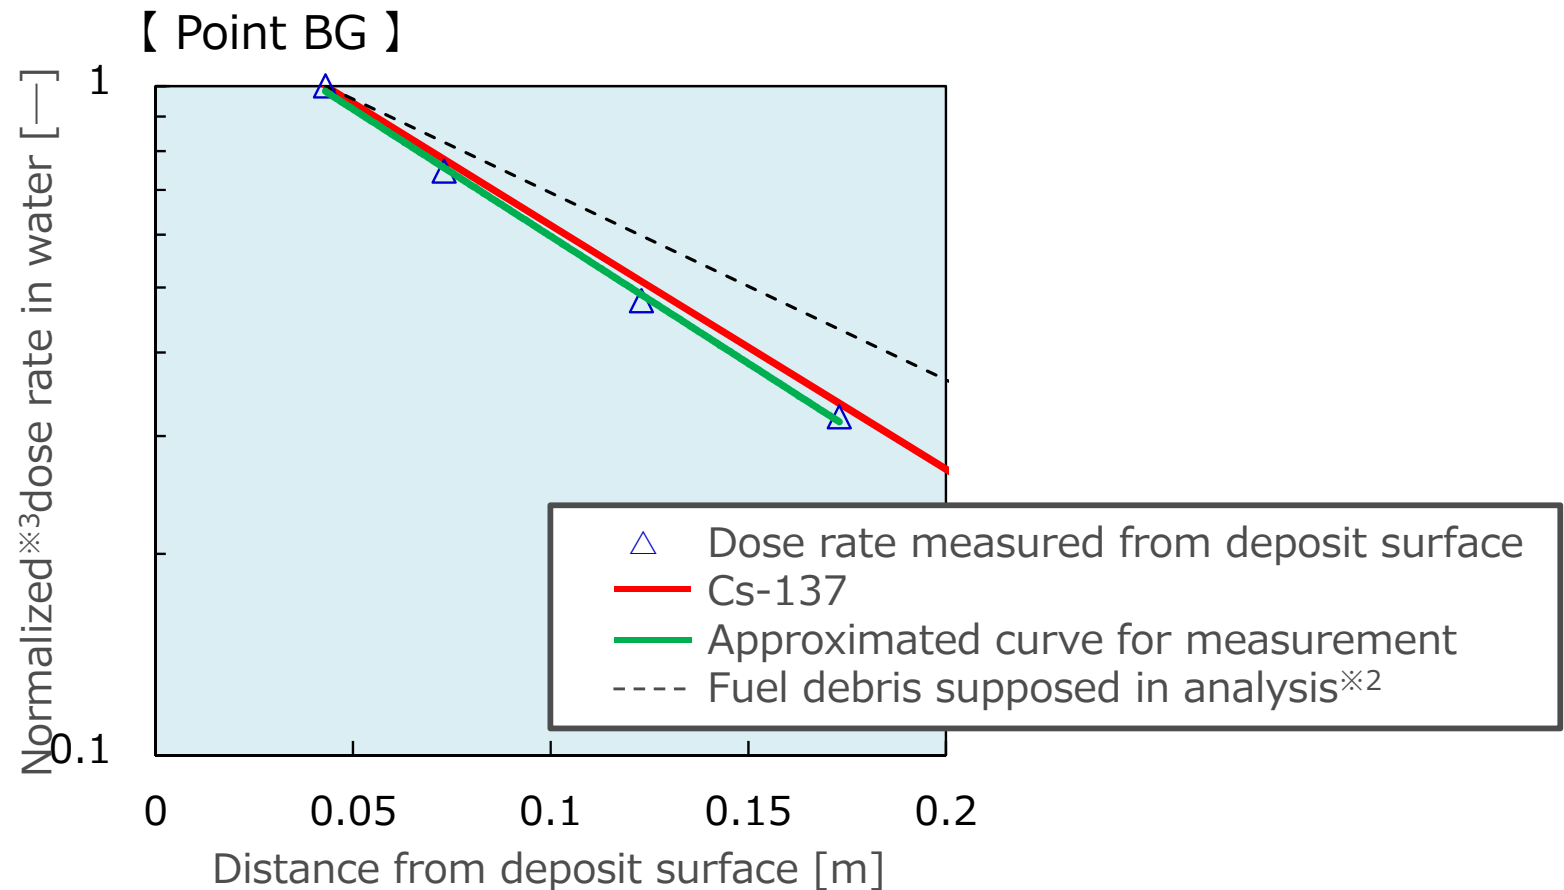
3.2 Analysis of dose distribution – BG: main source on the deposit surface

- As dose rate measured from the deposit surface^{※1} is almost equal to Cs-137 decay curve in decay rate by distance, main dose source (nuclide) is considered to be Cs-137.

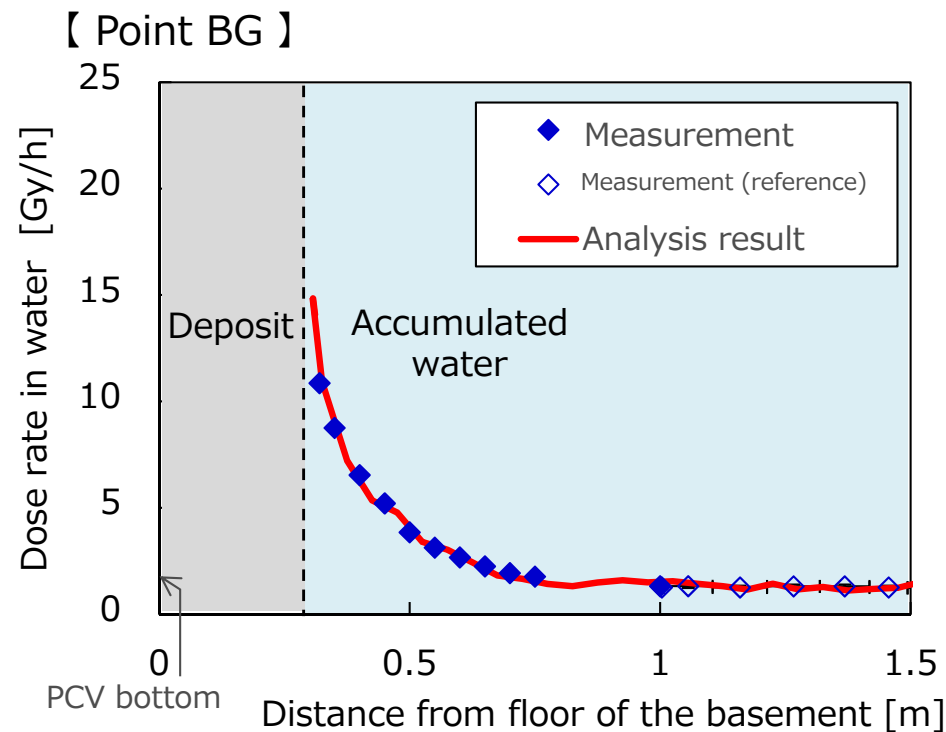
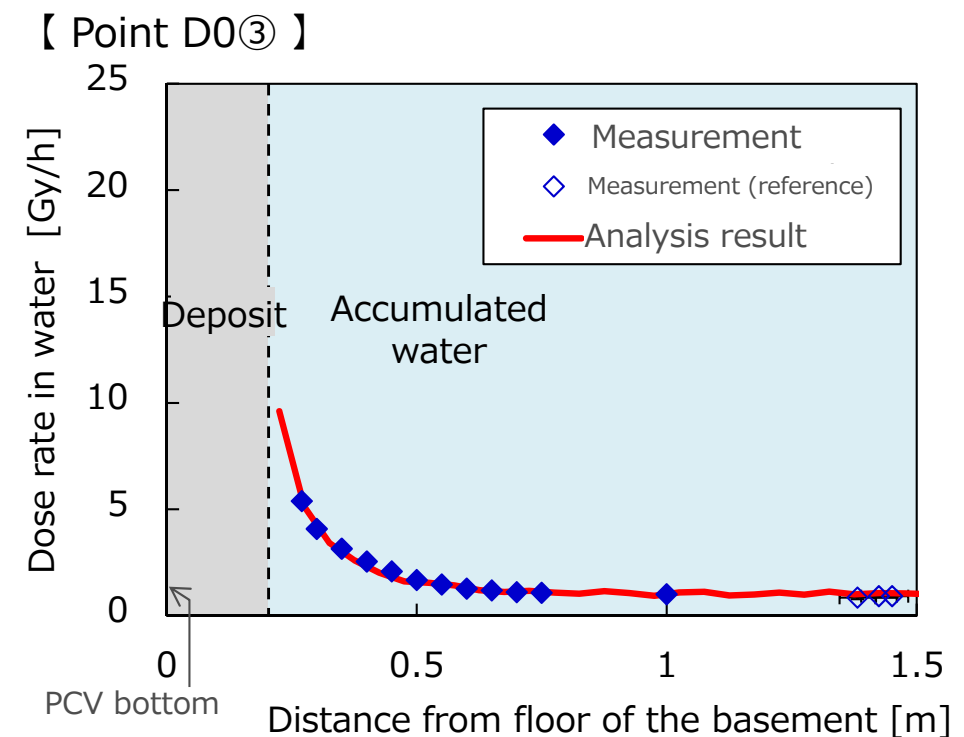
- We analyzed BG and D0③ assuming Cs-137 is main source on the deposit surface.
- It is assumed that there is no fuel debris at BG and D0③, because these points have thin deposits and enough distance from the pedestal opening.
- Analysis based on above assumption well-matches with measurement. Therefore, it is considered that there is no fuel debris under deposits at BG and D0③ or very little even if exist.

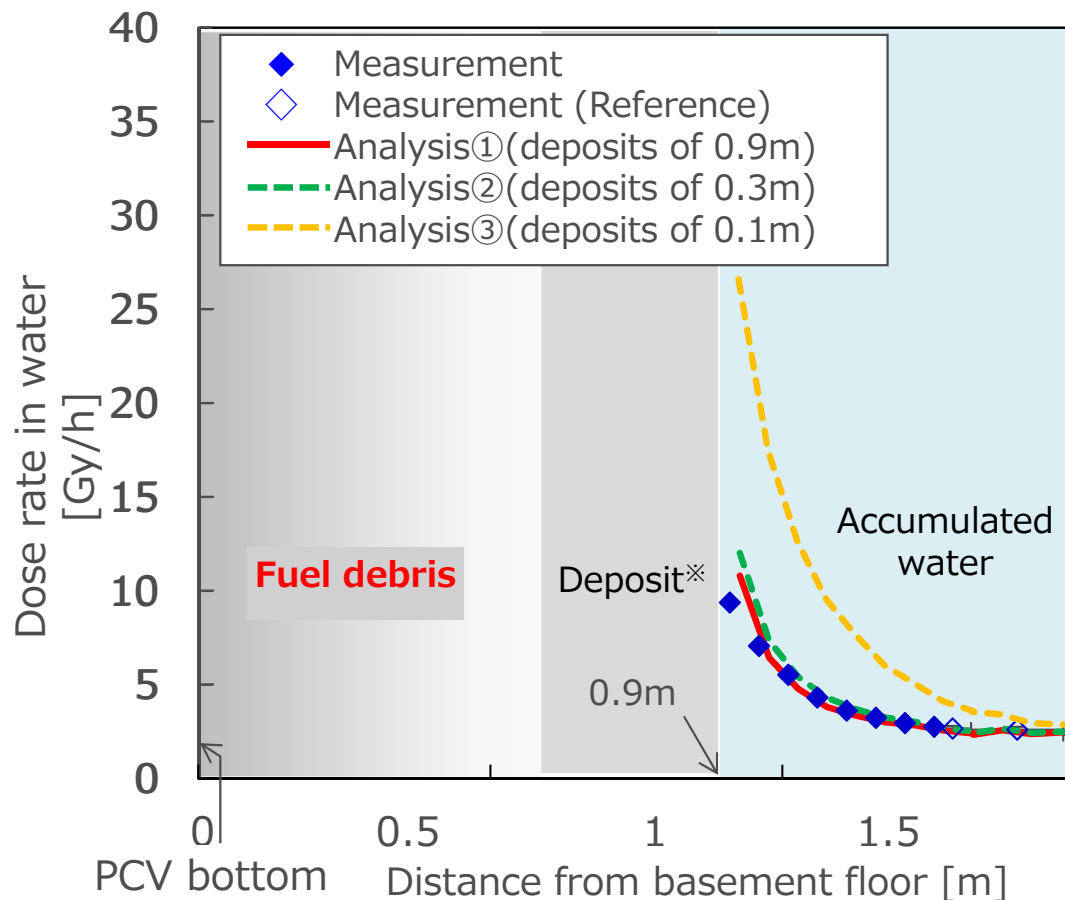
D2③ Analysis condition
(Height of deposits is 0.9m)

- We have analyzed dose rate in the case of fuel debris exist under deposits of about 0.9m height, in range of deposit height measured at D1 and D2.
- Analysis result for point D2③ near pedestal opening is as the figure bellow.
- Existence of fuel debris cannot be examined in the case of thick deposits due to their shield.
- The cause examination cannot be done is considered to be that there is no fuel debris, or that thick deposits and structures have profound shield effect. As the deposit thickness is currently unknown, we cannot determine it.

※ The structures might exist under the deposits.

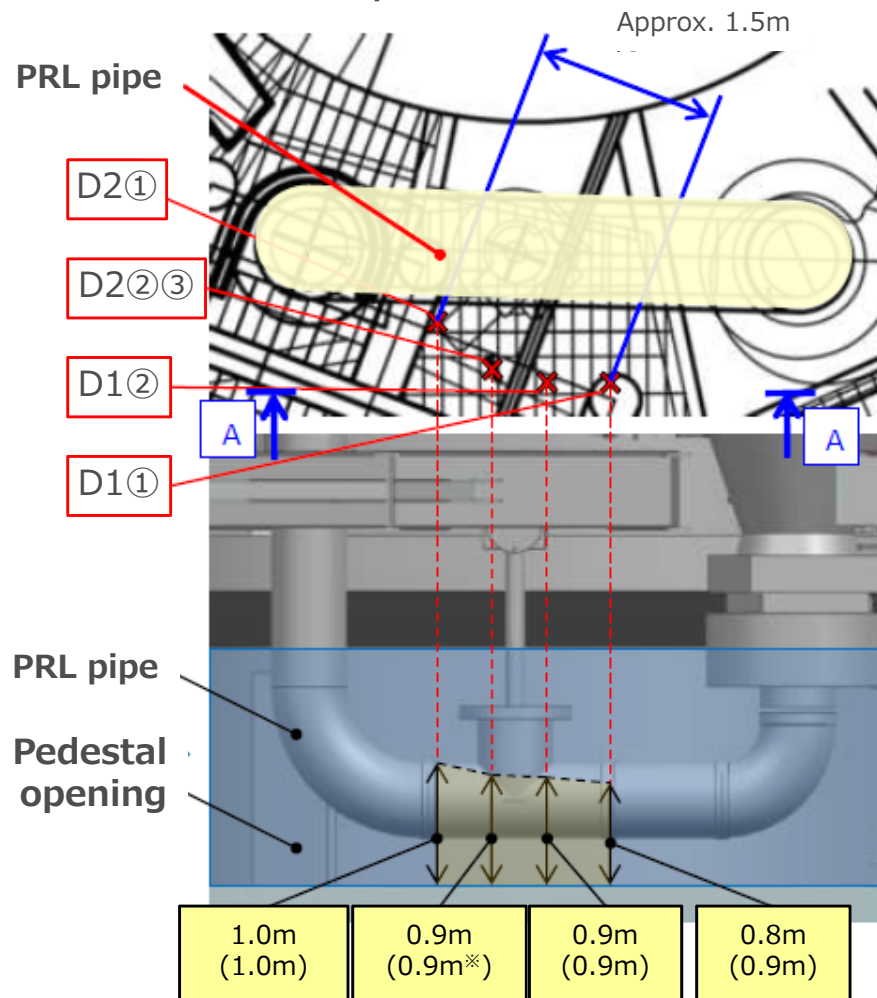
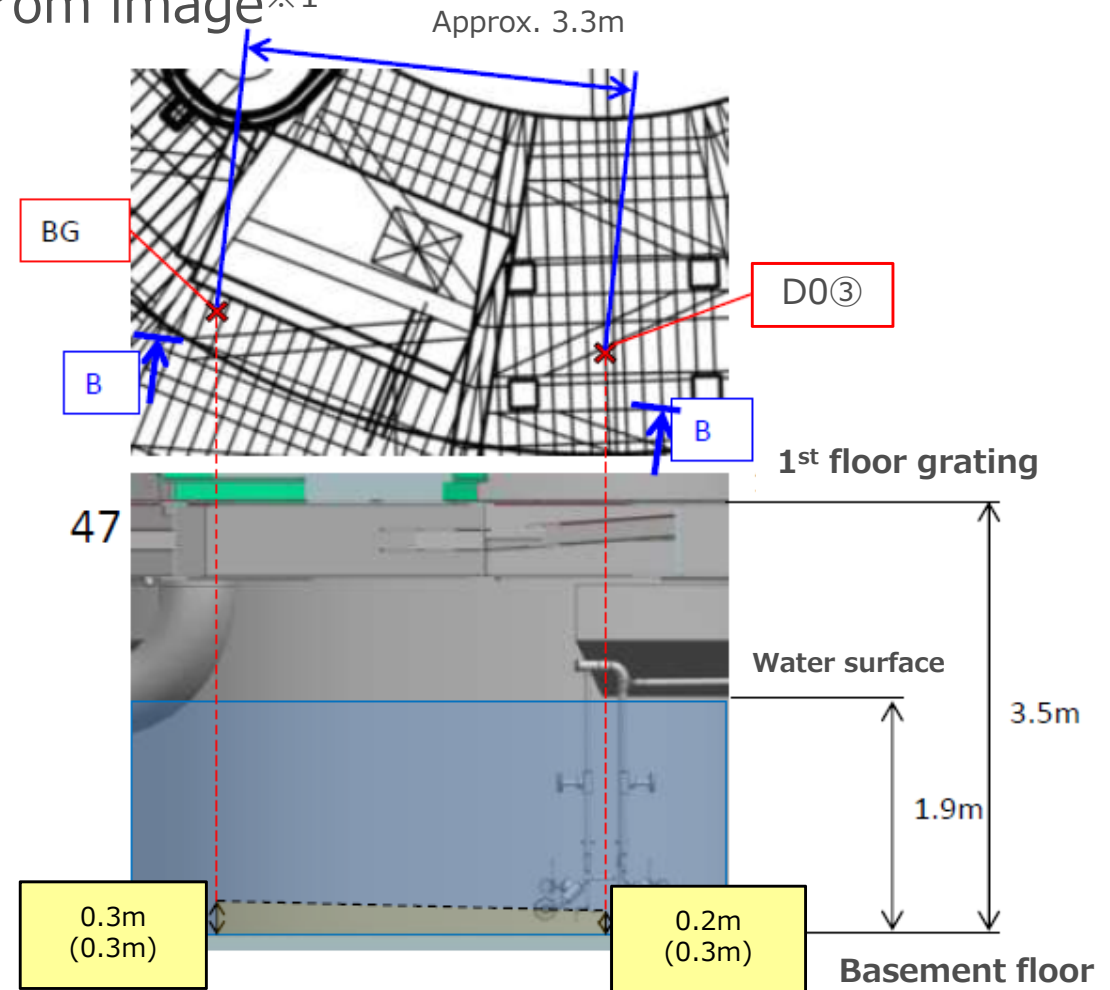
Estimation of deposit surface height

※1 Height of the deposit surface is calculated from the distance between censor and deposit surface obtained by SFM(Structure from Motion) and the dropping length of censor.

- Value in yellow box is estimated height of deposit surface calculated from image analysis.
- Value in () is lowest height of hanged censor.
- Deposit thickness below the deposit surface is unknown.
