Unit 2 Primary Containment Vessel Internal Investigation

November 30, 2017

Tokyo Electric Power Company Holdings, Inc.

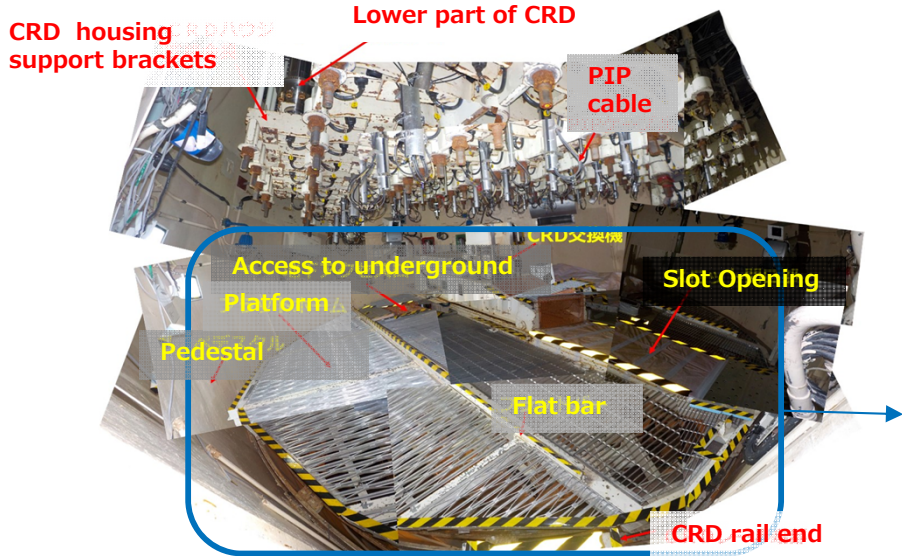
- It was found that a part of grating was missing during the pre-investigation of the inside of the pedestal conducted through the guide pipe during the PCV Internal Investigation from January to February, 2017.

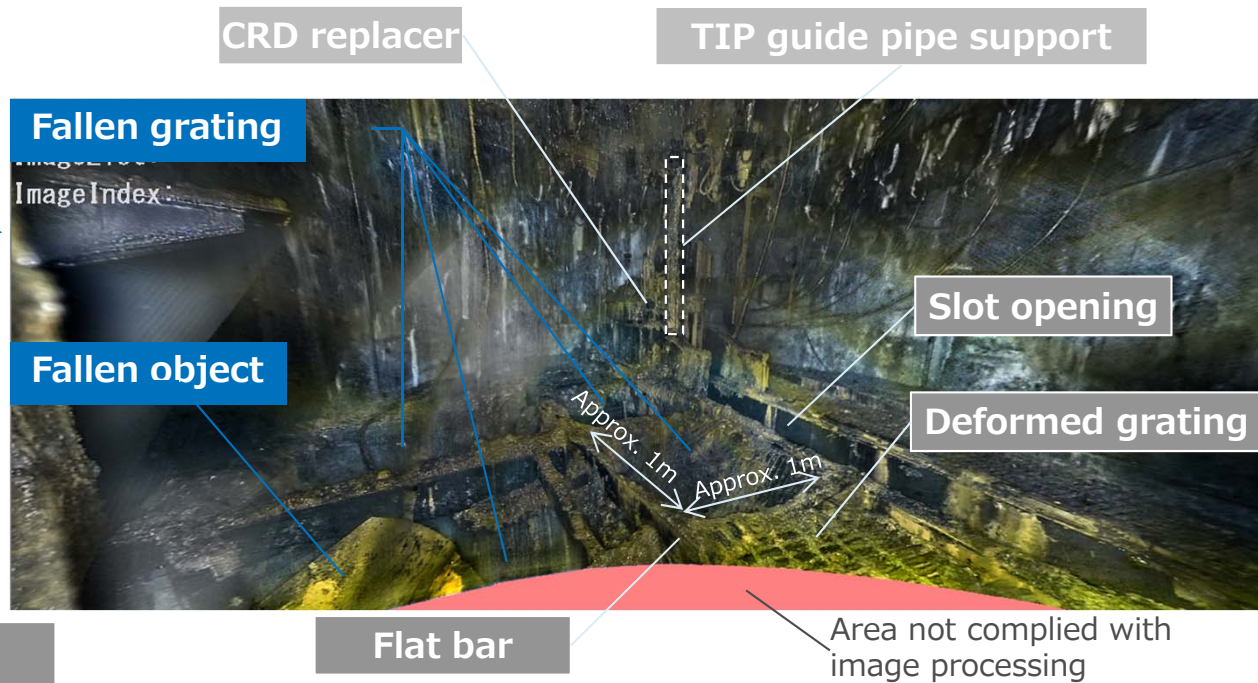
(Reference) Photo taken during periodic inspection inside Unit 2 pedestal

※ The TIP guide pipe and its supports were removed to inspect Unit 5.
