Unit 2 Primary Containment Vessel Internal Investigation

December 21, 2017

Tokyo Electric Power Company Holdings, Inc.

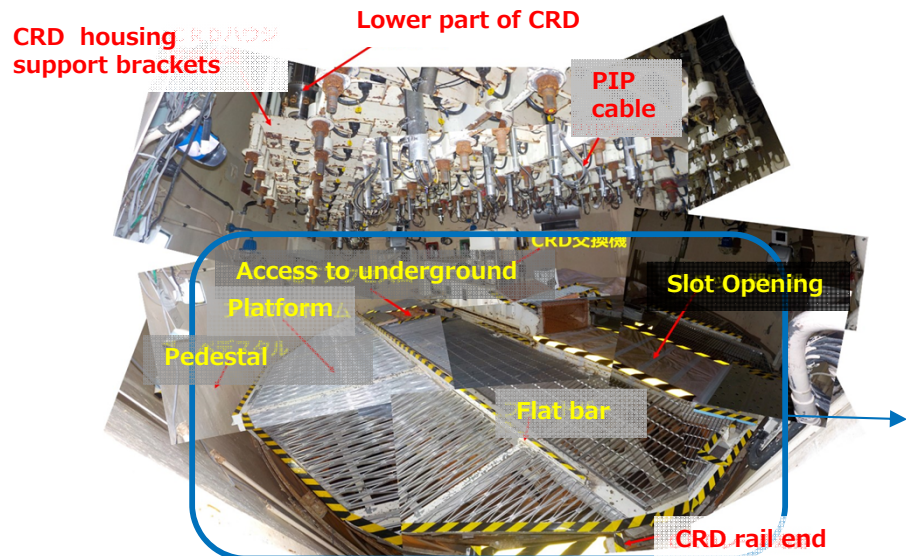
- It was found that a part of grating was missing during the pre-investigation of the inside of the pedestal conducted through the guide pipe during the Primary Containment Vessel (PCV) Internal Investigation from January to February, 2017.
