Fukushima Daiichi Nuclear Power Station Unit 2 Primary Containment Vessel Internal Investigation

April 26, 2018

Tokyo Electric Power Company Holdings, Inc.

1. Primary containment vessel internal investigation overview

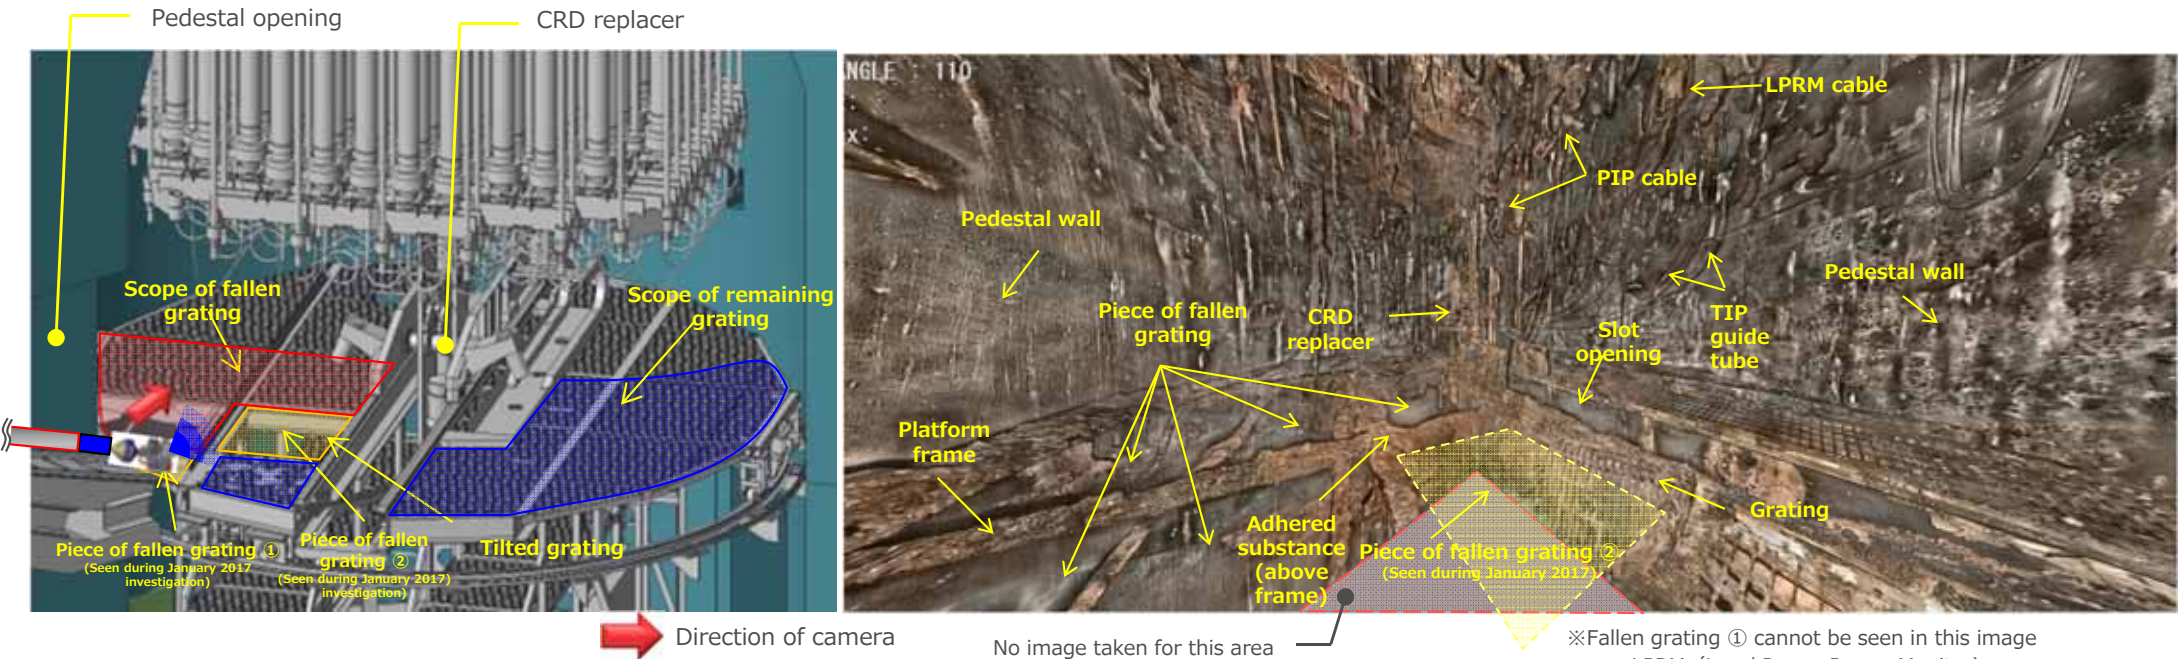
3. Investigation results ① Top of Platform

- No significant damage was seen to the CRD replacer or platform frame, etc., and the conditions of these objects remain unchanged from the last investigation (January 2017).
- Structures in the foreground of the camera image (TIP guide tube, PIP cable and grating, etc.) were found to be damaged and fallen, which may indicate the path of the fallen fuel debris in consideration of the relatively large amount of adhered substances on top of the platform frame.
- Blind spots in the background of the camera image prevent observation of structure deformation or damage, as well as the conditions of the fallen grating and adhered substances.
- As with the previous investigation (January 2017) no damage was seen to the inner walls of the pedestal within the scope of the observed area.

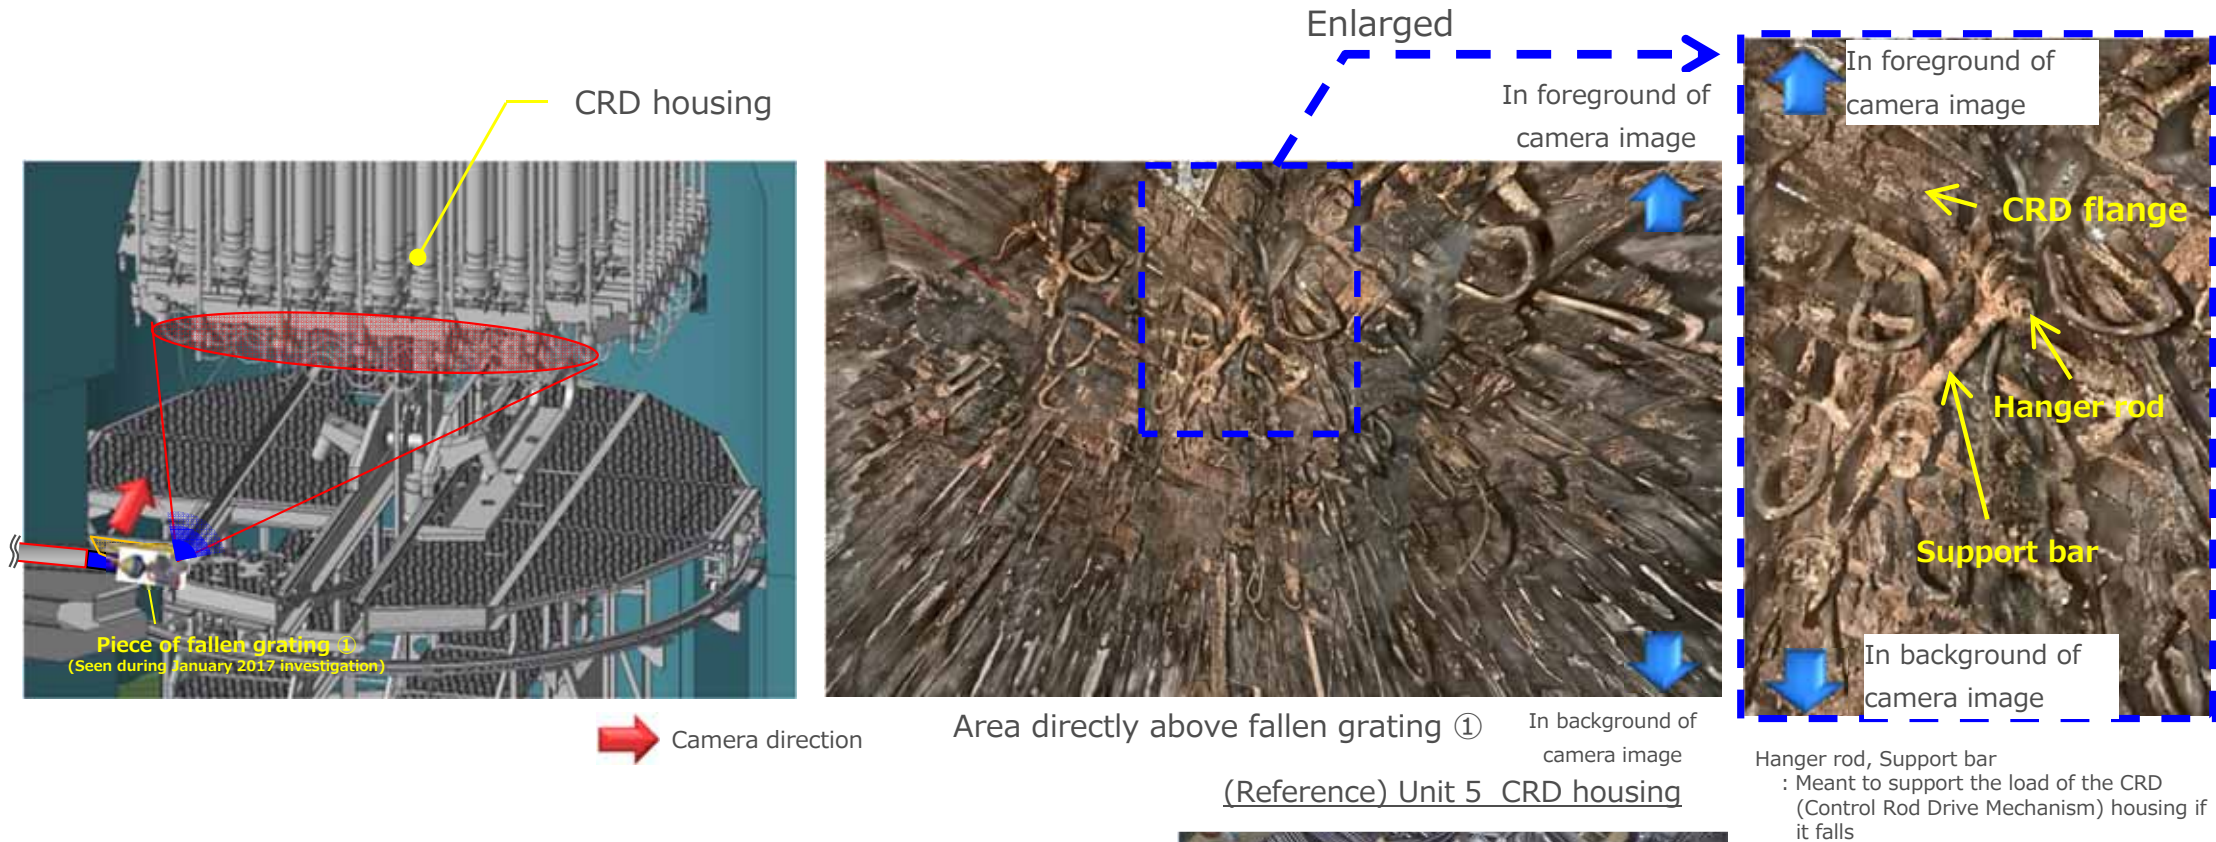
② Around CRD housing (1/2)

- The CRD housing supports directly above the piece of fallen grating ① shows no significant deformation or damage and remains unchanged since the last investigation (January 2017)
- Within the scope that was investigated none of the CRD housing supports appear to have fallen.

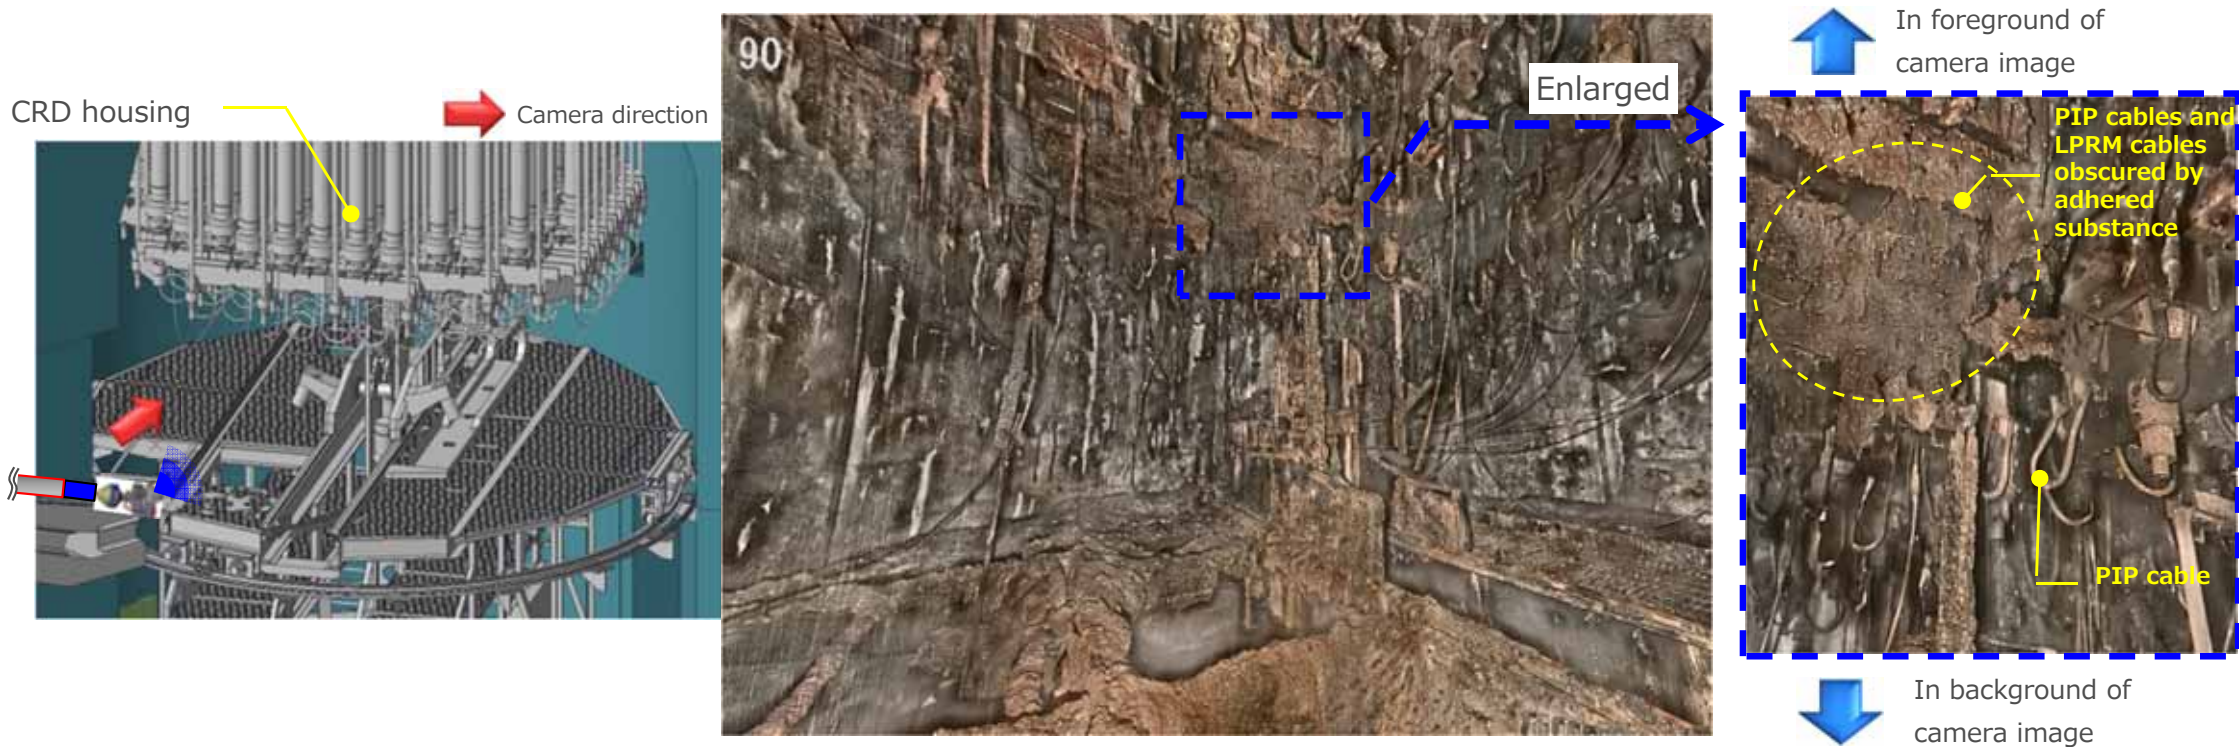
② Around CRD housing (2/2)

- Parts of the TIP guide tube, PIP cables and LPRM cables could not be observed due to adhered substances.
- The grating directly below the areas where parts of the TIP guide tube, PIP cables and LPRM cables could not be observed was found to have fallen.

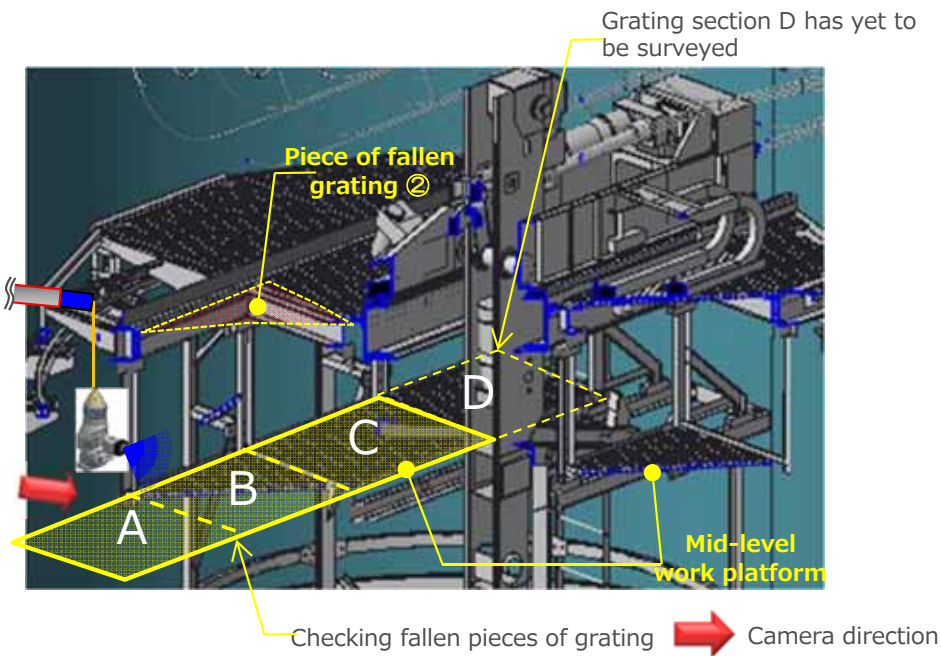
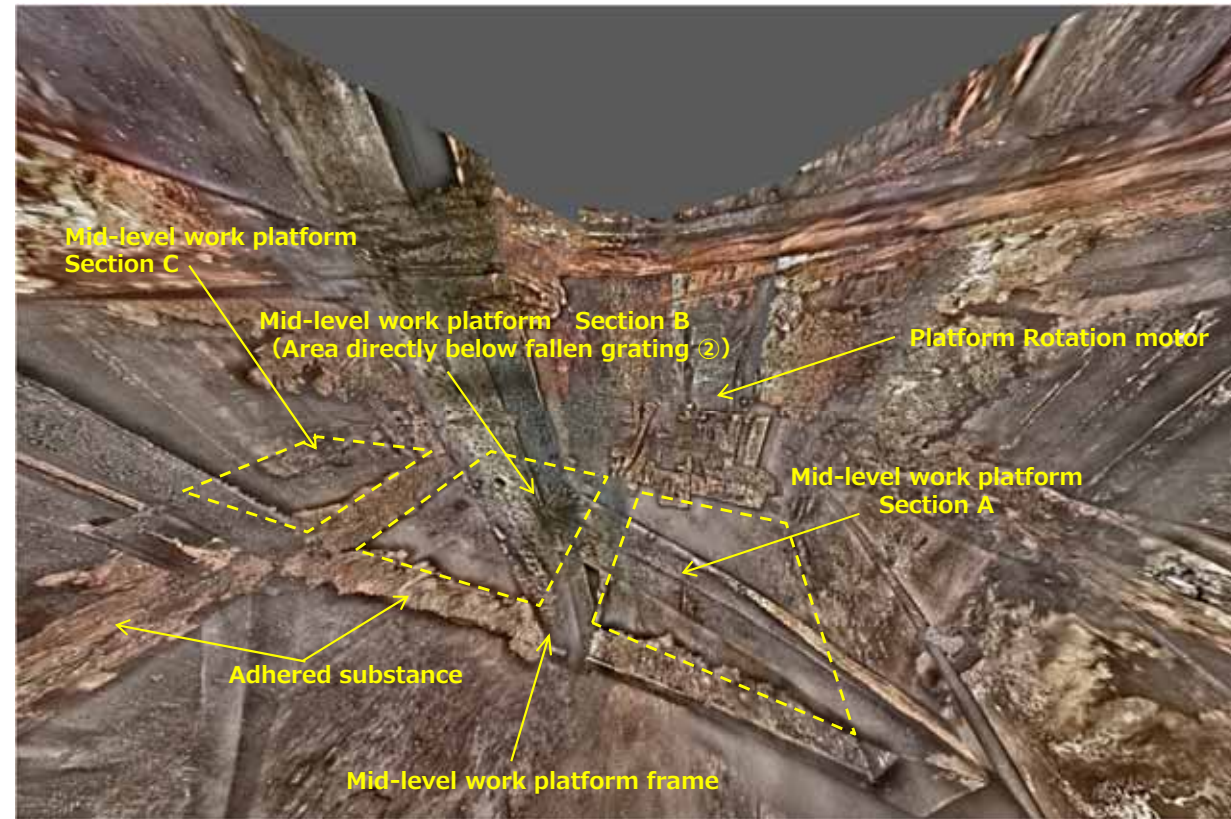
- It was confirmed that the grating (Sections A~C) in the foreground of the location where the camera was lowered has fallen. Locations where Section B and C grating has fallen show the same conditions as the platform.
- No significant deformation or damage was seen to the mid-level work platform frame

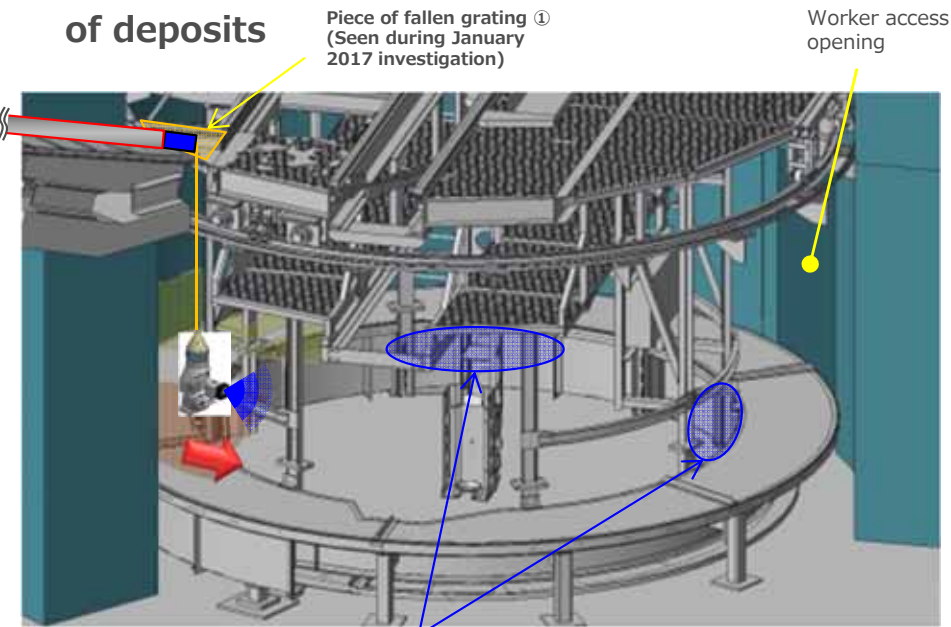
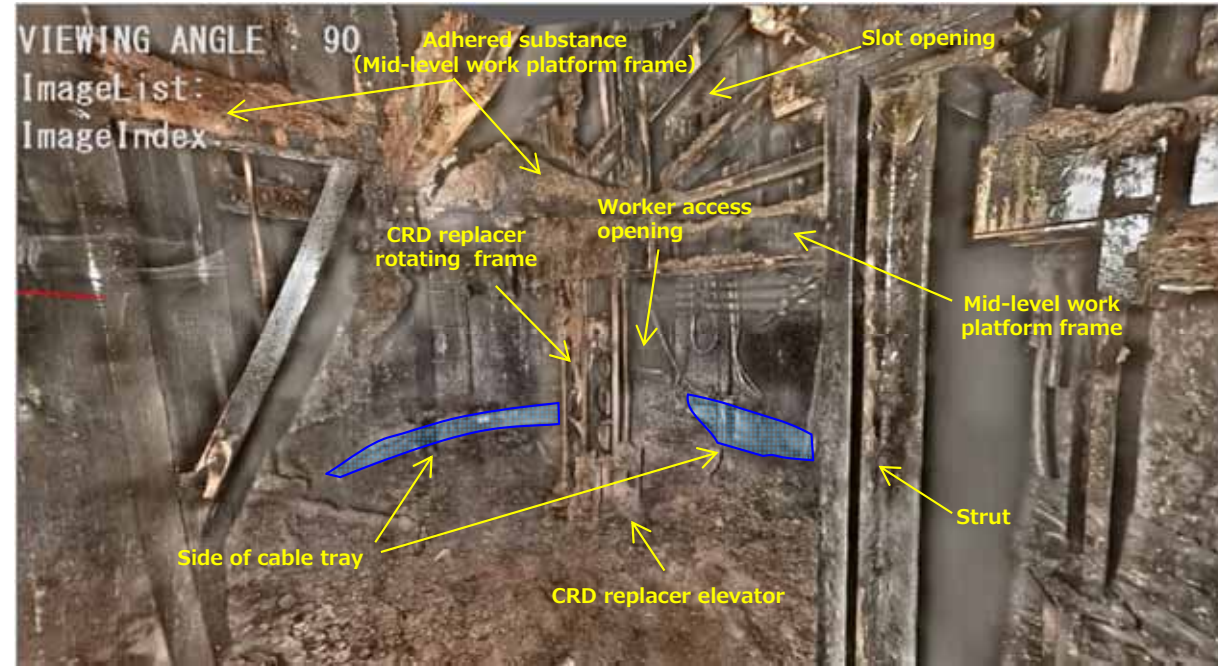
○ Condition of structures and distribution of deposits

- No significant deformation or damage was seen to structures such as the CRD replacer rotating frame, mid-level work platform frame, struts, or cable trays, etc.
- Pebble and clay-like deposits cover the entire bottom of the pedestal.
- Although the deposits appear to be solidified molten material, it is possible that the temperature of the deposits when this substance started to accumulate on top of the cable tray was not hot enough to cause deformation of the cable trays in consideration of the fact that no deformation of the cable trays (4mm thick stainless steel) could be observed.

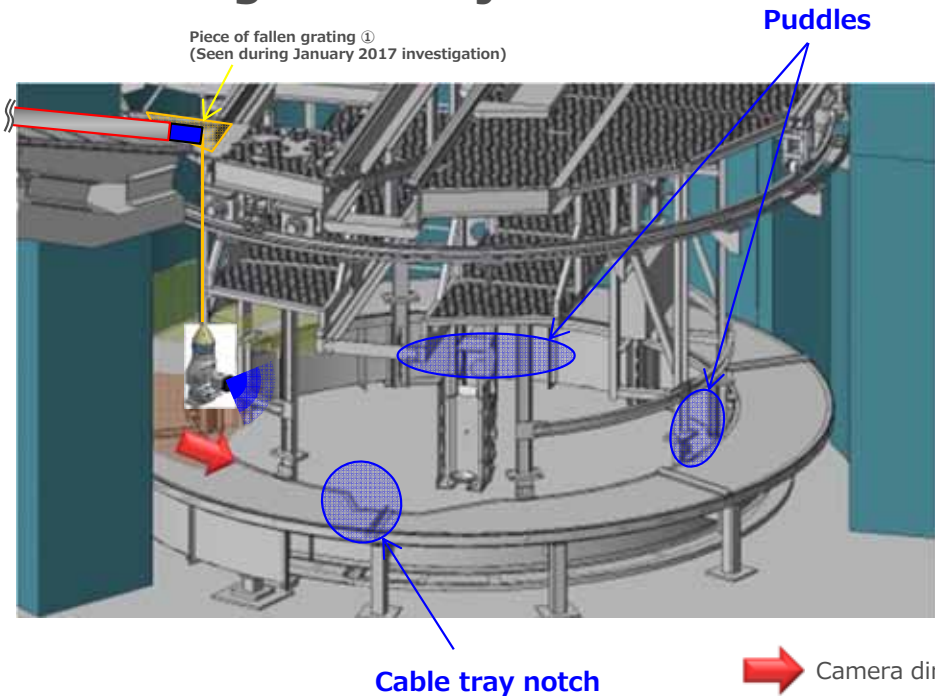
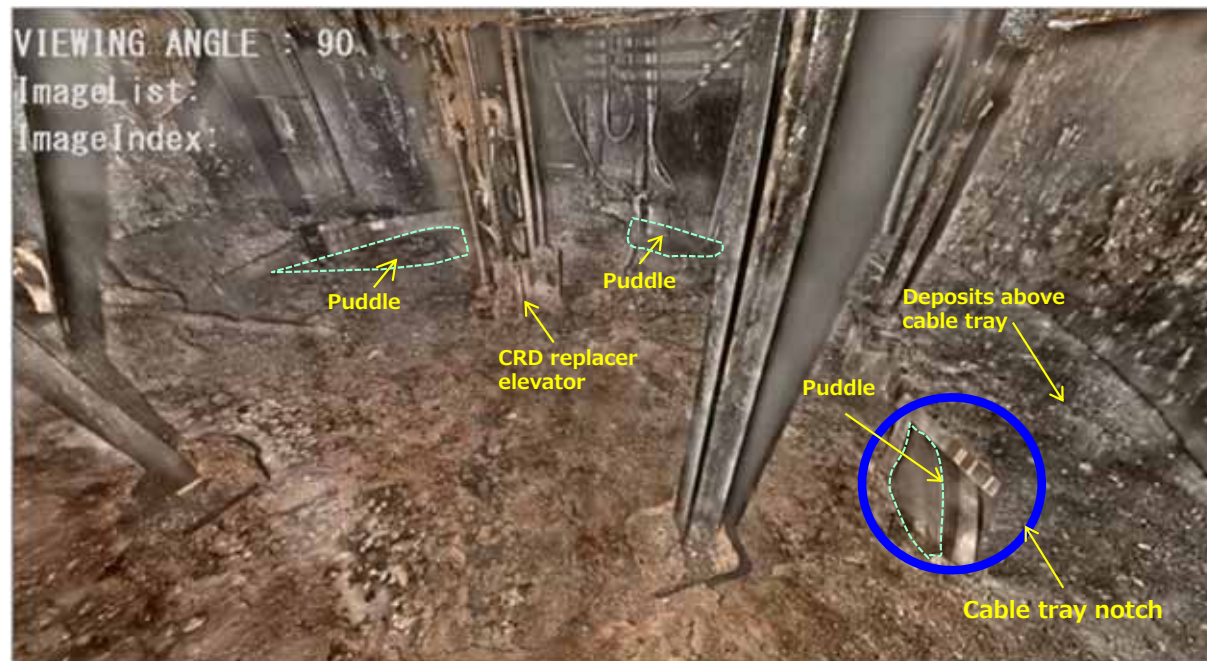
○ Cooling water injection status

- Considering that cooling water is pouring in and that the temperature around the bottom of the pedestal is approximately 21°C it is assumed that the deposits are being kept cool and stable by the cooling water that's being injected.
- Puddles were found on the side of the worker access opening and in cable trays through the cable tray notches.

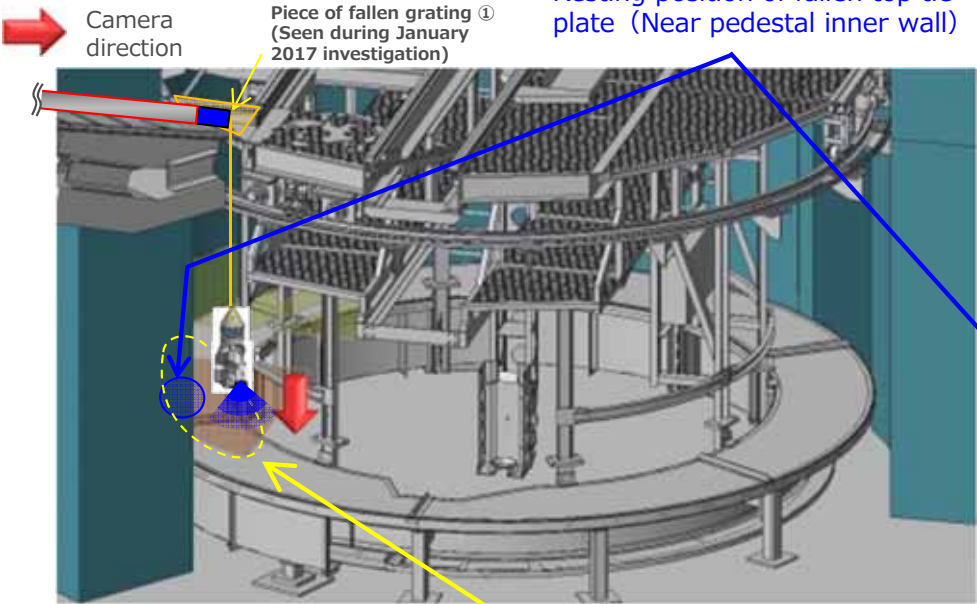
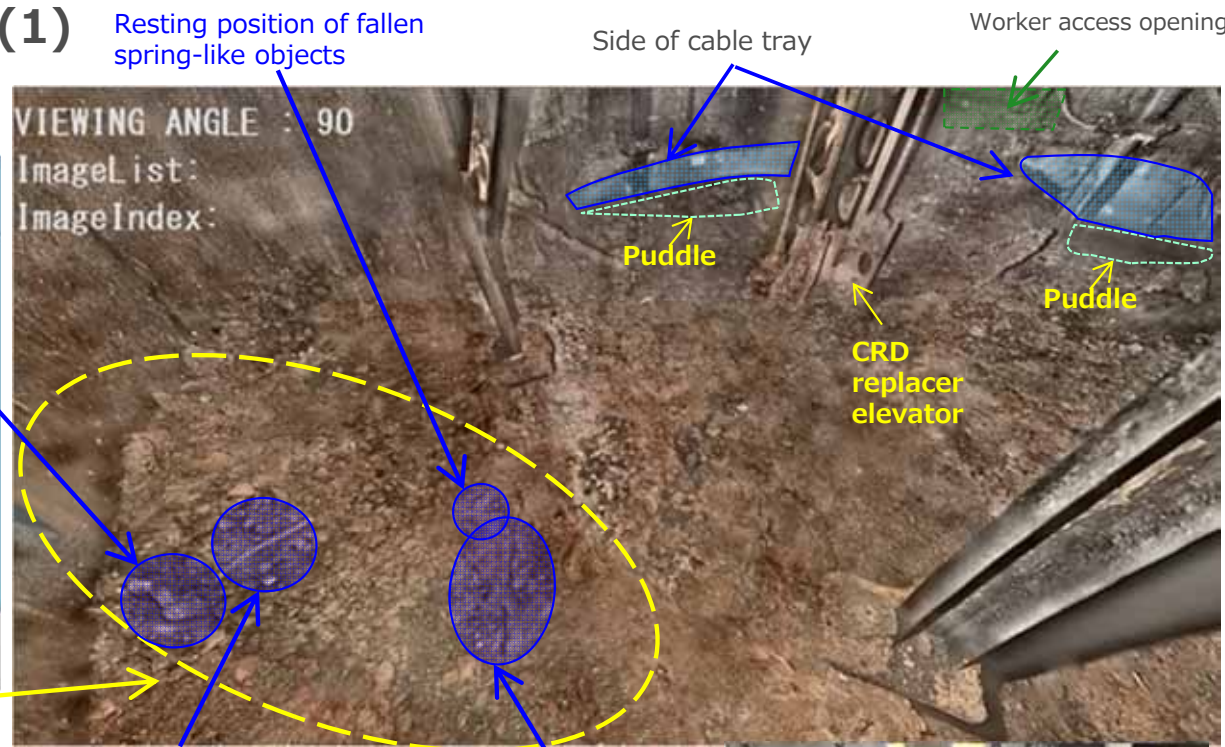
○ Detailed look at deposit distribution (1)

Area where deposits are relatively high (Directly below fallen platform grating ①)

- When looking at the center of the pedestal from the location of the lowered camera the step in elevation that should be present around the cable tray on the left side (approximately 70cm in height) was not clearly defined thereby suggesting that the height of deposits in this area may exceed 70cm at some points. The height of deposits around the CRD replacer elevator appears to be between 40cm to 50cm considering the extent to which the elevator is buried. Furthermore, when looking from the position where the camera was lowered, it was confirmed that the height of the deposits in the area behind the elevator are lower than the cable tray.

- When viewing the left side of the center of the pedestal from the location where the camera was lowered parts of a fuel assembly (top tie plate) could be seen and fallen objects shaped like rods, pipes, and springs, could be seen in the vicinity. Furthermore, since the height of deposits in this area is higher than that in the surrounding areas, it is possible that the area directly above this location marks one of the paths by which fuel debris fell.

- Since the height of the deposits at the bottom of the pedestal is higher on the left side of the center of the pedestal when viewed from the position of the lowered camera, it is possible that the area directly above this location may be one of the paths by which fuel debris fell.

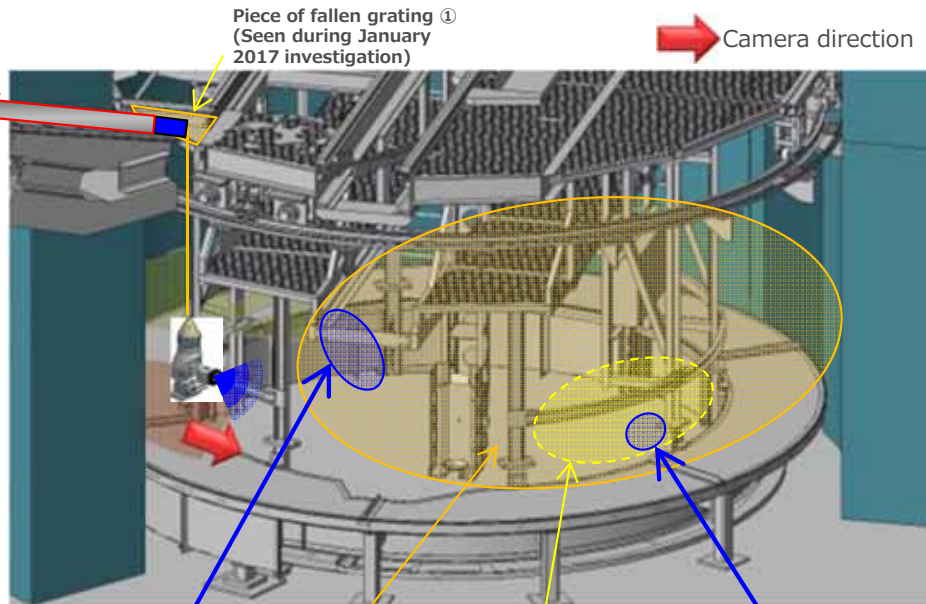
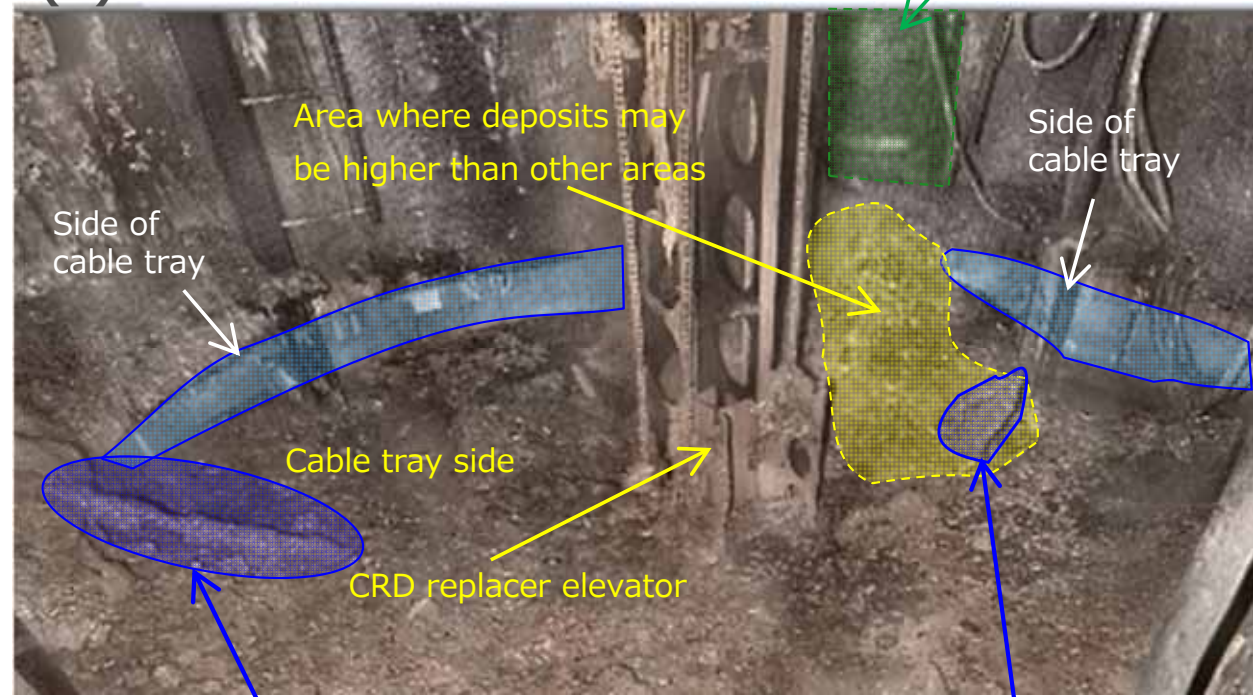
○ Detailed look at deposit distribution (2)

Area where deposits may be higher than other areas

- Spots where the height of deposits may be higher than those in the surrounding area were found near the worker access opening. Considering the distribution of these deposits it is possible that there may be multiple locations at which fuel debris fell in addition to the location to the left of the center of the pedestal when looking from the position of the lowered camera.
- Grate-like fallen objects were found in the vicinity of the location where the height of deposits may be higher than the surrounding area.
- Rod-shaped falling objects were found near the cable tray.
- In regards to the conditions outside the worker access opening, it cannot be confirmed whether or not deposits leaked outside of the pedestal because this area cannot be seen in the images obtained during this investigation.

- At the same time, since deposits on the side of the worker access opening are higher than in the surrounding area it is possible that there are multiple paths by which fuel debris fell.

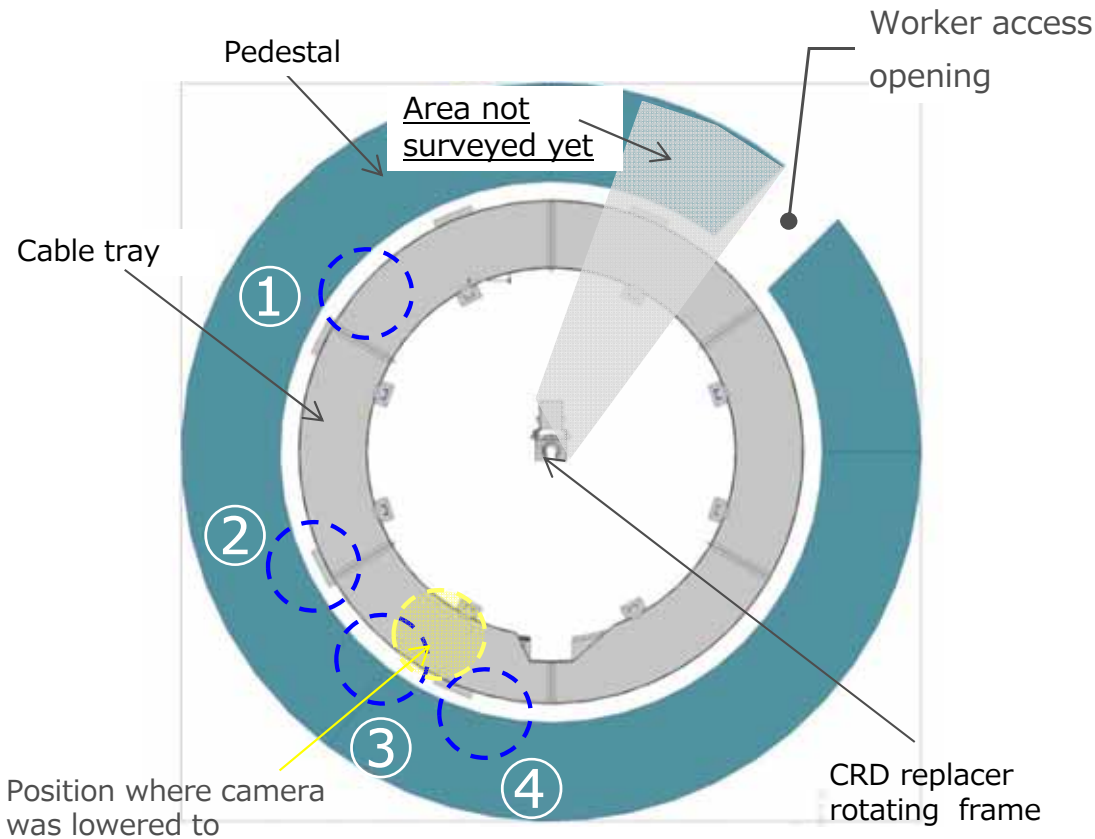
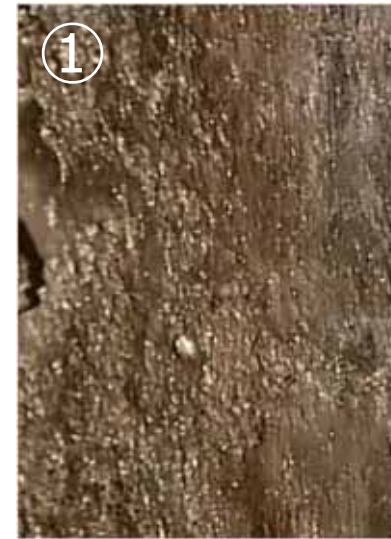
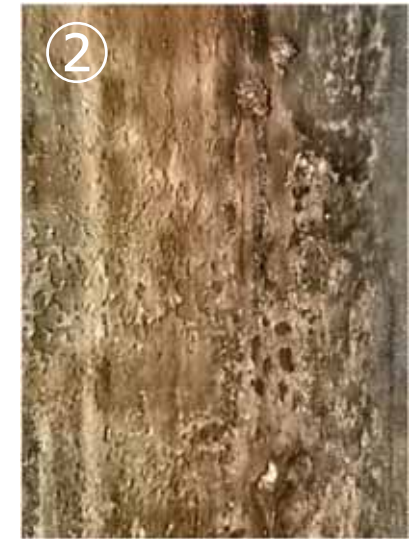
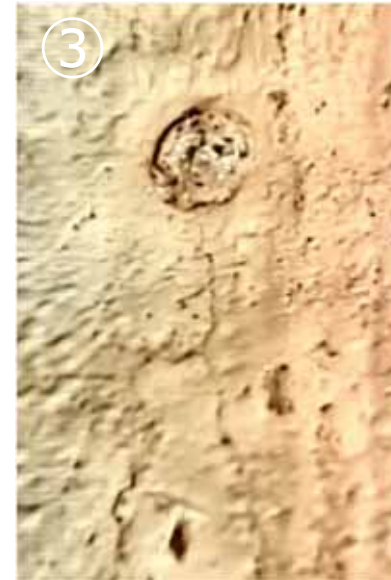
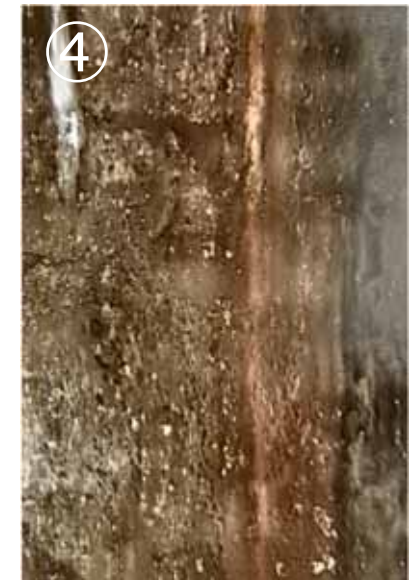
⑤ Bottom of pedestal (pedestal wall)

- Although the epoxy paint is flaking off and the surface is rough, no significant deformation or damage was found to the inner walls of the pedestal.

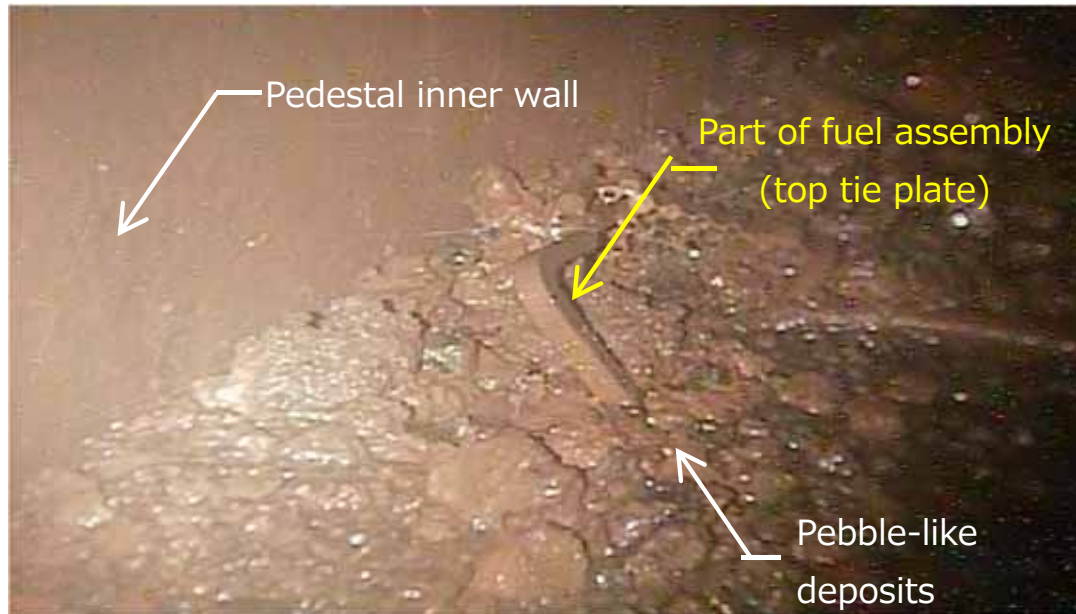
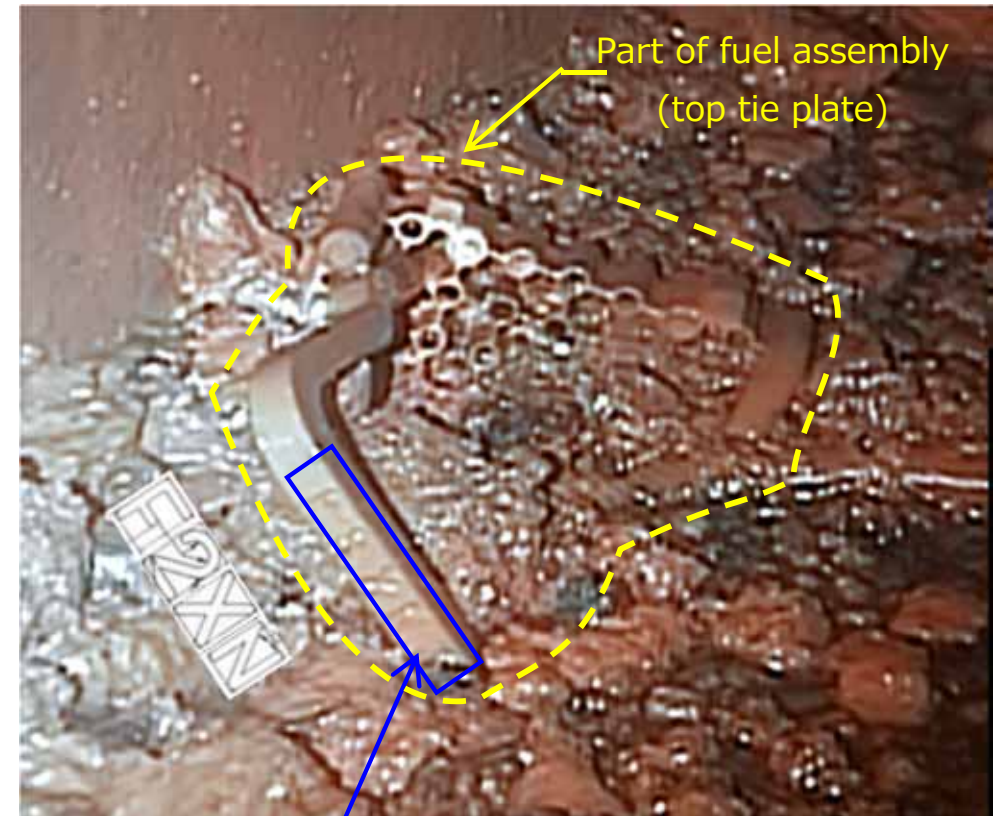
4. Inscription on top tie plate

- The inscription on the top type plate found at the bottom of the pedestal was examined in order to find out the charging location of the fuel assembly from which it came.
- Starting from the left the following four letters/numbers could be read: F2XN

However, since the serial number, which starts with the fifth letter in this series could not be seen we were unable to identify the charging location of the fuel assembly from which this top tie plate originated.

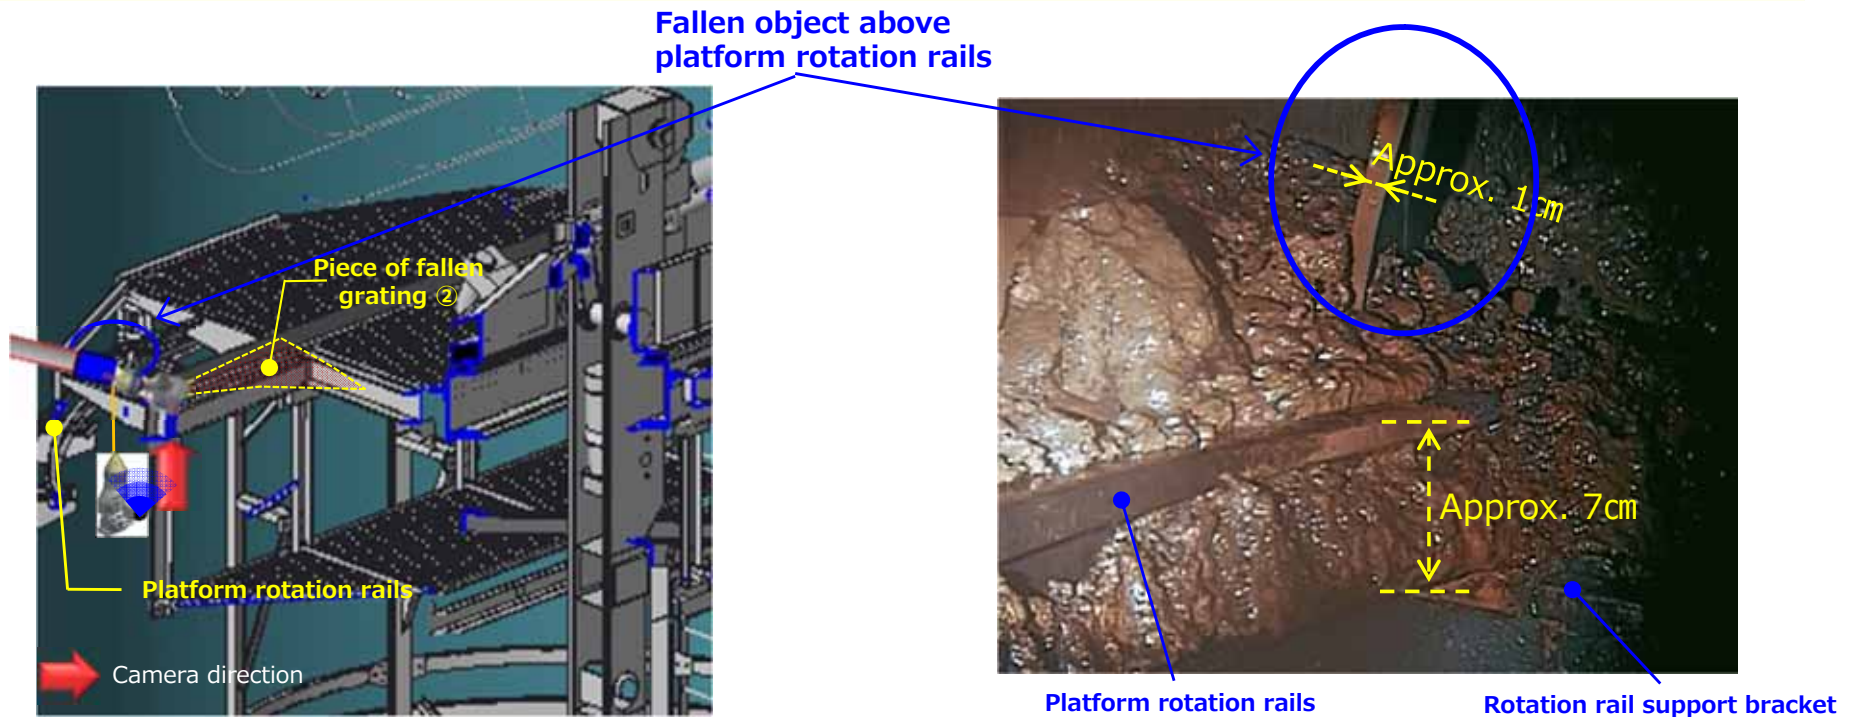
Fallen object above rotation rails

- An object resembling the handle of the top tie plate was found to have fallen on top of the platform rotation rails

- Using the height of the rotation rails (approximately 7 cm) as reference, the thickness of the object thought to be the handle was estimated to be approximately 1cm which matches the design dimensions of the handle.

- No identifying characteristics of the handle could be seen

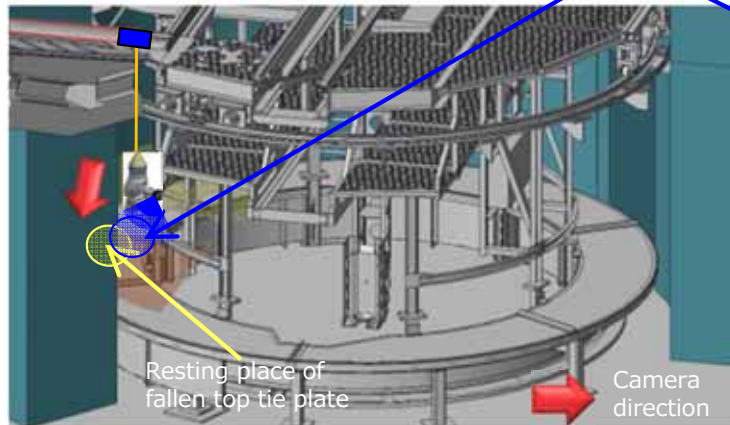
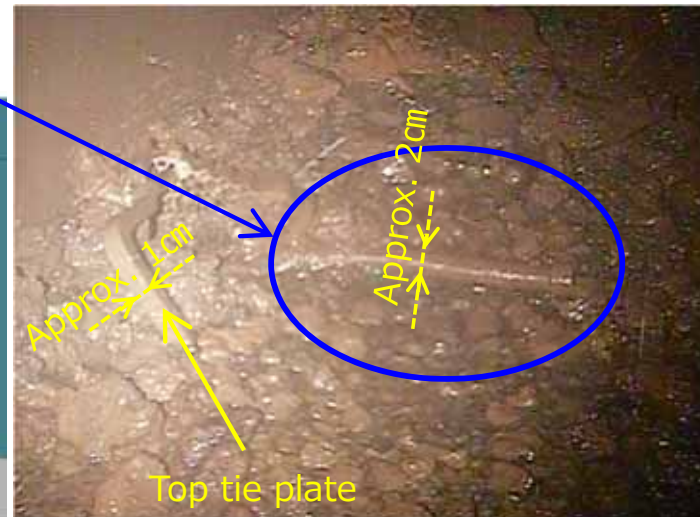
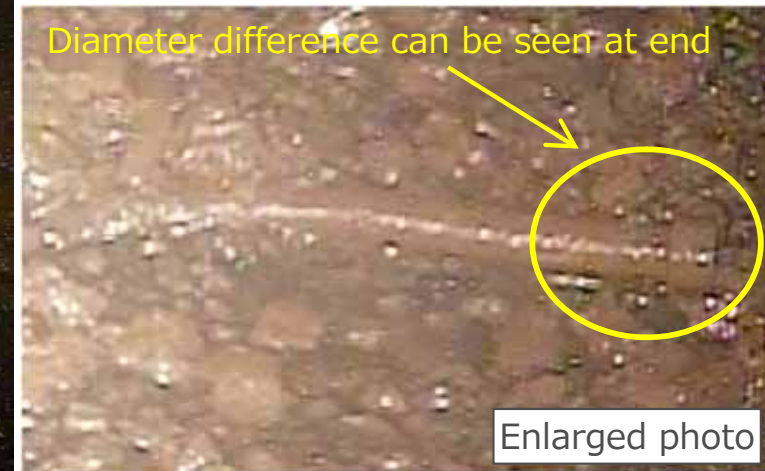
Pipe-like fallen objects

- A pipe-shaped fallen object was found near the location where the top tie plate has fallen at the bottom of the pedestal.
- A diameter difference can be seen at the end of this object

- Using the top tie plate width (approximately 1cm) as reference the width of this pipe was estimated at approximately 2cm.

- The object could not be identified based upon the visible external characteristics and estimated dimensions

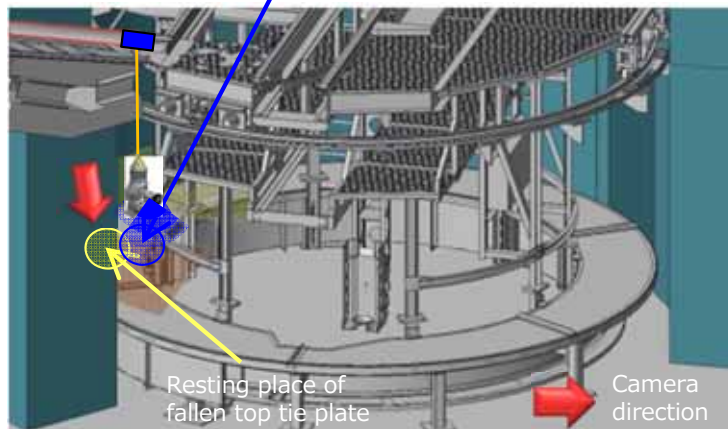
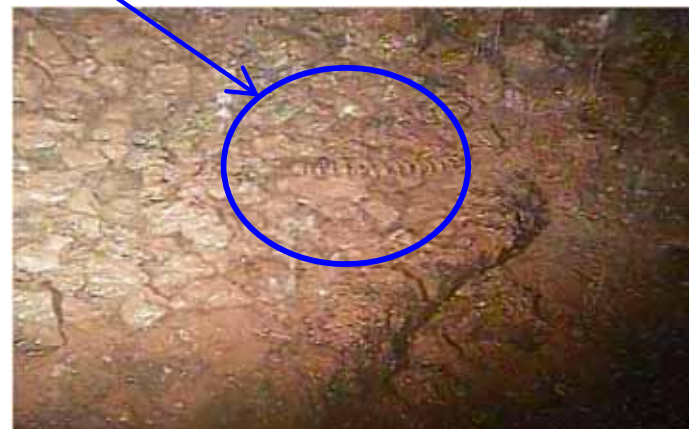
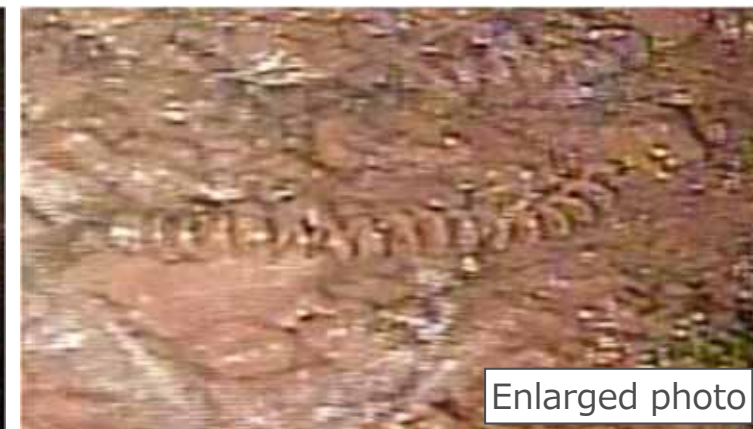
Spring-like fallen objects

- A spring-shaped fallen object was found near the location where the top tie plate has fallen at the bottom of the pedestal.

- There were no structures that could be used as reference for estimating the dimensions of this object so the dimensions were not estimated. This spring has a relatively small diameter and more than 15 coils.

- SRNM detectors, LPRM detector and fuel assemblies all use small diameter springs with more than 15 coils, but it could not be determined from what structure this object originated.

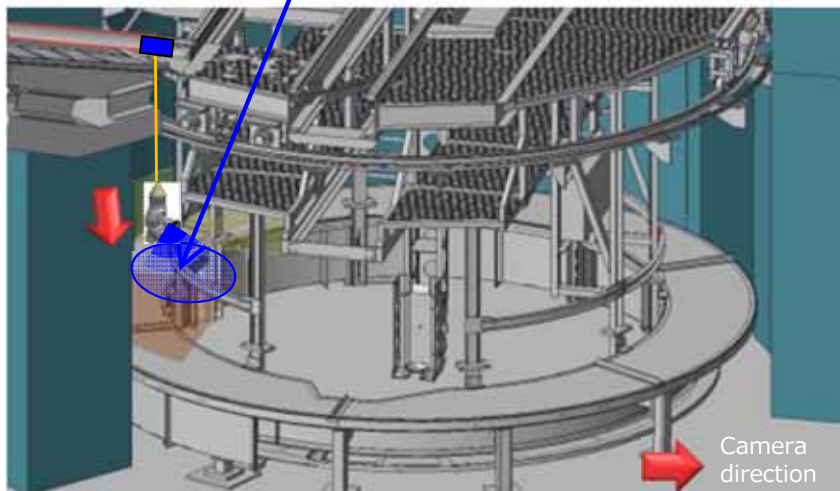
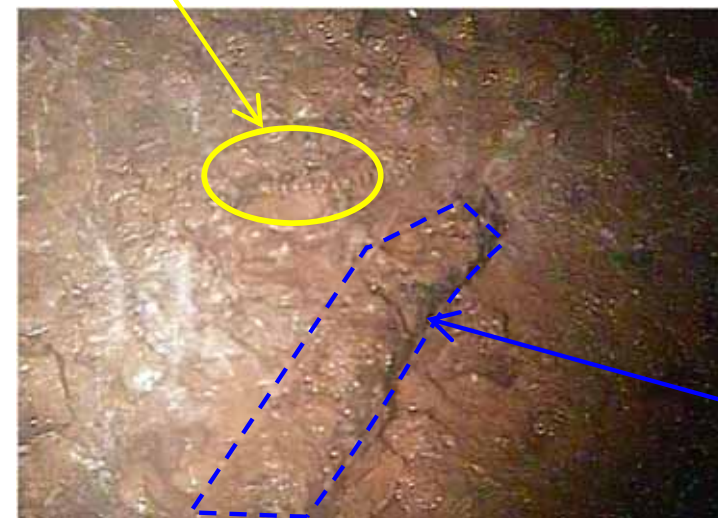
Rod-like fallen object (around springs)

- A rod-like fallen object was found near the spring-like fallen object at the bottom of the pedestal.

- The object does not have sufficient dimensions or structural characteristics to aid in identification.

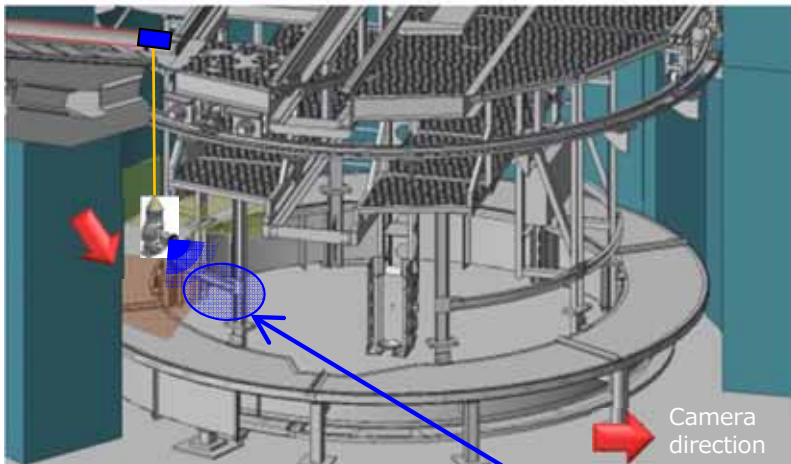
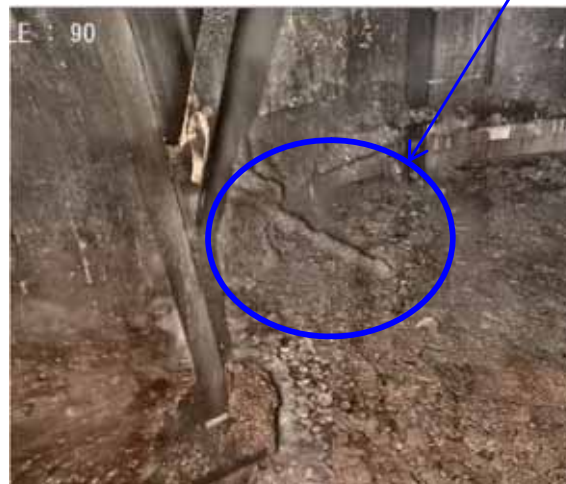
Rod-like fallen object

- A Rod-shaped fallen object was found at the bottom of the pedestal. The rod portion of the fallen object appears to have different diameters.

- The object does not have sufficient dimensions or structural characteristics to aid in identification.
