Fukushima Daiichi Nuclear Power Station Unit 2 Primary Containment Vessel Internal Investigation

April 26, 2018

Tokyo Electric Power Company Holdings, Inc.

1. Primary containment vessel internal investigation overview

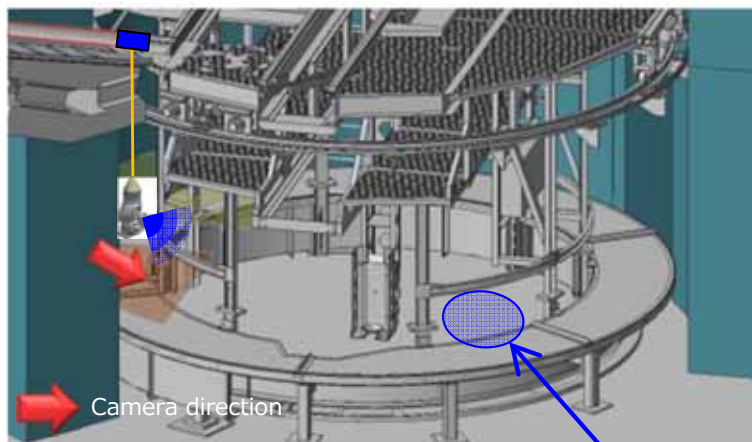
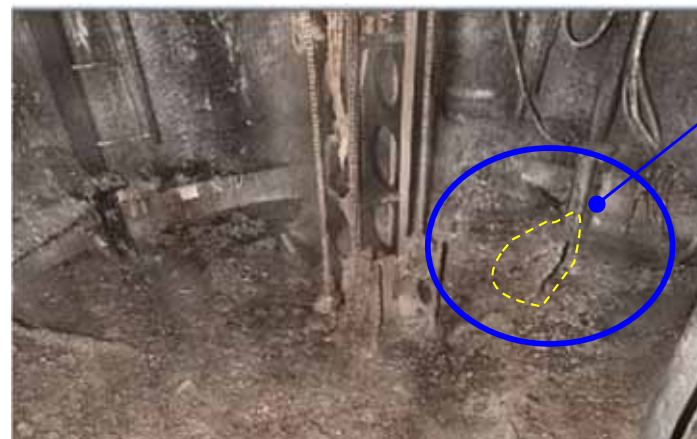
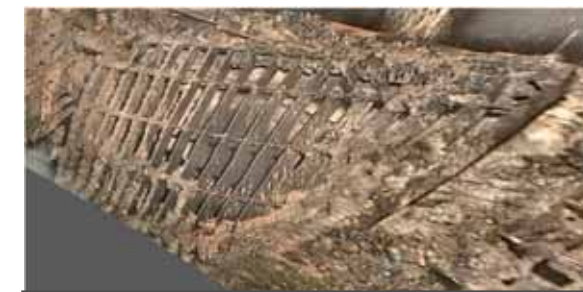
Grate-like fallen object

- Plate-like fallen objects were found near the CRD replacer elevator at the bottom of the pedestal. These fallen objects appear to have grating and are buried in deposits. The objects also appear to be deformed.

- This object is assumed to be grating based on the visible external characteristics. If it is assumed that this grating fell from directly above then it must be from the mid-level work platform because the grating on the platform still remains. However, the mid-level work platform has only been partially examined so it was impossible to identify the location from which this grating originated.

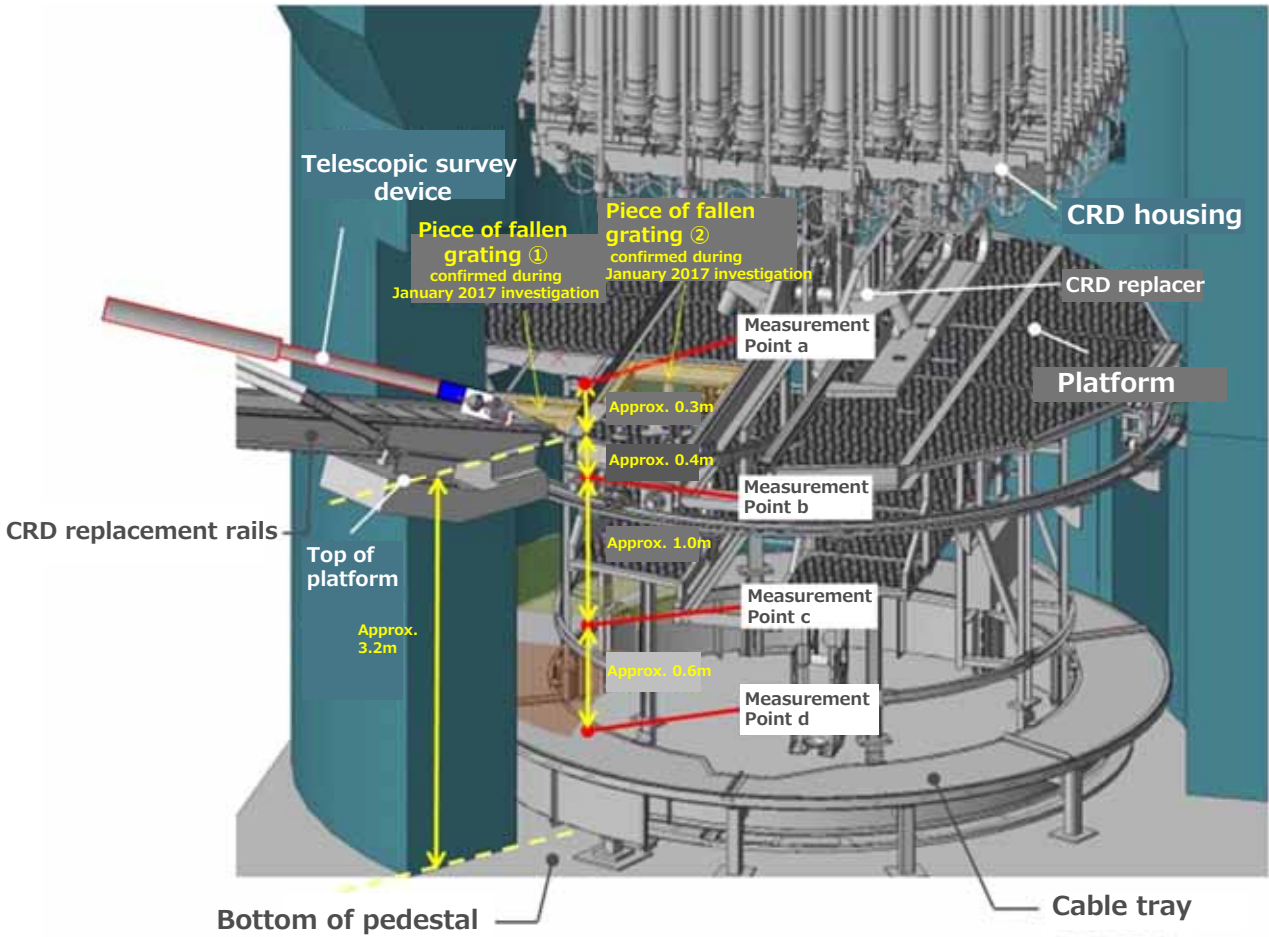
Reference 2 : Dose rate and temperature measurements from inside the pedestal

Measurement point	Dose rate ^{※1, 2} [Gy/h]	Temp. ^{※2} [°C]
a	7	21.0
b	8	21.0
c	8	21.0
d	8	21.0
