Tokyo Electric Power Company

Current Status of Fukushima
Daiichi Nuclear Power Station
in photos

Photos taken on August 17 ~ September 7, 2011

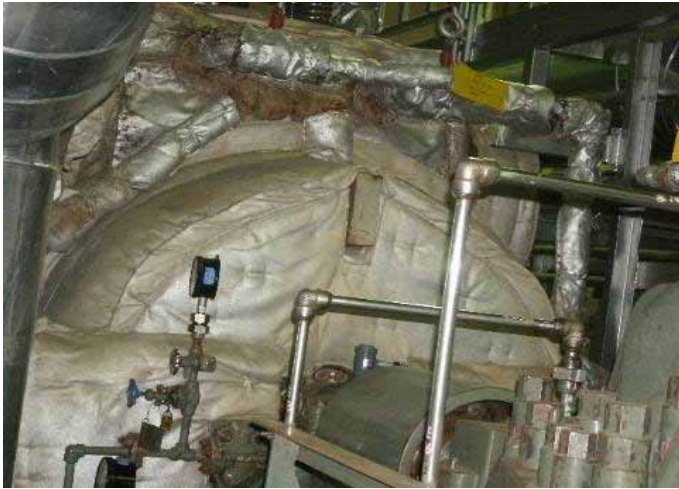
(1) Unit 5 High Pressure Coolant Injection System turbine (Reactor building B2F)

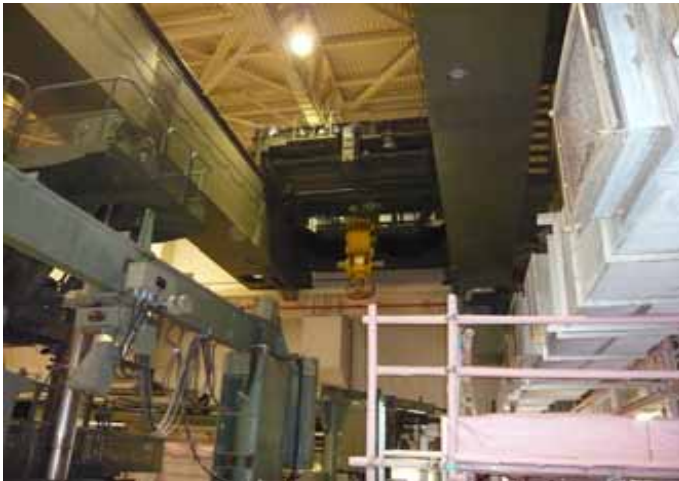
(3) Unit 5 Reactor building ceiling crane

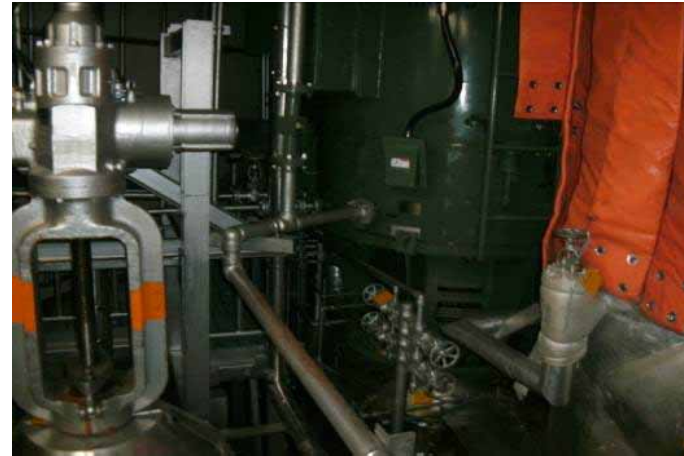
(2) Unit 5 residual heat removal system (RHR) pump (B)(D) (Reactor building B2F)

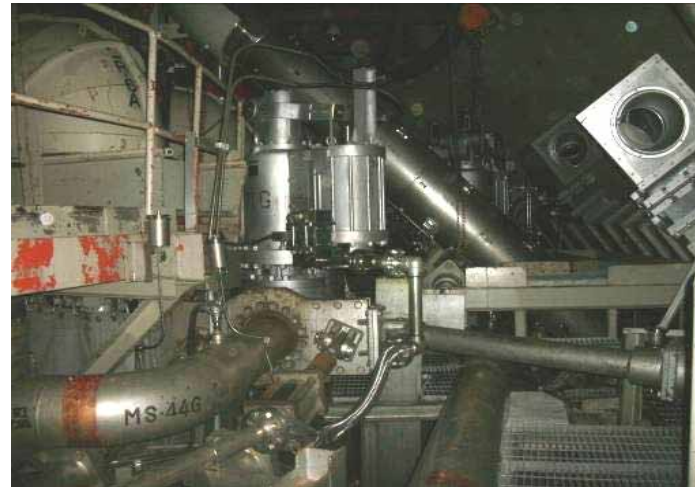
(4) Condition at Unit 5 Primary Containment Vessel 2F

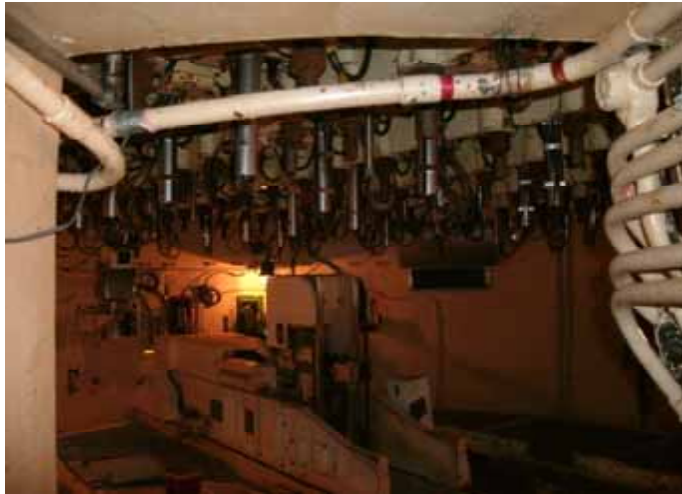
(5) Inside Unit 5 pedestal (reactor foundation)
Taken by TEPCO employee on August 17, 2011

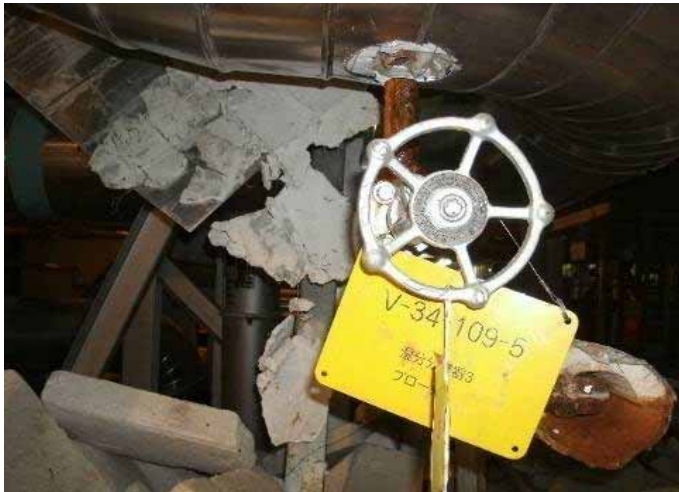
(7) Unit 5 Moisture separator(3) (Turbine building B1F)
Taken by TEPCO employee on August 23, 2011

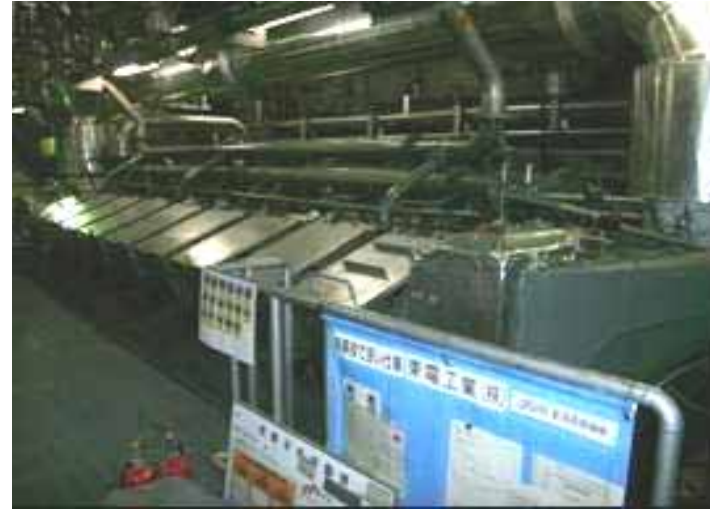
(6) Unit 5 Emergency diesel generator (Turbine building B1F)

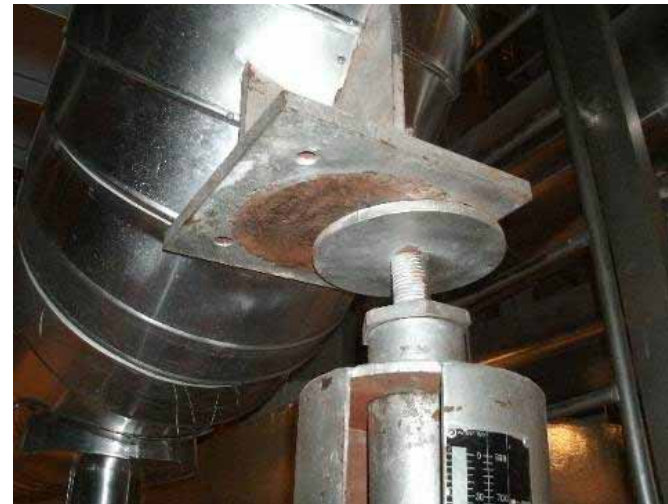
(8) Unit 5 Moisture separator drain pipe support
(Turbine building B1F)

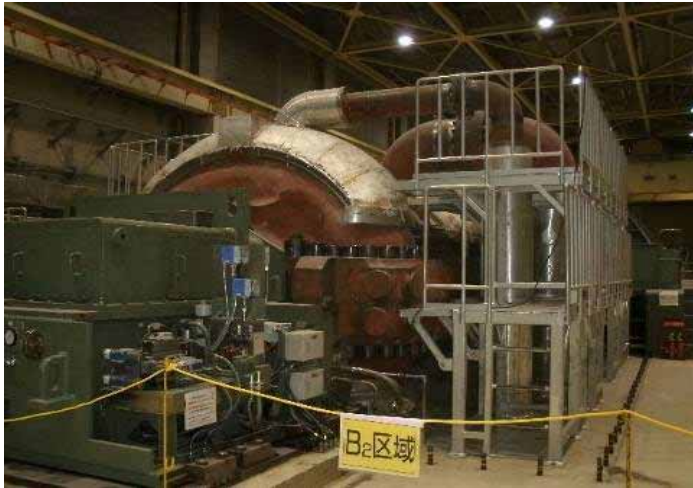
(9) Unit 5 High pressure turbine (Turbine building 2F)
Taken by TEPCO employee on August 23, 2011

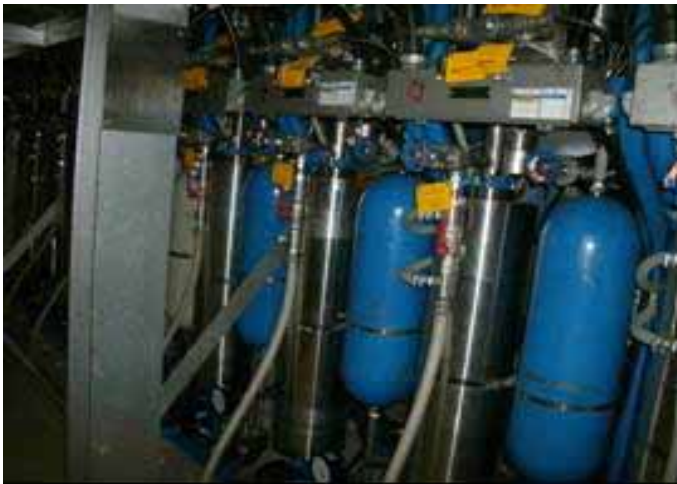
(11) Unit 5 Control rod water pressure control unit
(Reactor building 1F)
Taken by TEPCO employee on August 19, 2011

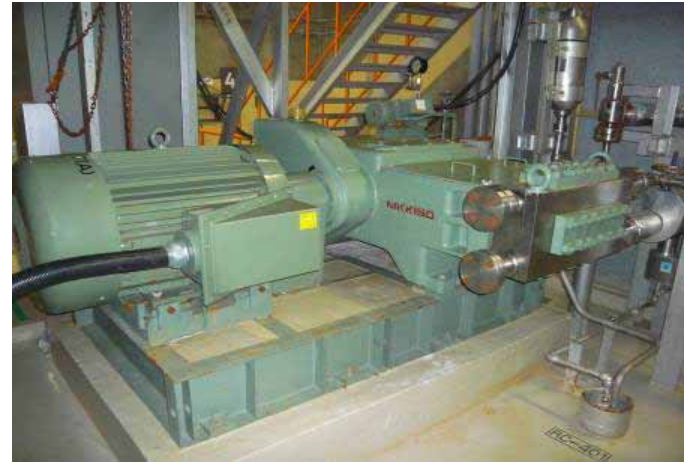
(10) Unit 5 Boric acid injection pump (A)
(Reactor building 4F)
Taken by TEPCO employee on August 19, 2011

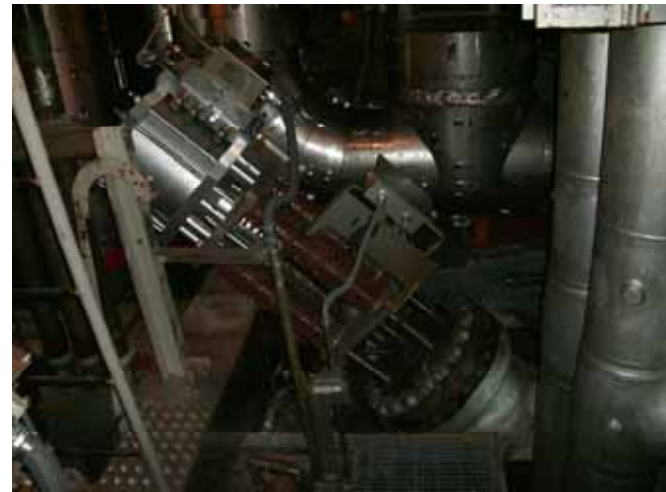
(12) Unit 5 Main steam isolation valve (Primary
Containment Vessel 1F)
Taken by TEPCO employee on August 17, 2011

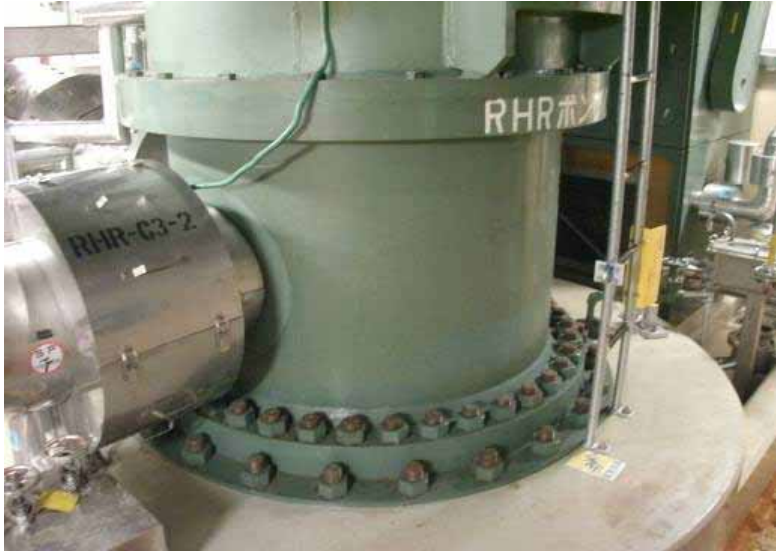
(13) Unit 6 residual heat removal system (RHR) pump (C) (Reactor building B2F)
Taken by TEPCO employee on August 18, 2011

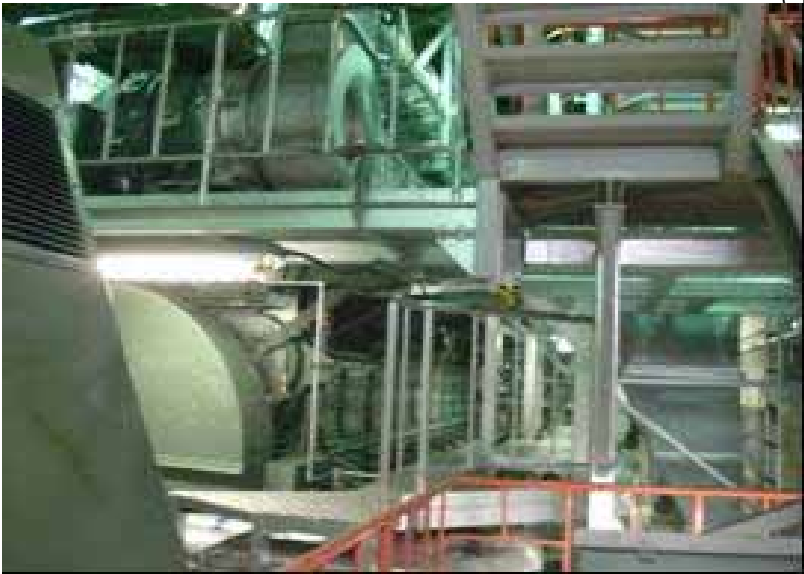
(14) Unit 6 Emergency diesel generator (A) (Turbine building B1F)
Taken by TEPCO employee on August 19, 2011

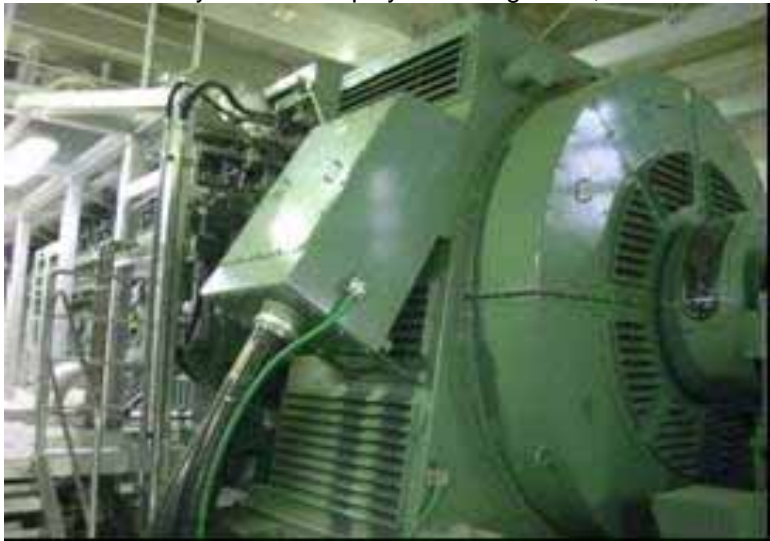
(15) Unit 6 High Pressure Core Spray System diesel generator (Reactor building B1F)
Taken by TEPCO employee on August 19, 2011

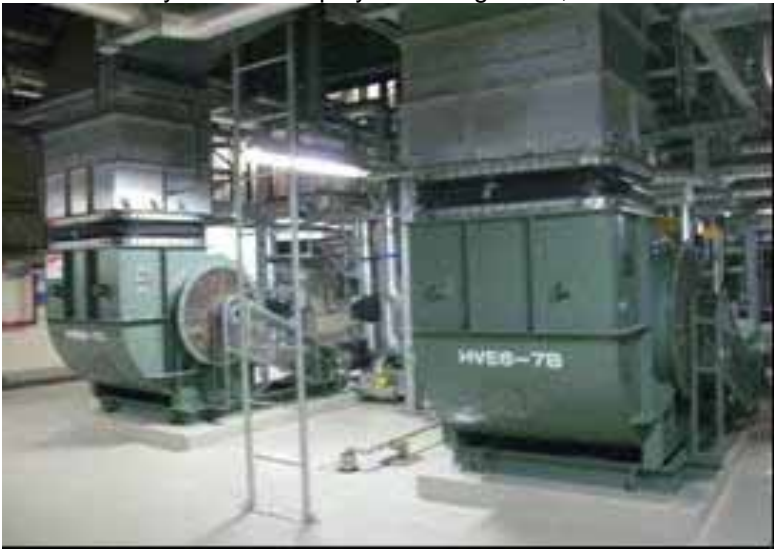
(16) Unit 6 gas treatment System (A)(B) (Reactor building 3F)
Taken by TEPCO employee on August 19, 2011

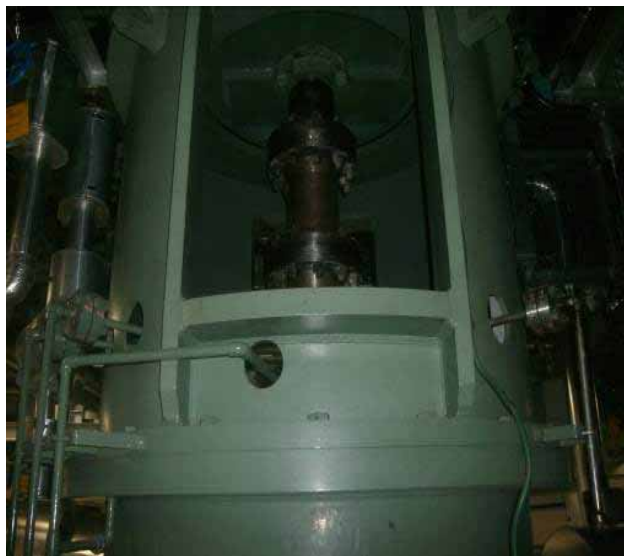
(17) Unit 6 Low Pressure Core Spray System pump
(Reactor building B2F)

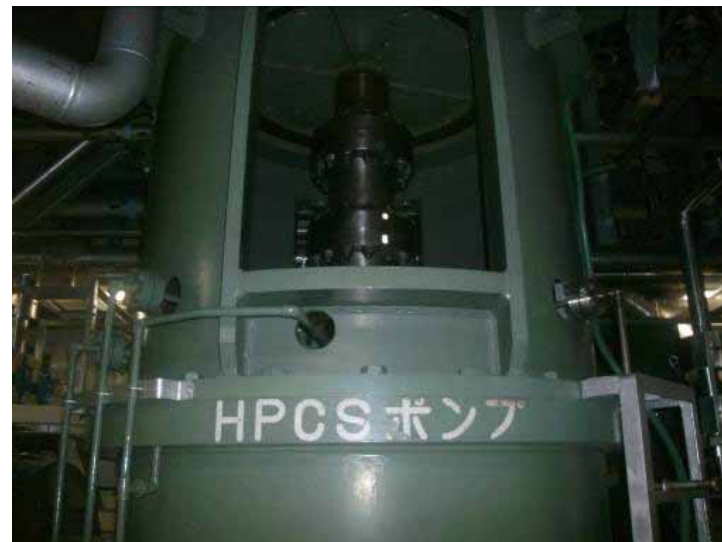
(18) Unit 6 High Pressure Core Spray System pump
(Reactor building B2F)

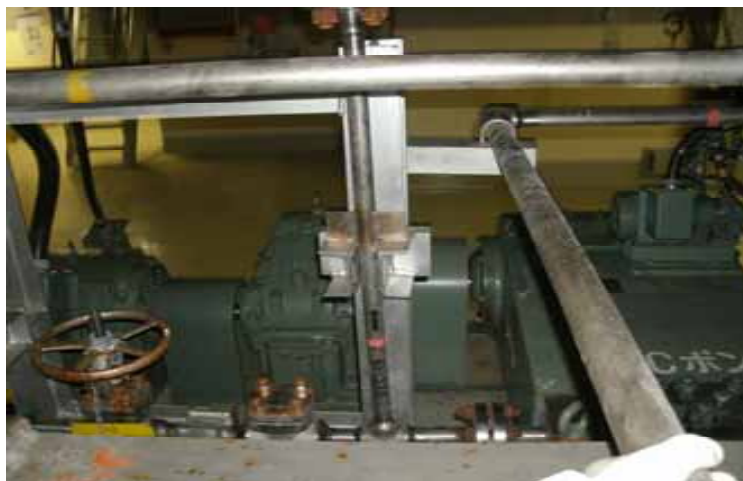
(19) Unit 6 Boric acid injection pump (A)
(Reactor building 5F)

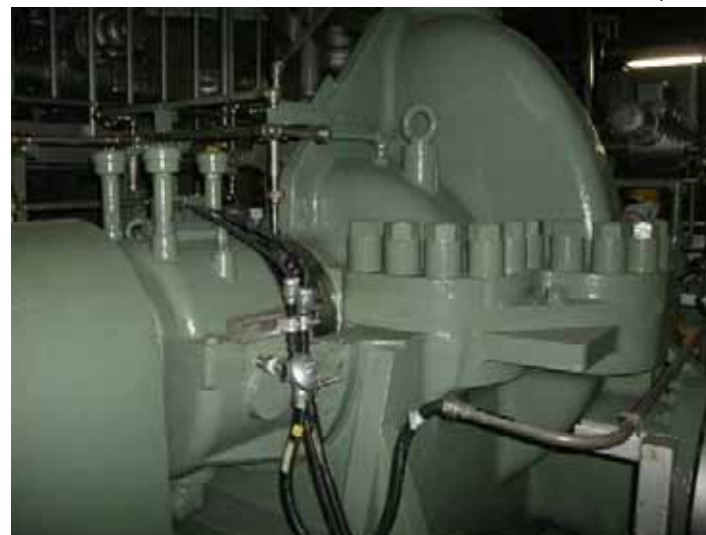
(20) Unit 6 High pressure condensate pump (Turbine building B1F)

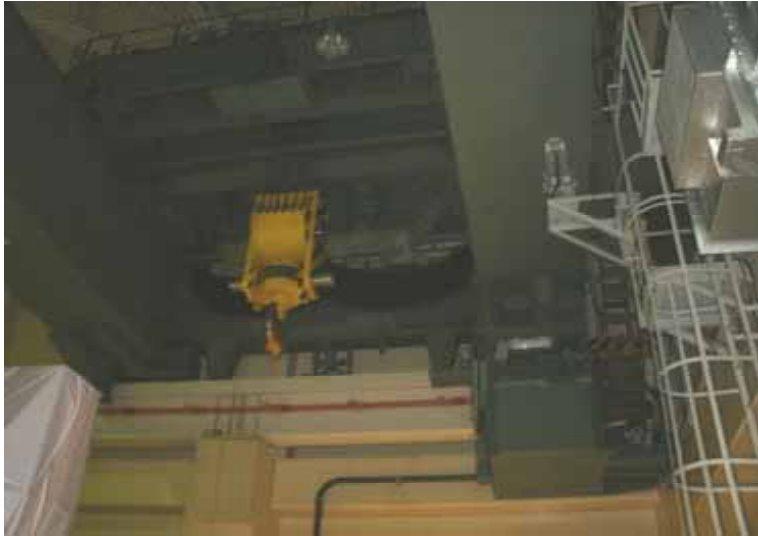
(21) Unit 6 Reactor building ceiling crane
Taken by TEPCO employee on August 24, 2011

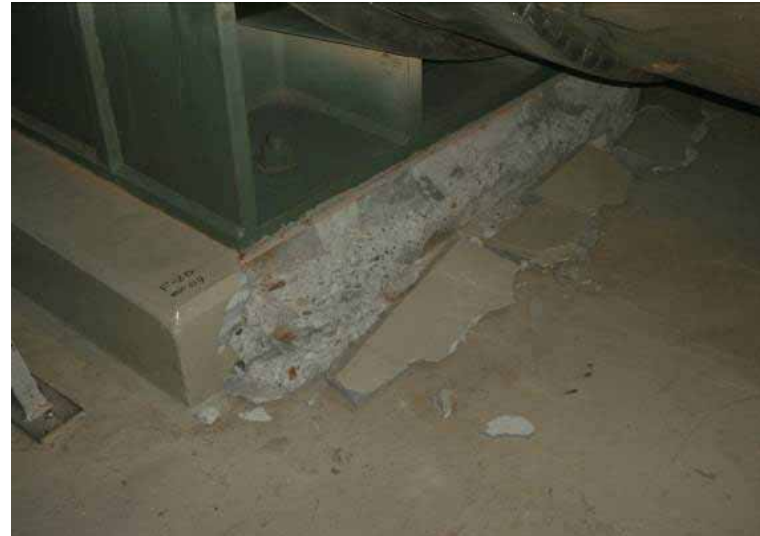
(22) Unit 6 feed water heater (Turbine building 1F)
Taken by TEPCO employee on August 25, 2011

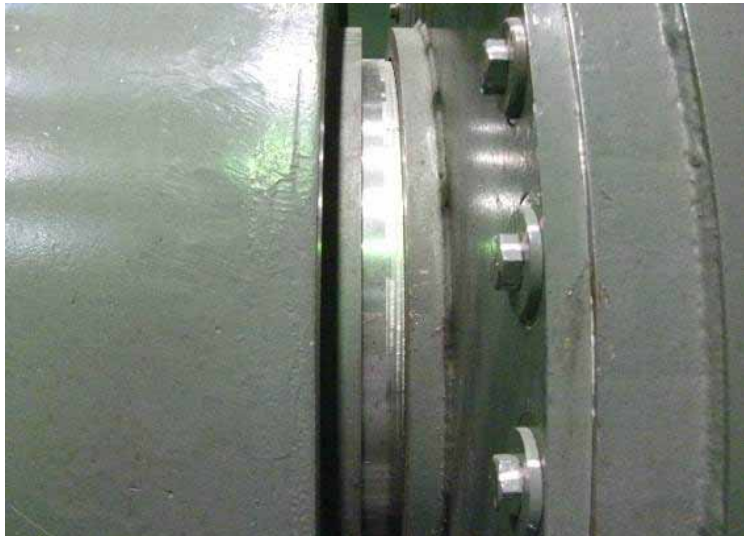
(23) Unit 6 Low pressure turbine (Turbine building 2F)
Taken by TEPCO employee on August 23, 2011

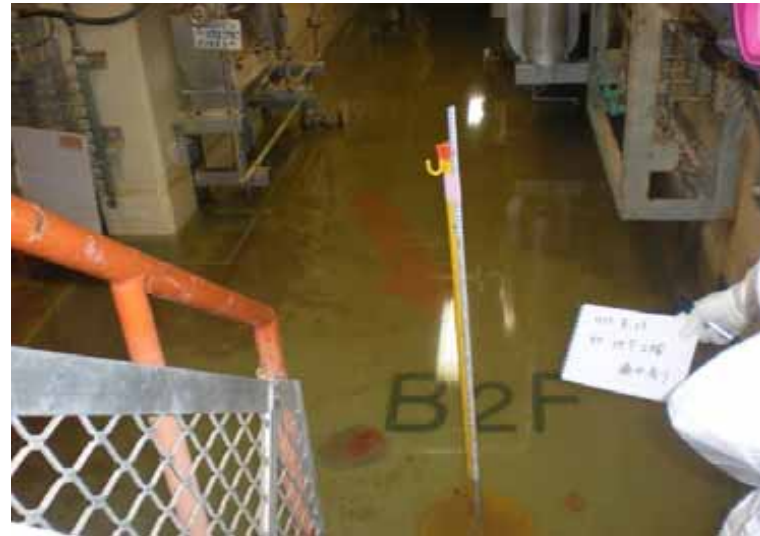
(24) Unit 6 Complex building B2F
Taken by TEPCO employee on August 23, 2011

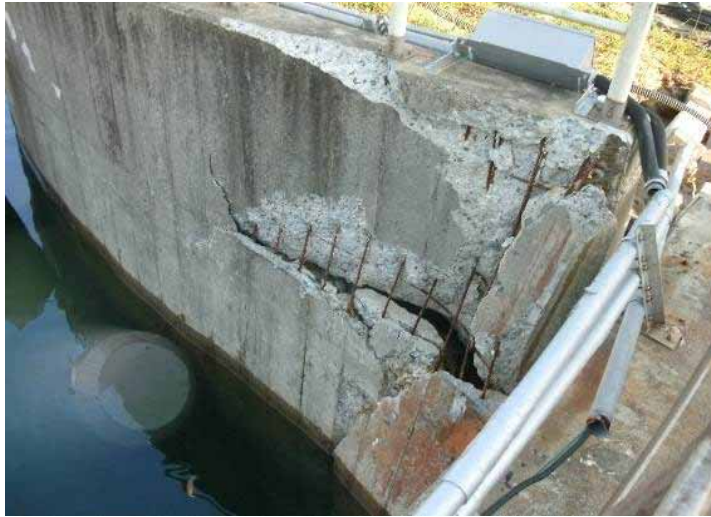
(25) Unit 5 Intake channel
Taken by TEPCO employee on August 23,2011

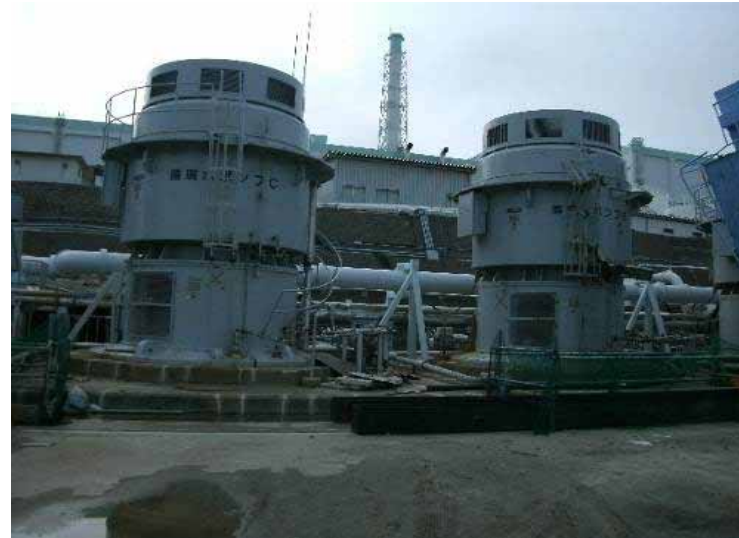
(26) Unit 5 Circulating water pump (B)(C)
Taken by TEPCO employee on August 23,2011

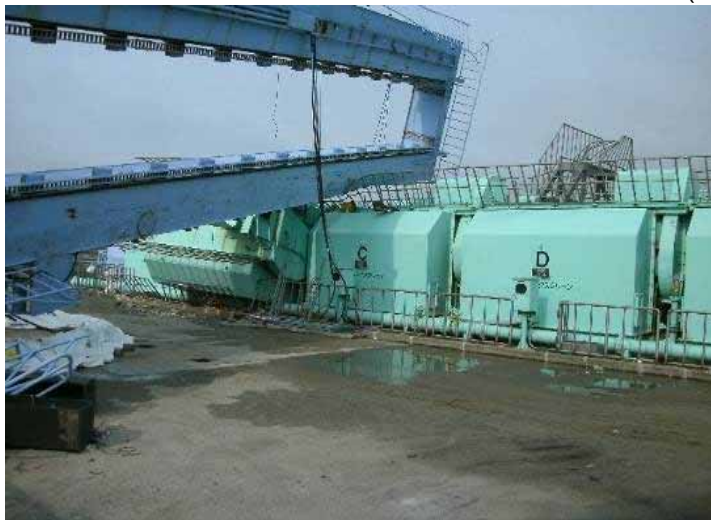
(27) Unit 5 Screen
Taken by TEPCO employee on August 23,2011

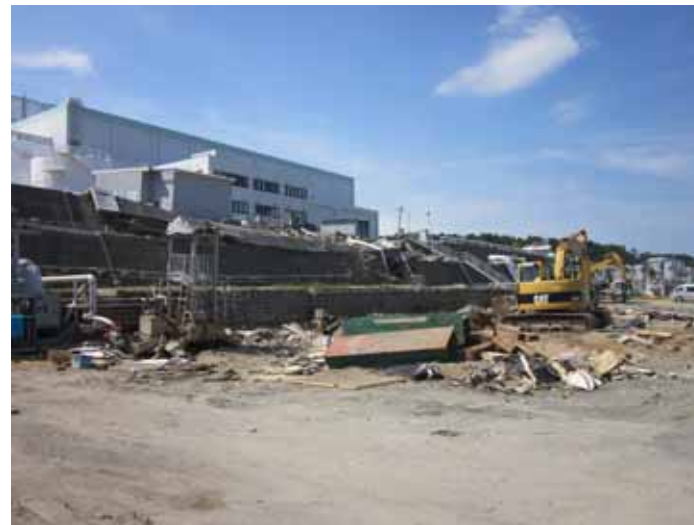
(28) Unit 5 Seaside slope
Taken by TEPCO employee on August 25,2011

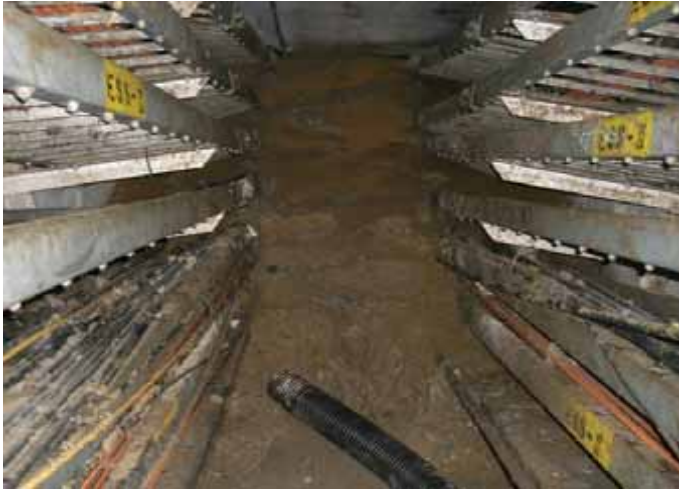
(29) Unit 5 Water intake cable pit
Taken by TEPCO employee on August 25,2011

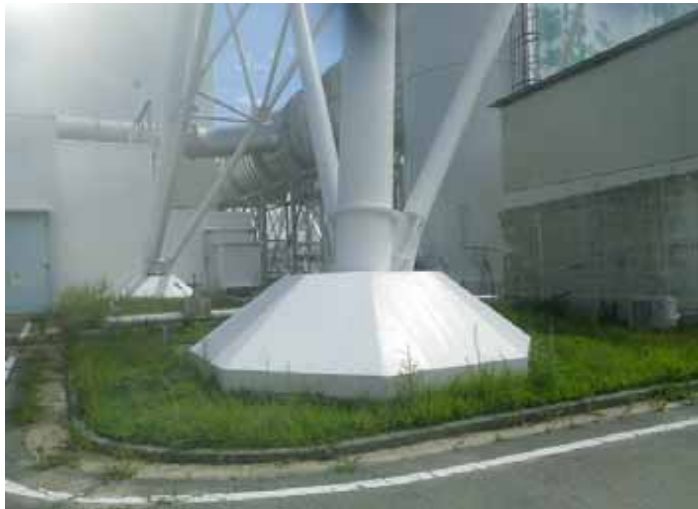
(31) Unit 5 Basement of Main exhaust stack
Taken by TEPCO employee on September 7,2011

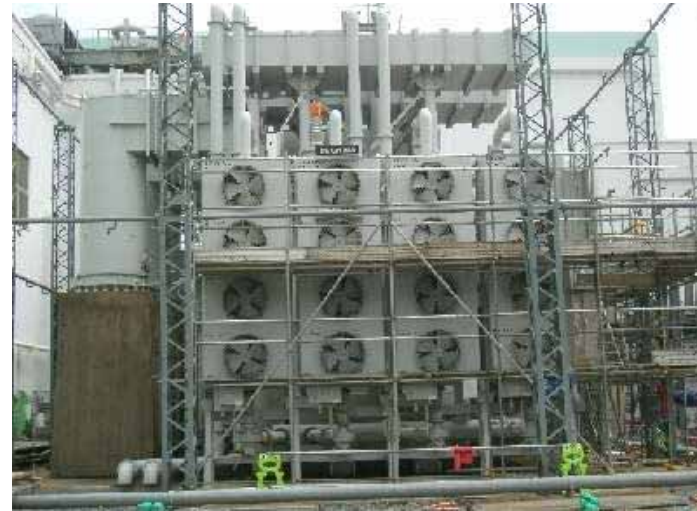
(30) Unit 5 Main transformer
Taken by TEPCO employee on August 24,2011

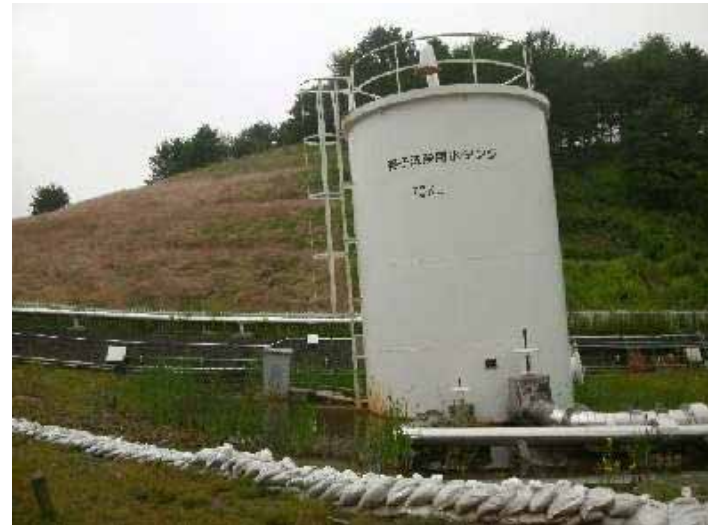
(32) Unit 5 Insulator cleaning tank
Taken by TEPCO employee on August 24,2011

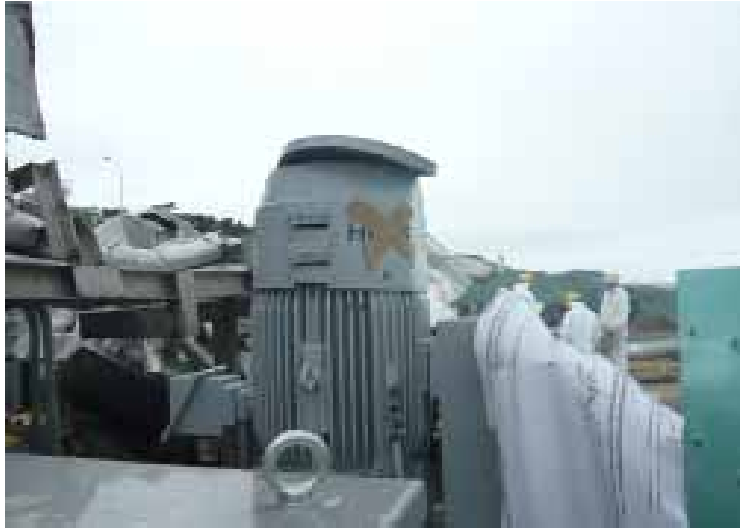
(33) Unit 6 High pressure core spray system Diesel generator
Seawater system pump
Taken by TEPCO employee on August 23,2011

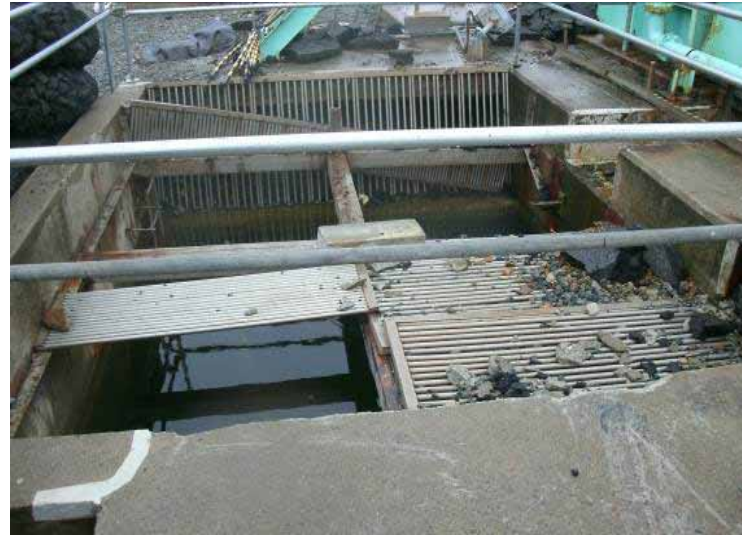
(34) Unit 6 Around screen
Taken by TEPCO employee on August 28,2011

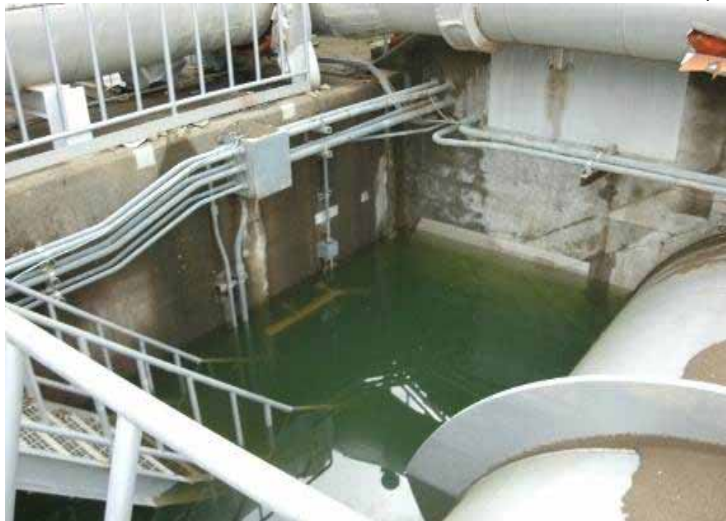
(35) Unit 6 Reversing valve pit
Taken by TEPCO employee on August 22,2011

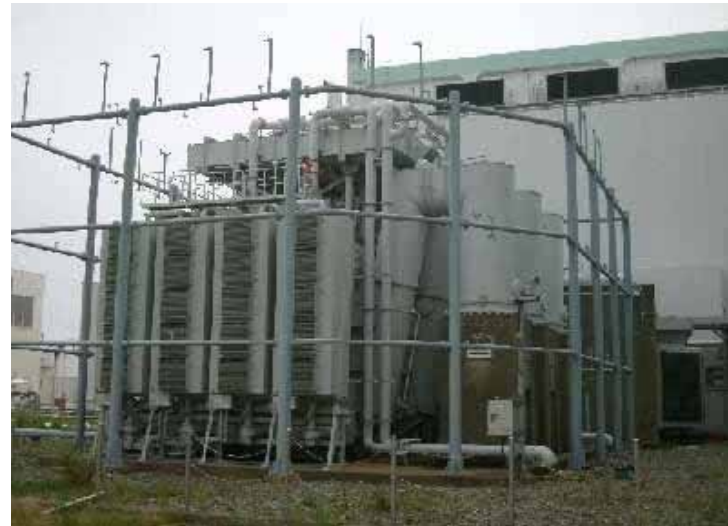
(36) Unit 6 Main transformer
Taken by TEPCO employee on August 24,2011

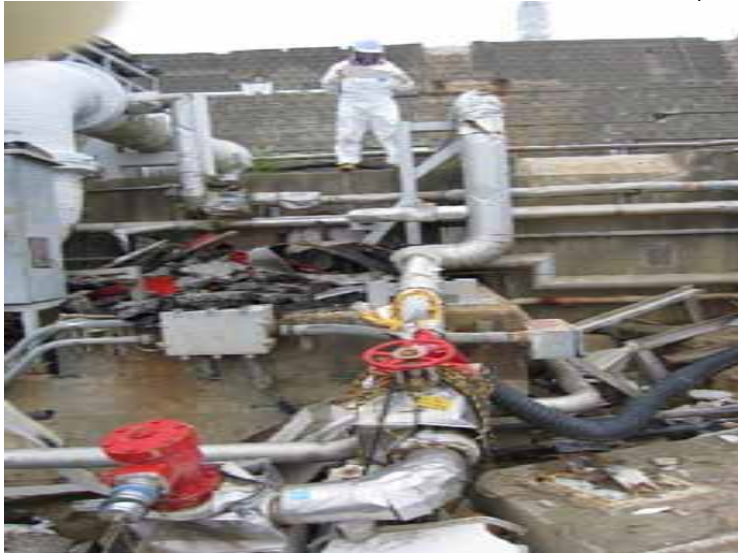
(37) Unit 5 and 6 Extinction pipes
Taken by TEPCO employee on August 22,2011 (39)

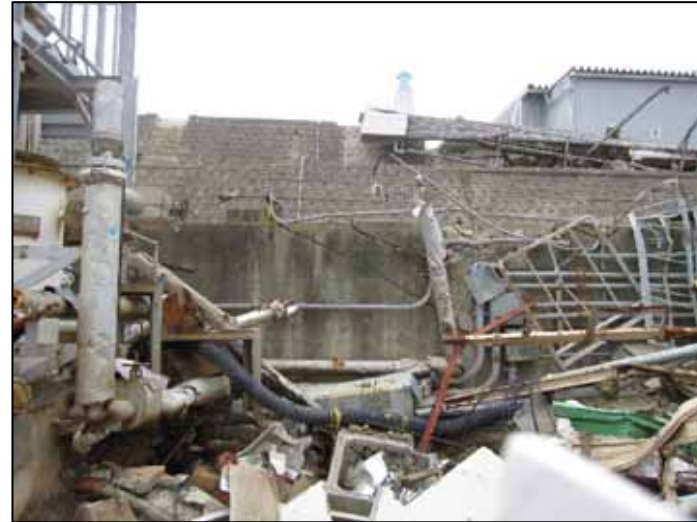
(38) Unit 5 and 6 Extinction pipes
Taken by TEPCO employee on August 22,2011

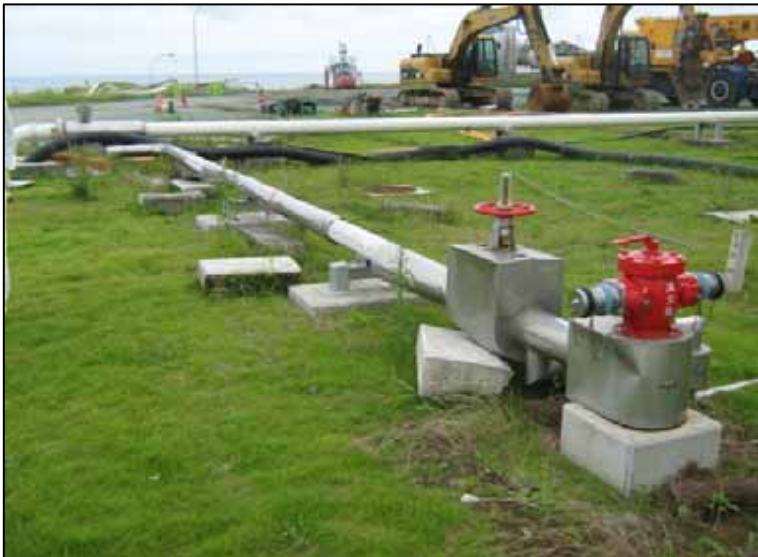
(38) Unit 5 and 6 Extinction pipes
Taken by TEPCO employee on August 22,2011
