The crack of axle linkage casing at the overhead crane in the building of spent fuel common pool, Fukushima Daiichi Nuclear Power Station (survey result)

< Reference >
Dec.23 2011
Tokyo electric Power Company

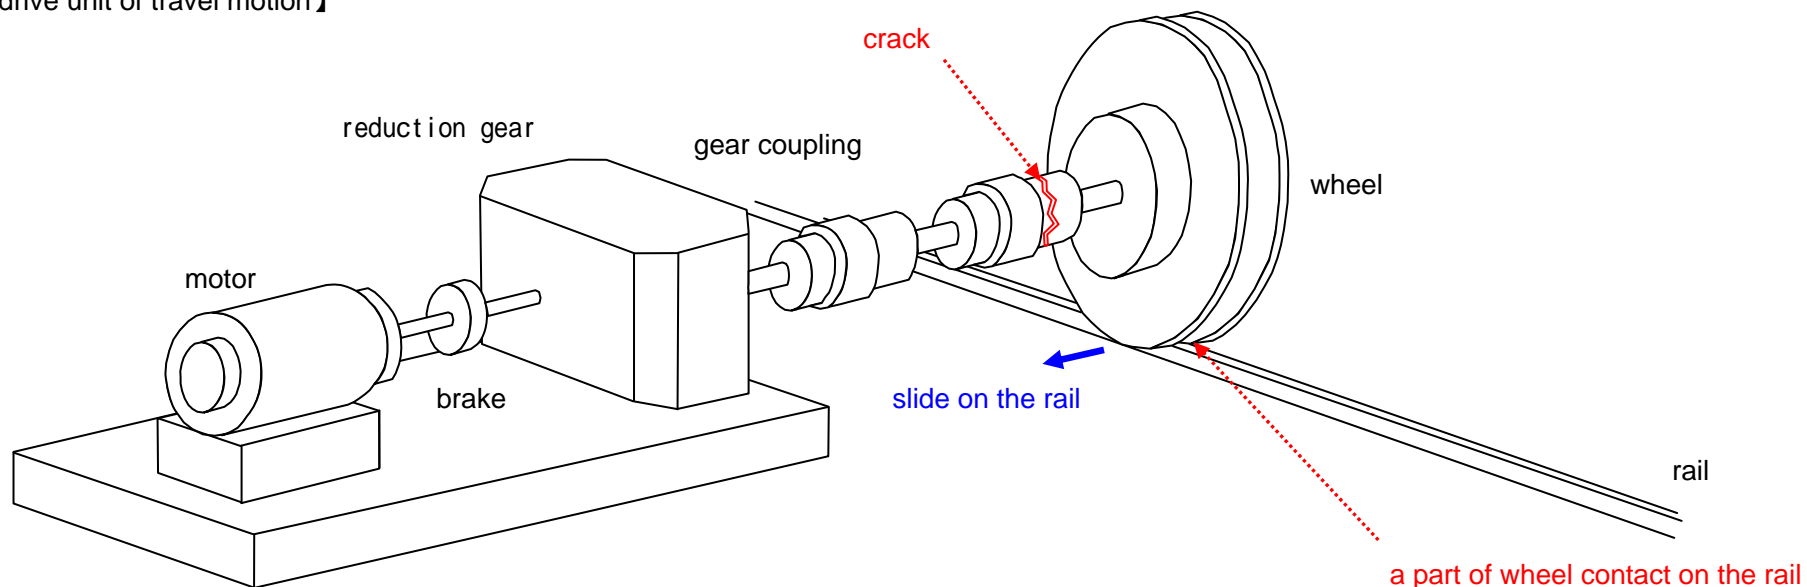
【drive unit of travel motion】

At the time of the earthquake, it is conjectured that the wheel slipped to the cross direction on the rail, because the wheel which connected with the gear coupling contacts on the rail.

When the wheel stopped moving at the top of the rail, the cover of the coupling hit the gear and it was cracked by the impulsive load.

We are ordering new gear coupling and will exchange it on arrival.

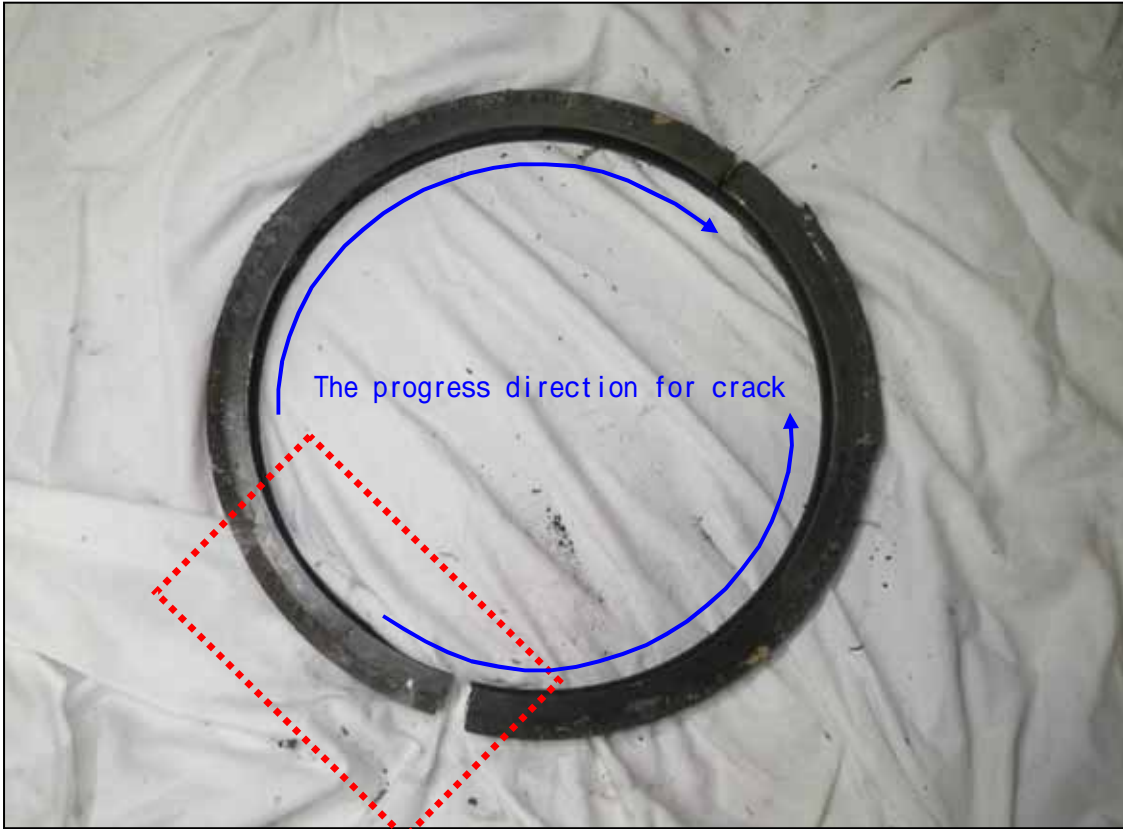
【The photo of damaged part】

The condition of fracture surface at the damaged gear coupling

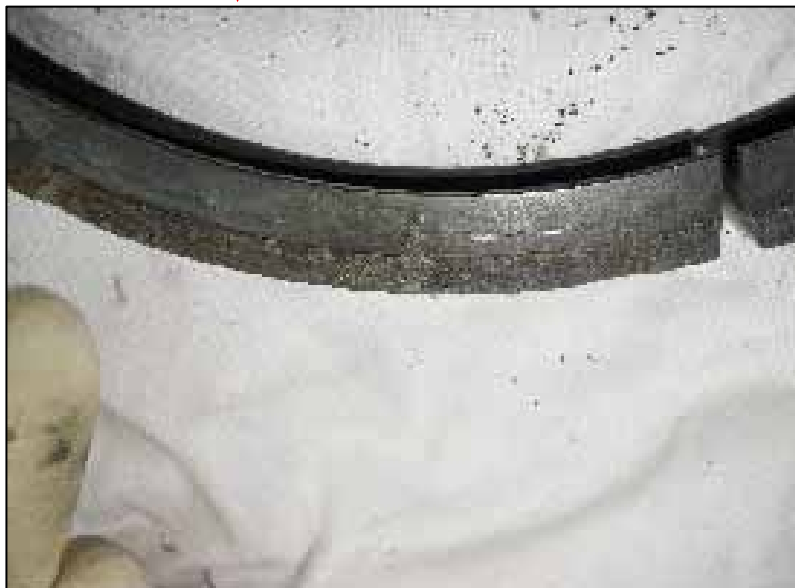
The part of the most remarkable damaged mark hit by the gear
