Status of inspection work of the main turbine of Unit 4

< Inspected equipment >

Low pressure turbine (A) 【moving blade(whole), stationary blade(upper half)】
 High pressure turbine 【moving blade(whole), stationary blade(upper half)】
 Bearing(from High pressure turbine to Low pressure turbine (A))

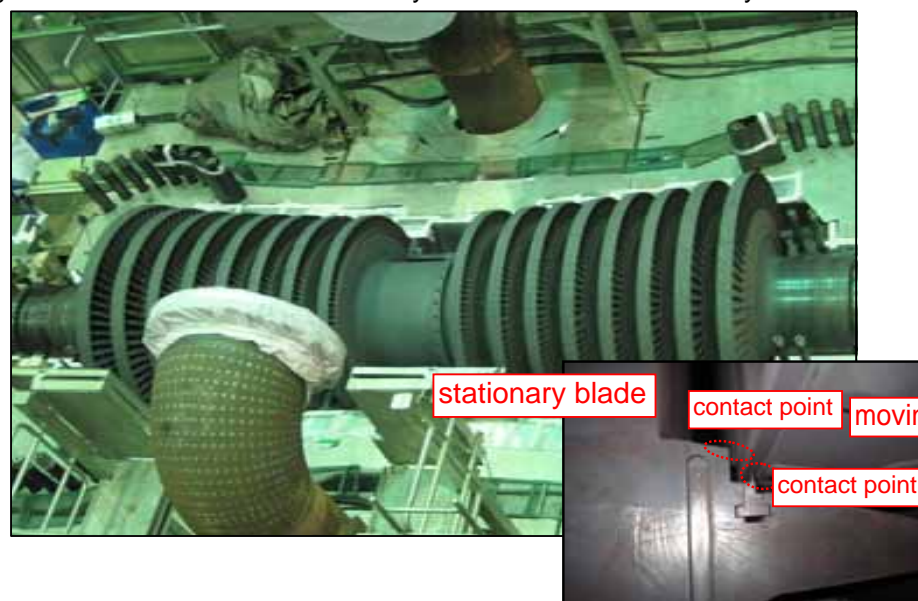
Eight (No.1 to No.8) moving blades and stationary blades are located symmetrically.

We found some contact traces between moving and stationary blade at the edge of No.1 to No.8 blades caused by the Tohoku-Chihou-Taiheiyou-Oki

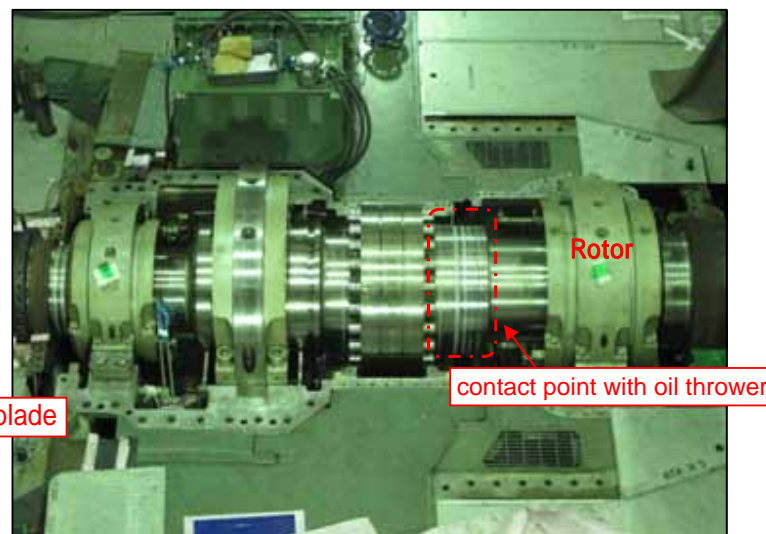
We found some contact traces between oil thrower bearing and rotor caused by the Tohoku-Chihou-Taiheiyou-Oki Earthquake through the result of bearing inspection.

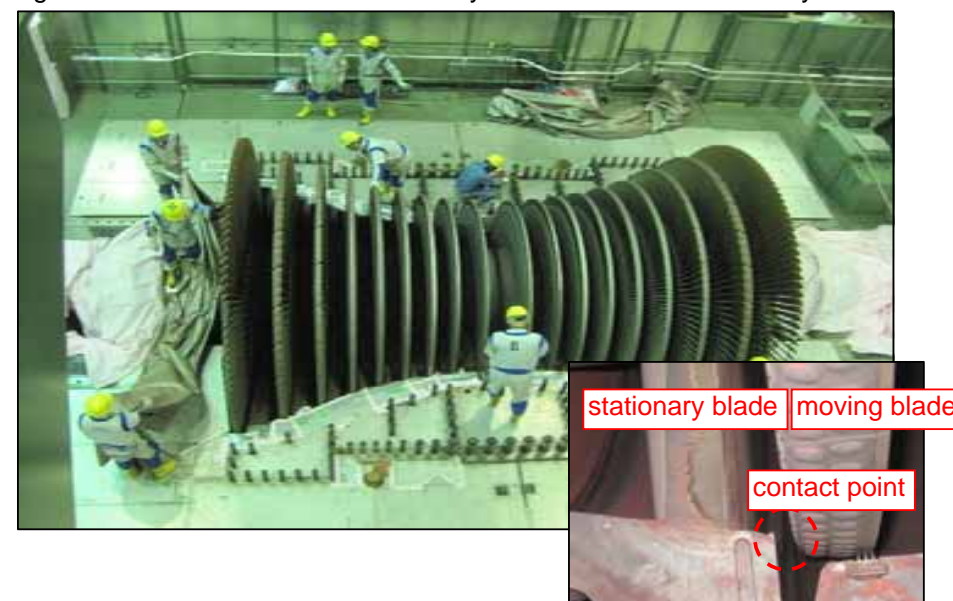
Six (No.9 to No.14) moving blades and stationary blades are located symmetrically.

We found some contact traces between moving and stationary blade at the edge of No.9 to No.14 blades caused by the Tohoku-Chihou-Taiheiyou-Oki

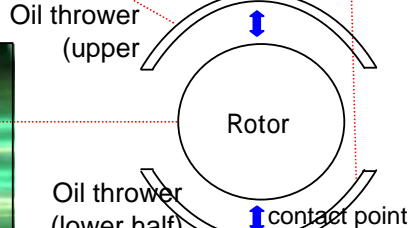
Rotor (contact point)

[Photo of contact trace]
