Inspection Status of Trench, etc. at Fukushima Daiichi Nuclear Power Station (Preliminary Result, February 6, 2012)

February 6, 2012

Tokyo Electric power Company

Inspection Status View of Trench, etc. at Fukushima Daiichi Nuclear Power Station

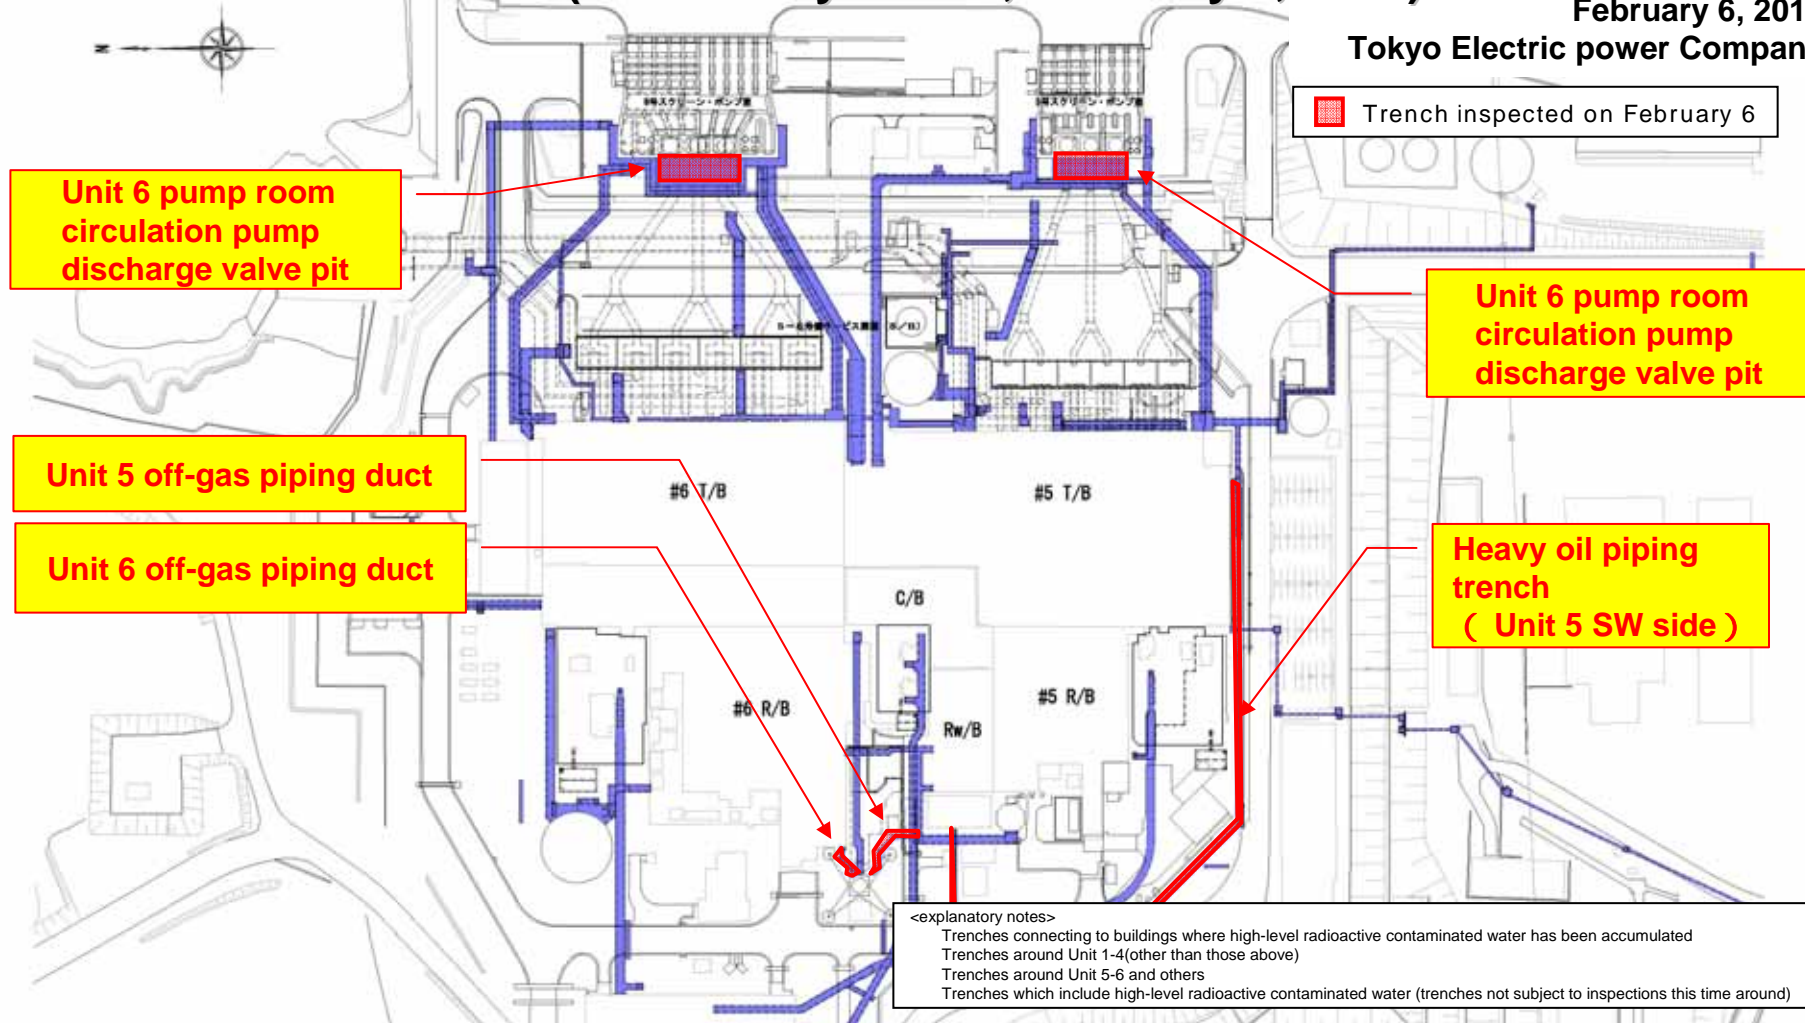
date of inspection	Place	Puddle	Surface dose rate	Result of nuclide analysis (Bq/cm ³)		
				I - 131	C s - 134	C s - 137
February 6	Inside unit 5 pump room circulation pump discharge valve pit	Existing	Approx. 5.0 μ Sv/h	ND	1.0 × 10 ⁻¹	1.6 × 10 ⁻¹
	Inside unit 6 pump room circulation pump discharge valve pit	Existing	Approx. 4.0 μ Sv/h	ND	1.1 × 10 ⁻¹	1.4 × 10 ⁻¹
	Unit 5 off-gas piping duct	Not found	—	—	—	—
	Unit 5 off-gas piping duct	Existing	Approx. 1.0 μ Sv/h	ND	1.2 × 10 ⁻¹	1.9 × 10 ⁻¹
	Heavy oil piping trench (Unit 5 SW side)	Not found	—	—	—	—
