Inspection Status of Trench, etc. at Fukushima Daiichi Nuclear Power Station (Preliminary Result, February 7, 2012)

February 7, 2012

Tokyo Electric power Company

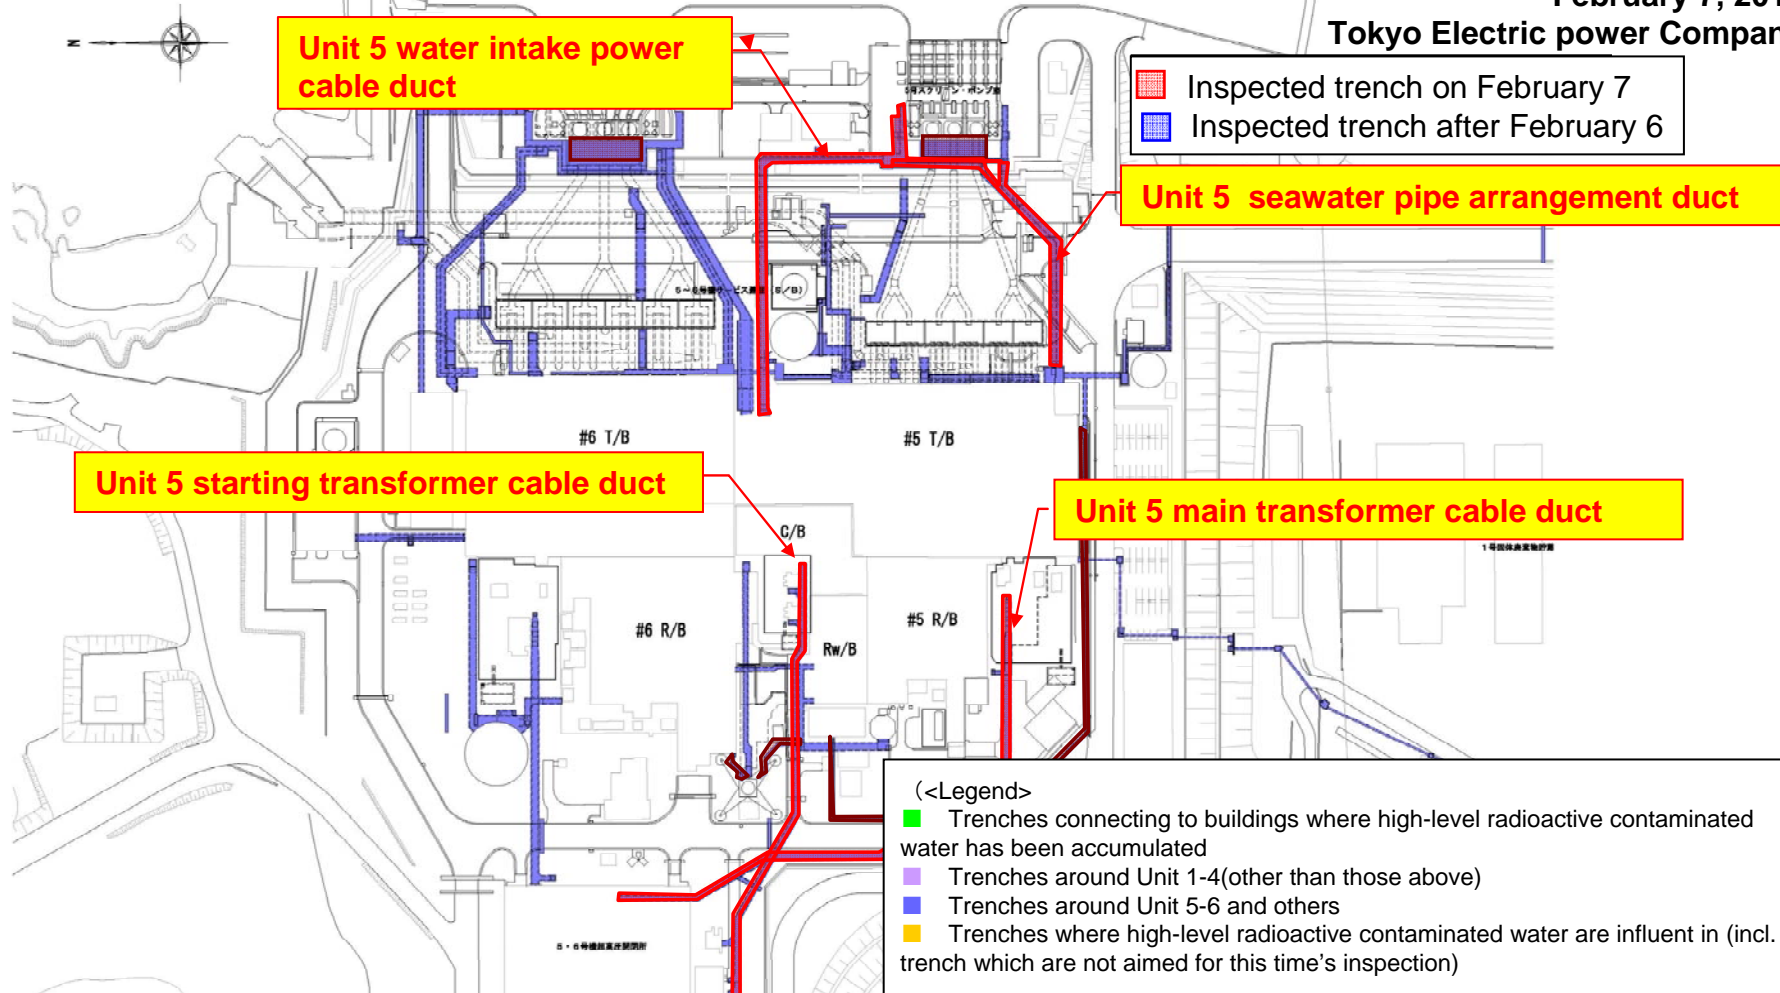
Date of inspection	Place	Puddle	Surface dose rate	Result of nuclide analysis (Bq/cm ³)		
				I-131	Cs-134	Cs-137
February 7	Unit 5 water intake power cable duct	Discovered	Approx. 8.0 μSv/h	ND	1.4 × 10 ⁻¹	2.0 × 10 ⁻¹
	Unit 5 seawater pipe arrangement duct	Discovered	Approx. 8.0 μSv/h	ND	8.2 × 10 ⁻²	1.1 × 10 ⁻¹
	Unit 5 main transformer cable duct	Discovered	Approx. 10 μSv/h	ND	7.3 × 10 ⁻²	1.3 × 10 ⁻¹
	Unit 5 starting transformer cable duct	Discovered	Approx. 8.0 μSv/h	ND	2.0 × 10 ⁻¹	2.9 × 10 ⁻¹
