Status of survey for water leakage at welded part of filter valve at B line of 2nd Cesium adsorption apparatus (SARRY)

At 8:30 am on February 25, 2012, we found water leakage at welded part of filter valve at B line of 2nd Cesium adsorption apparatus (SARRY). On February 26, 2012, we confirm that there was no water leakage after repair work.

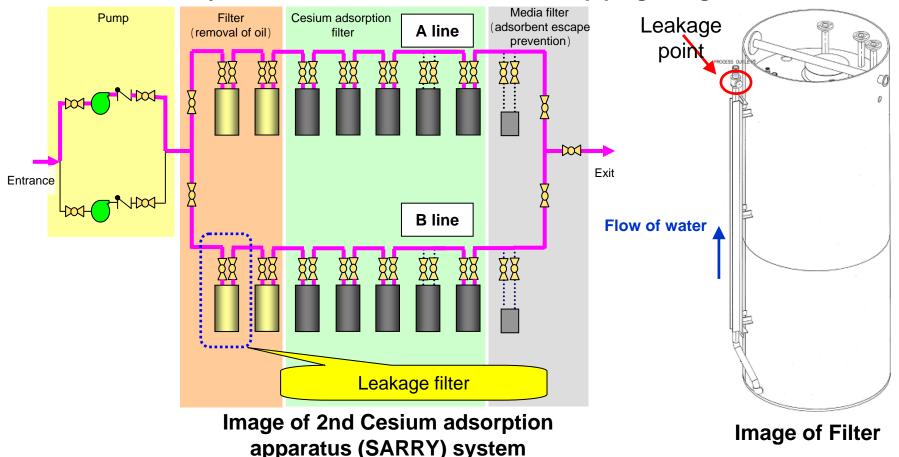
Status of piping inside (Leakage point)

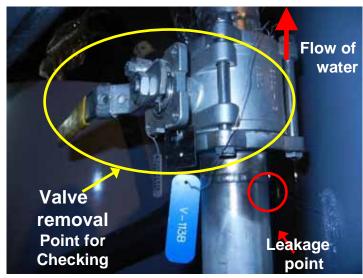
Picture of piping (at the time of water leakage)

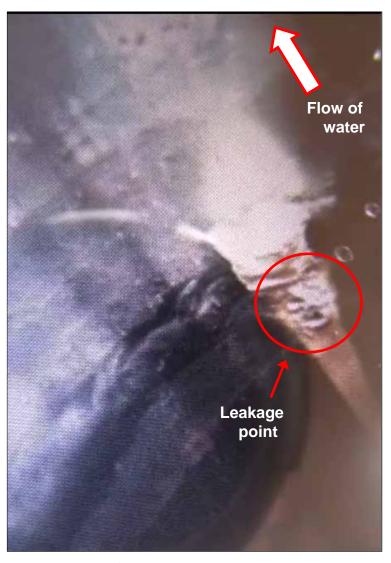
After valve removal (from upper part)

After valve removal (taken with CCD camera)
