To verify the reactor building health, we checked the levelness of the spent fuel pool (SFP) and the reactor well before commencement of cover installation work for removing fuels of Unit 4.

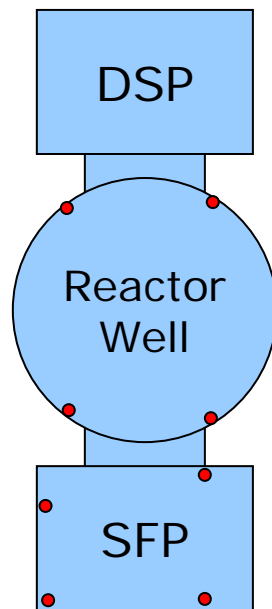
< Position >

Although we recognize a small measurement error due to rubbles near measurement points and the shape of curve liner just like last results, we didn't find a significant difference of water level measured from the top of the curve liner.

At the fifth floor of the reactor building, between the floor and water level of SFP and reactor well are horizontal.

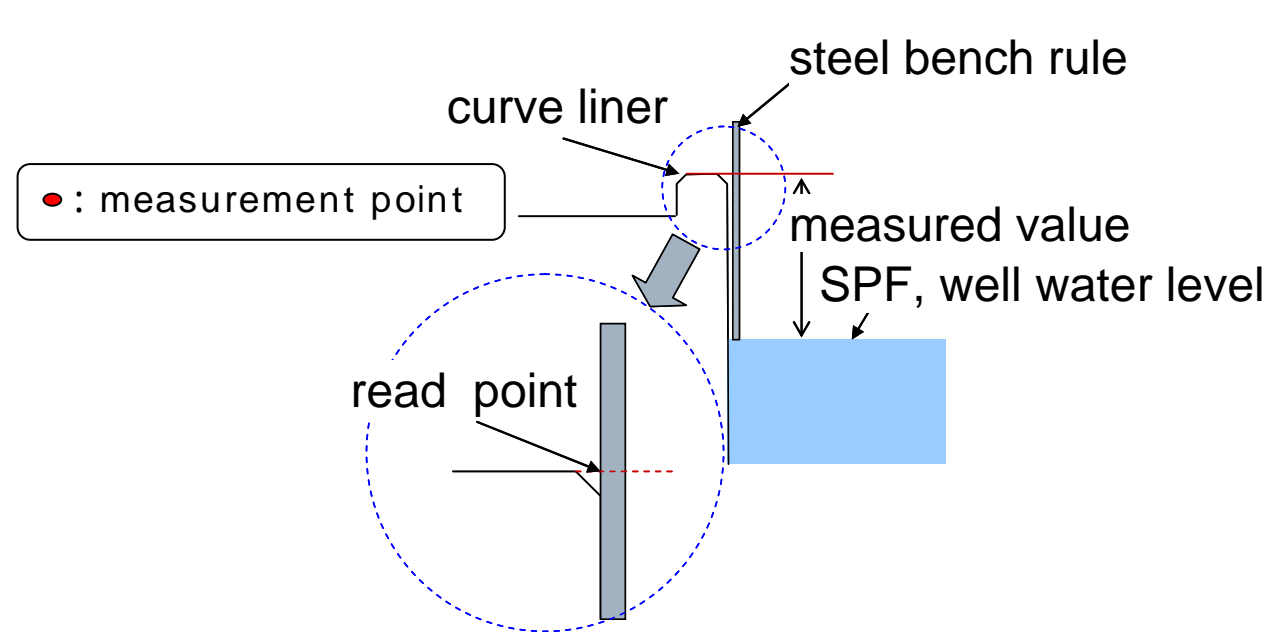
< Method >

We measured distance between operation floor of the reactor building and water level of SFP and reactor well.
