## **Water Leakage from the Desalination System (Reverse Osmosis Membrane) 3**

# Overview of the Desalination System

# Water Leakage Area in the Desalination System (Reverse Osmosis Membrane) 3

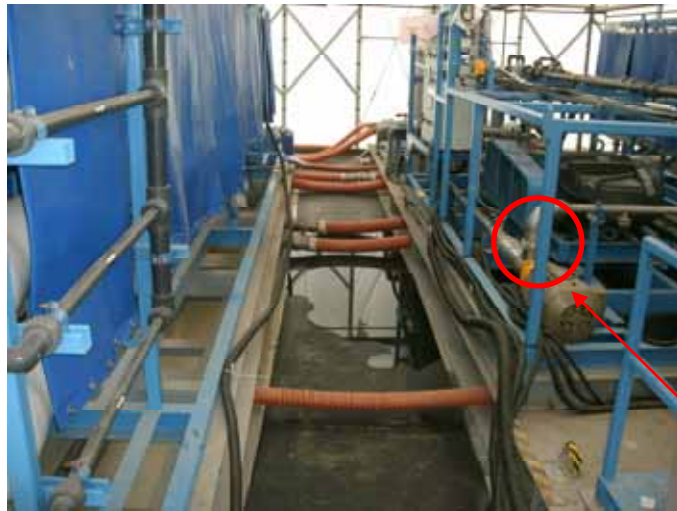
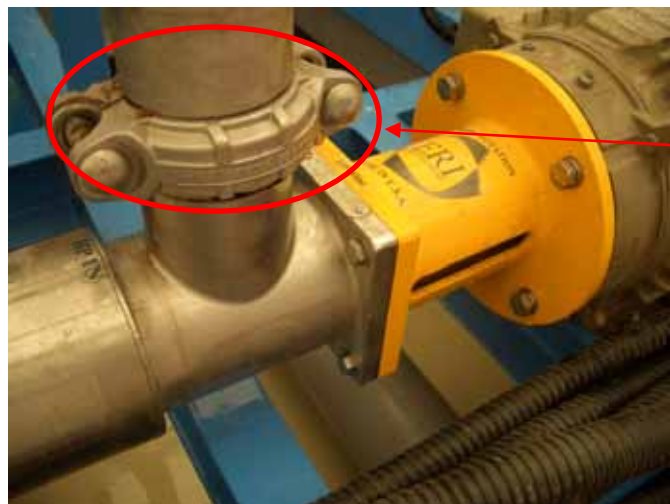
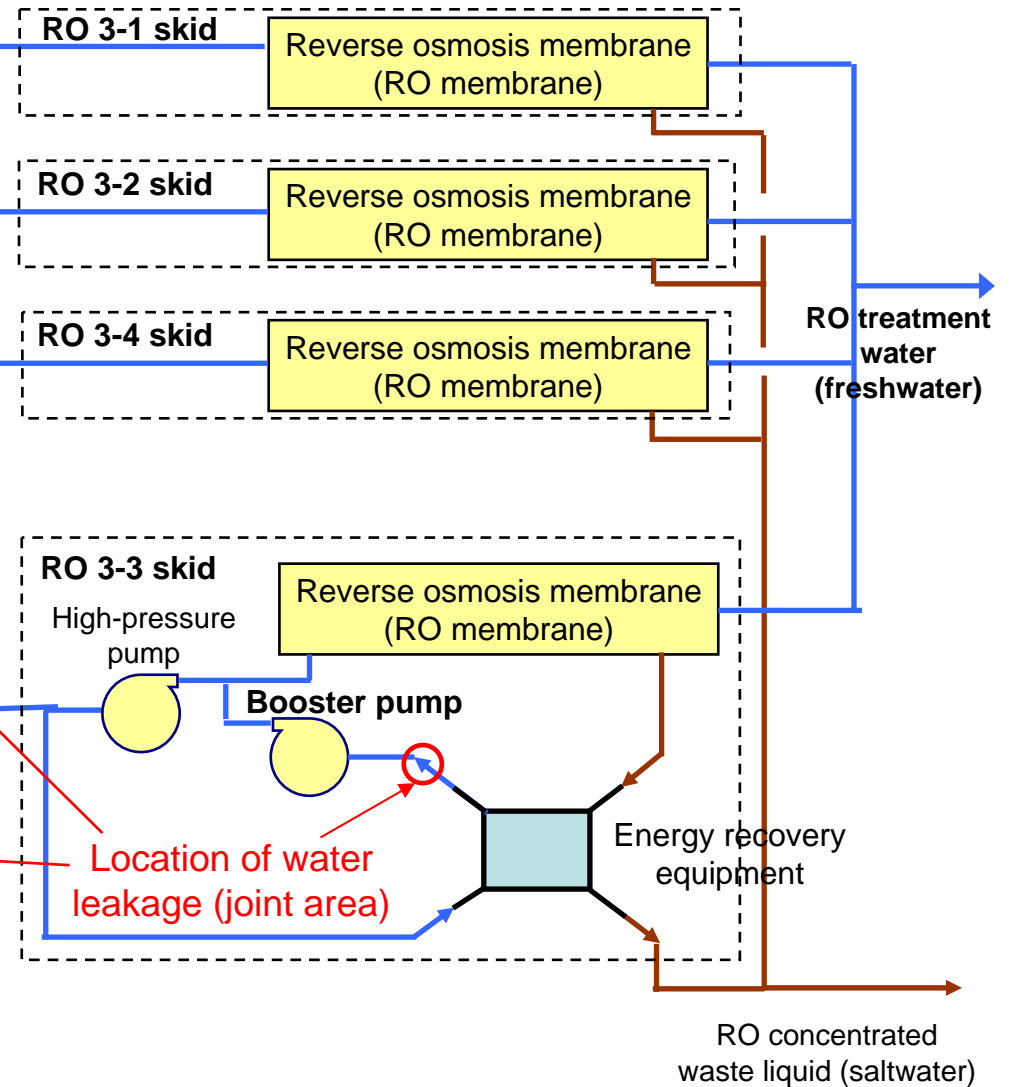
From the waste liquid  
RO supply pump

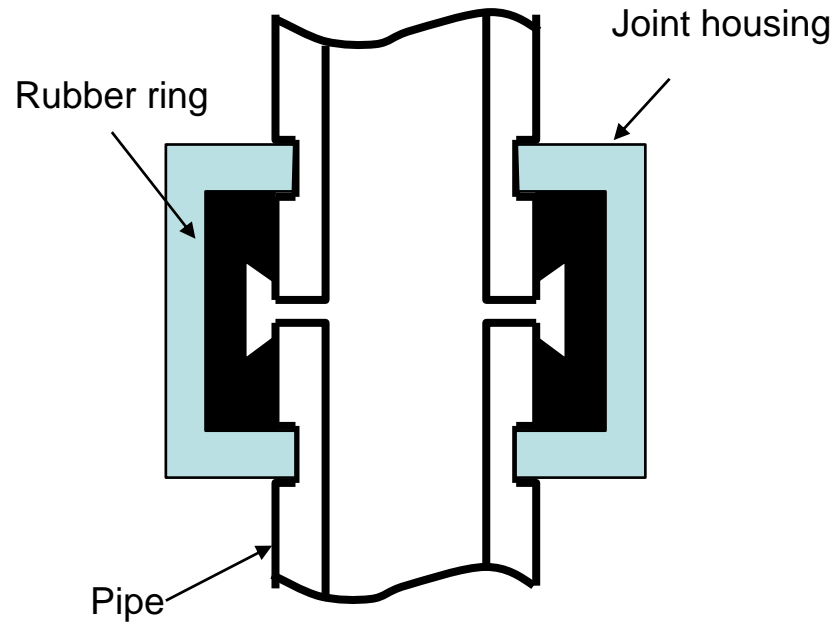
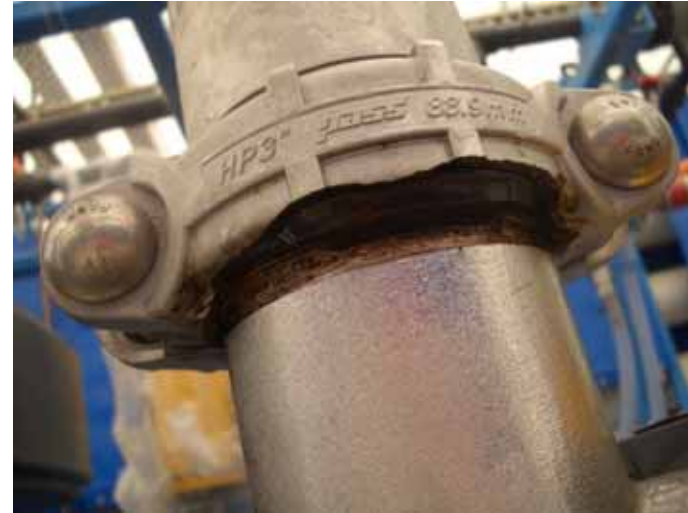
Joint area

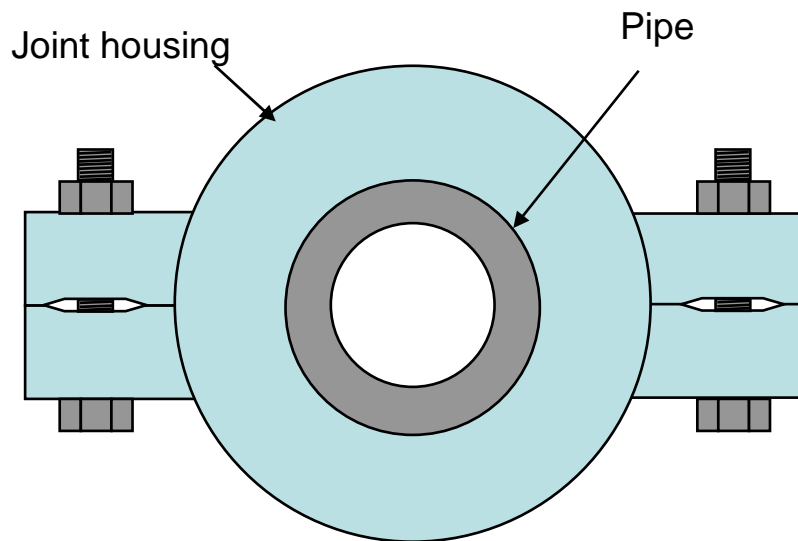
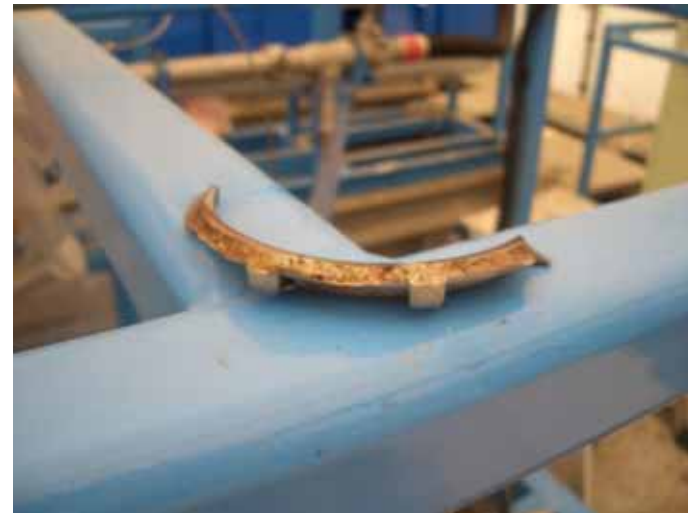
Damaged joint area

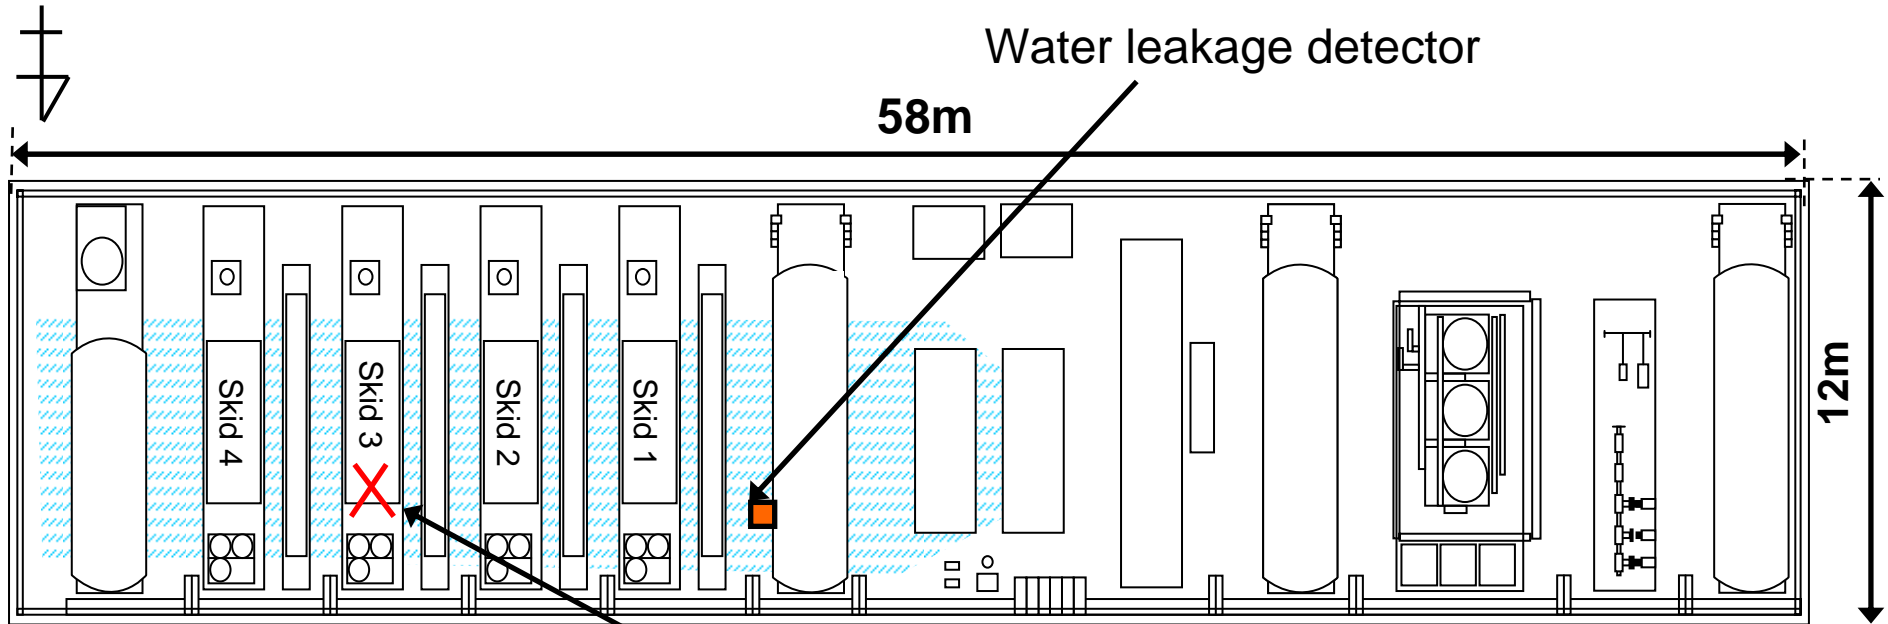
Water leakage location

10m × 20m × 1mm (Depth)

(Estimated leakage amount: Approx. 0.2m<sup>3</sup>)
