Duct Repair for Unit 3 PCV Gas Control System at Fukushima Daiichi Nuclear Power Station

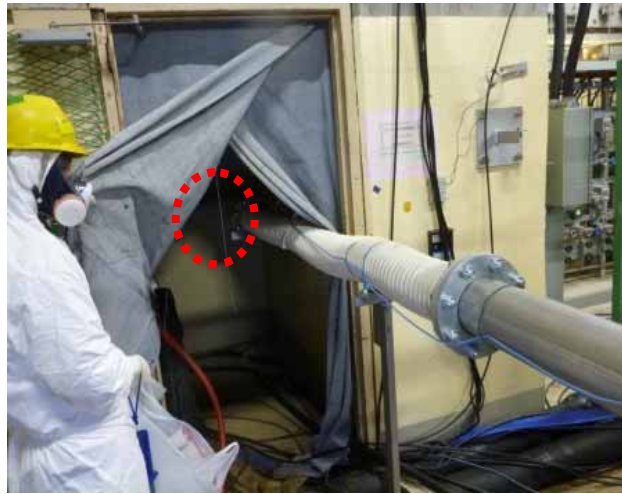
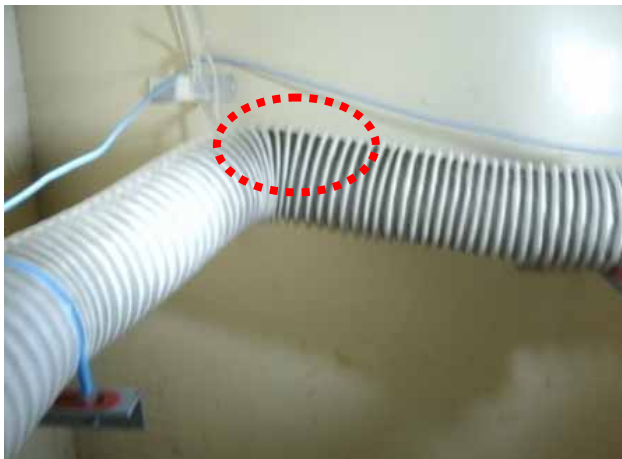
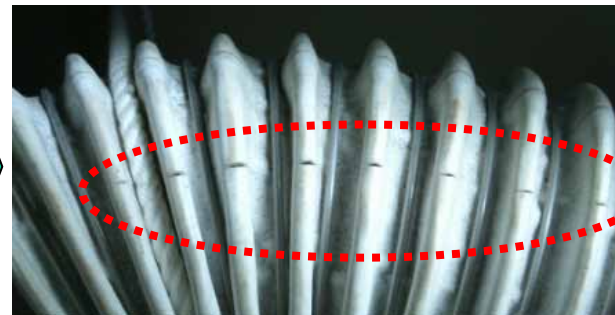
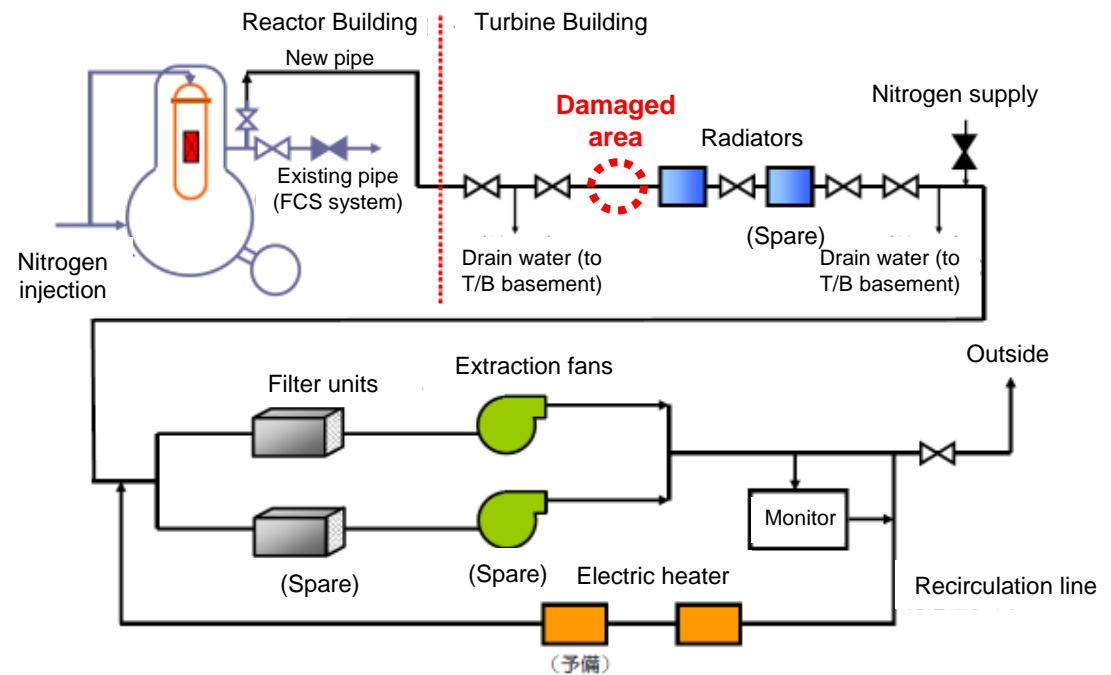
1. Duct damage (Occurred on June 19)

The damage is assumed to be caused by an external factor considering its shape and direction

(No damage was found in other locations in Unit 3.)

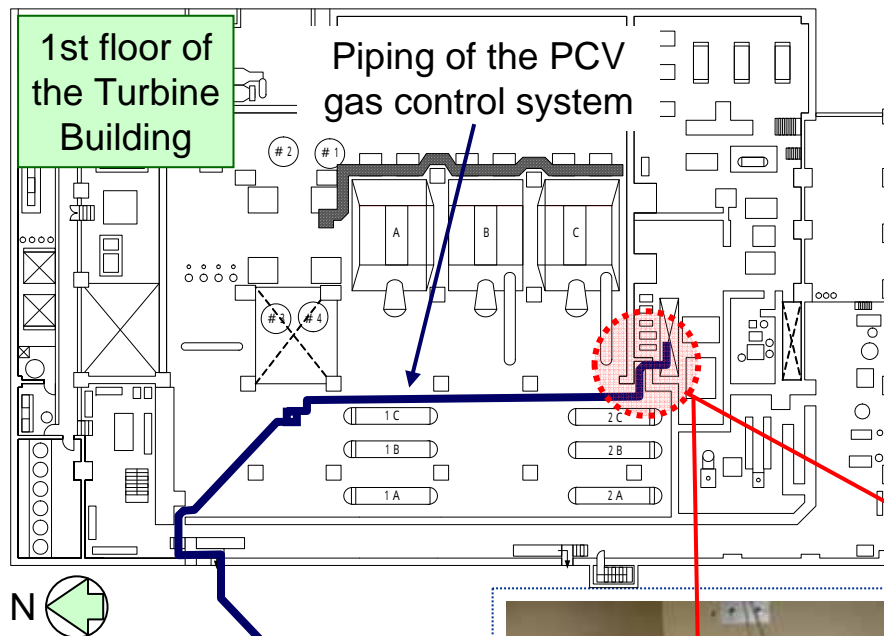
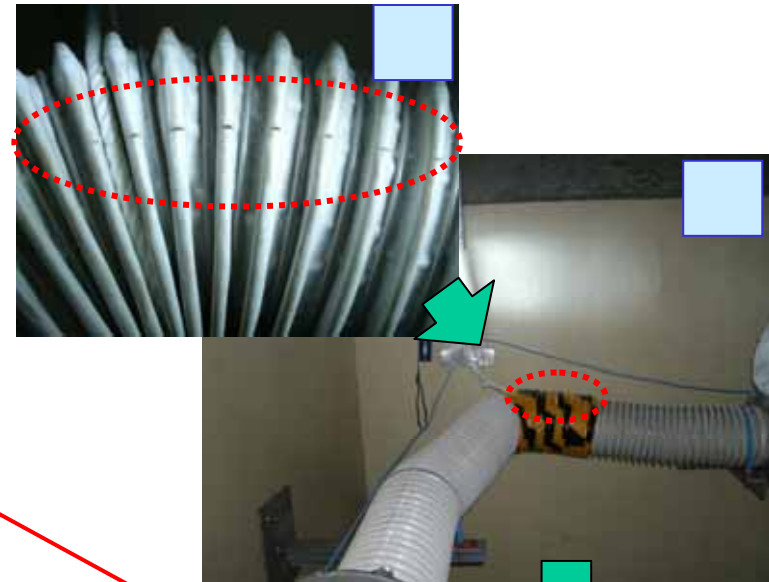
2. Measures taken so far

Damage found (June 19)
Emergency repair (June 19)
Protection applied (June 28)
[Current]
