- Date of investigation: September 13, 2012
- Number of workers involved: 19

An underwater camera was hung from the crawler crane down into the spent fuel pool to investigate the condition of the tip of steel members partially immersed in the pool water.

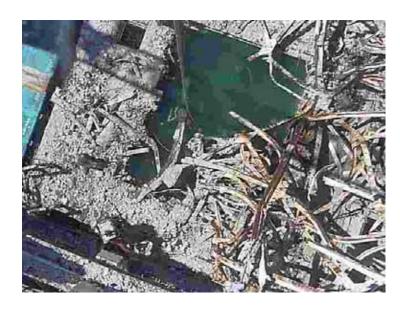
The entire view of the spent fuel pool

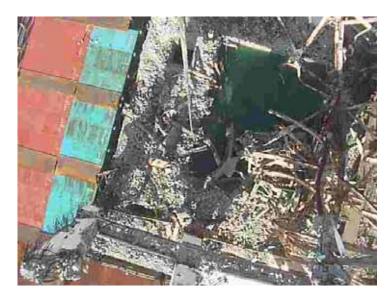
The entire view of the spent fuel pool

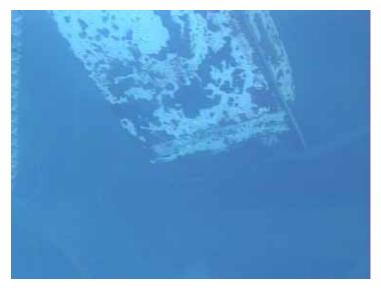
Debris in the spent fuel pool (under water)

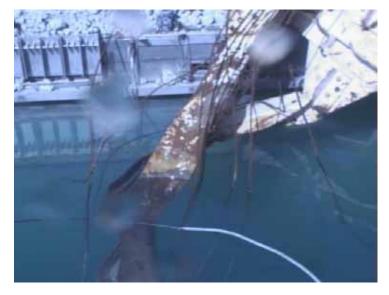
Debris in the spent fuel pool (water surface)

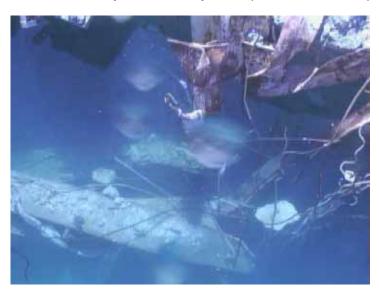
Debris in the spent fuel pool (water surface)
