Evaluation of the Impact of a Steel Beam Falling into Unit 3 Spent Fuel Pool at Fukushima Daiichi Nuclear Power Station on the Surrounding Environment

During debris removal from the upper part of Unit 3 Reactor Building, a steel beam slipped and fell into the spent fuel pool. We have evaluated the impact of this incident on the surrounding environment based on the data below.

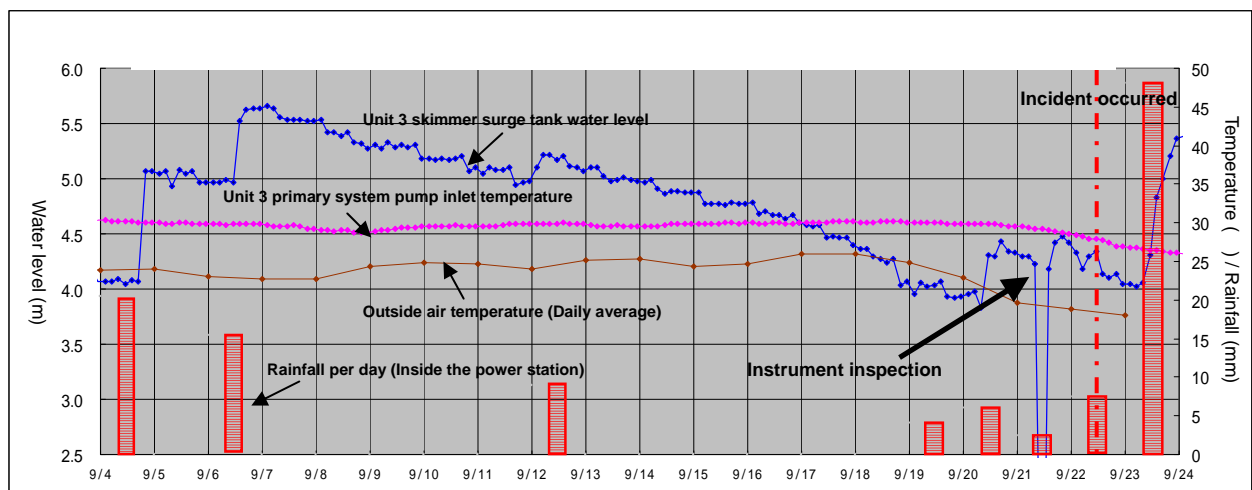
3. Skimmer surge tank water level

Upon check the skimmer surge tank water level, no significant change was found due to the steel beam falling into the pool.

*1 Skimmer surge tank water level is subject to change as it is calculated based on the pump inlet pressure and flow rate.

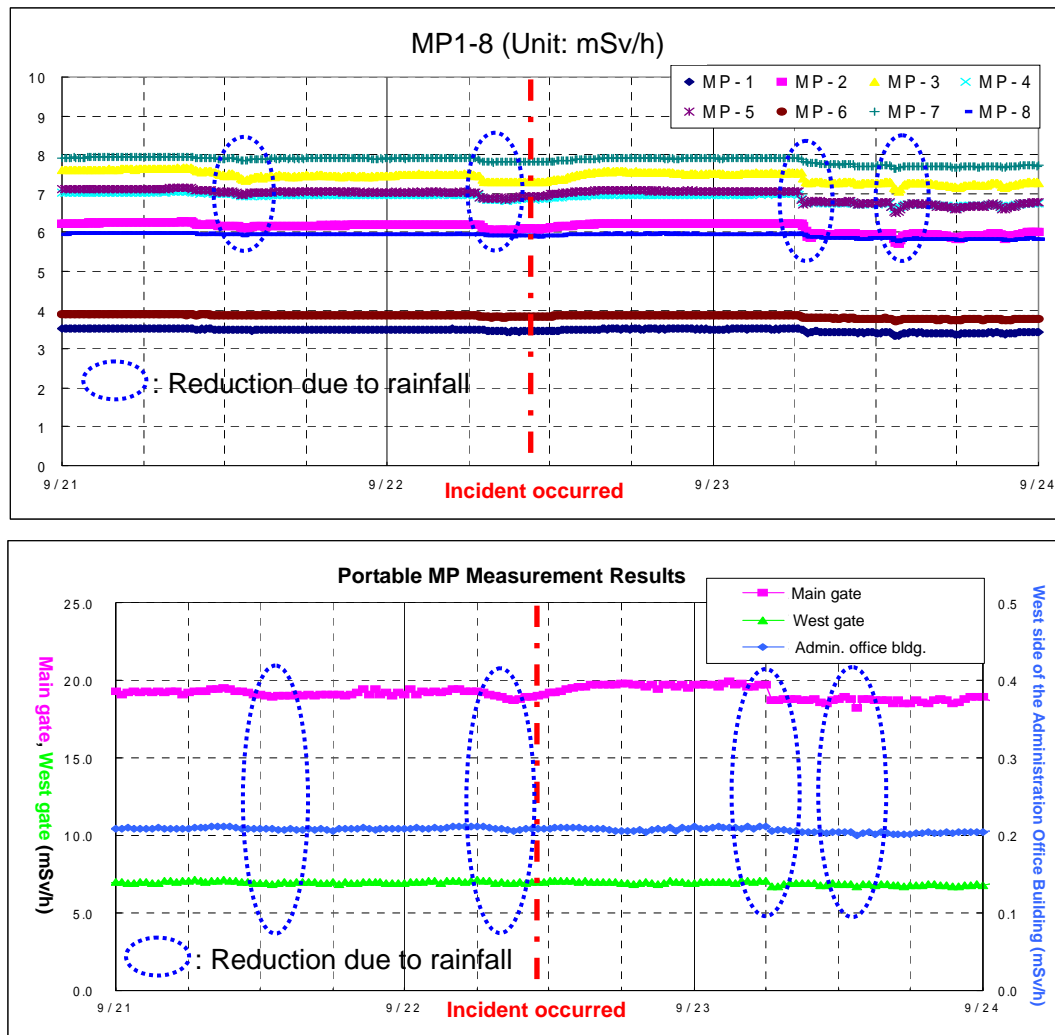
4. Monitoring post

Upon checking the radiation dose rates measured by monitoring posts and portable monitoring posts, no significant change was found before and after the incident.
