A Steel Beam Fell into the Spent Fuel Pool in Unit 3 Reactor Building at Fukushima Daiichi Nuclear Power Station

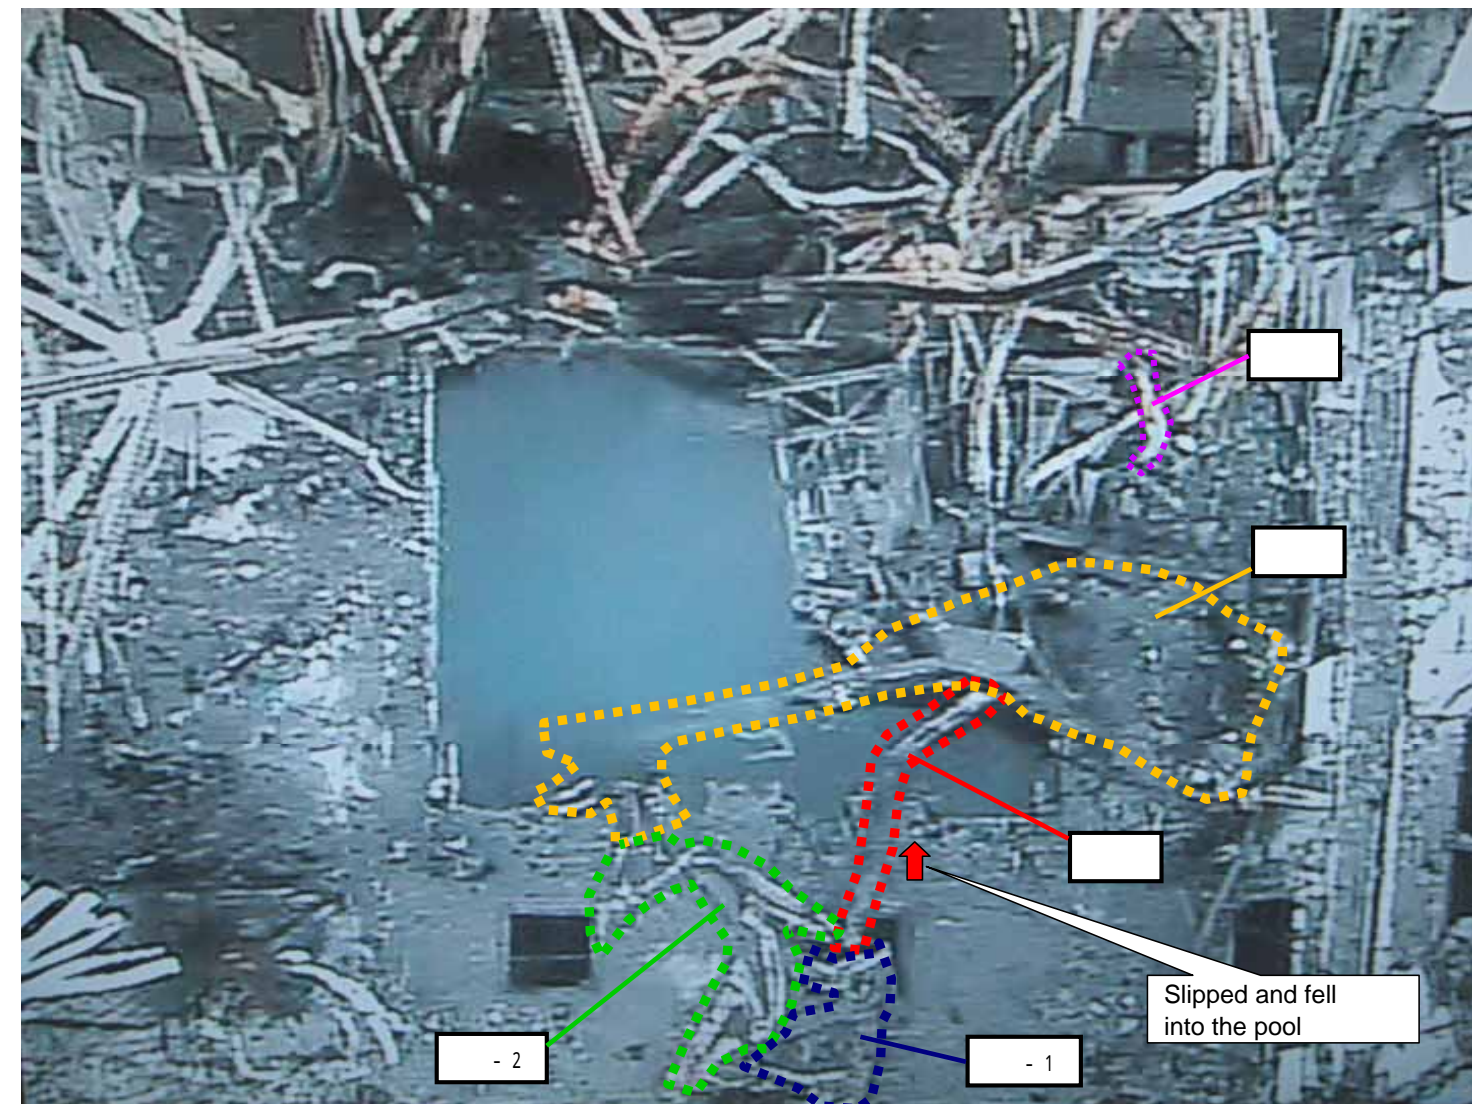
Condition

While a connected steel beam (between steel truss -2 and steel truss) was being cut to prepare for debris removal scheduled on September 22, another steel truss (assumed to be a truss, approx. 300mmX200mmX7m, approx. 470kg) which had been on the side of the spent fuel pool was found to be unstable. The work was temporarily suspended and we decided to promptly remove the unstable steel beam upon discussion with the contractor. Just when an operator was trying to grab the beam using an oil pressure fork lift, steel beam slipped and fell into the pool.

- 11:05 As steel truss was found to have moved from the original position (unstable with half of it being underwater), TEPCO and JV decided to have it removed using an oil pressure fork lift.

- 11:07 While trying to grab steel truss with an oil pressure fork lift, steel truss slipped and fell into the pool when the tip of the oil pressure fork touched it
