# Investigation Results of the Water Leakage from the Second Cesium Absorption Apparatus (SARRY) Vent Line

< Reference >  
November 22, 2012  
Tokyo Electric Power Company

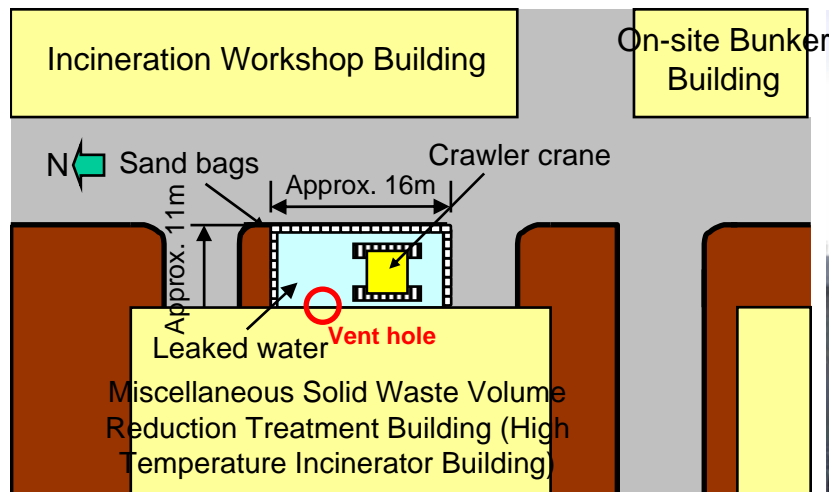
Area affected by the leakage

Amount of the leaked water: Approx. 176L (16mx11mx1mm)

\* Since the leaked water had reached the concrete foundation (25cm higher than the adjacent ground) of the crawler crane used for replacing cesium absorption towers and its foundation wall surface, the water may have been absorbed into the ground.

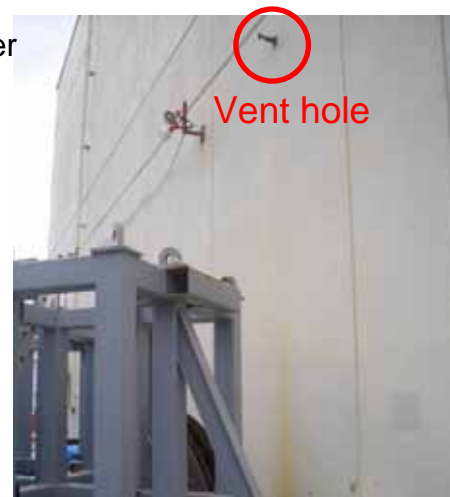
Leakage location

- At around 8:00 AM on November 20, 2012, a TEPCO employee on patrol in the water treatment facility found the water leakage from the second cesium absorption apparatus (SARRY) vent hole located at approx. 5m above the ground on the east exterior wall of the Miscellaneous Solid Waste Volume Reduction Treatment Building (High Temperature Incinerator Building).

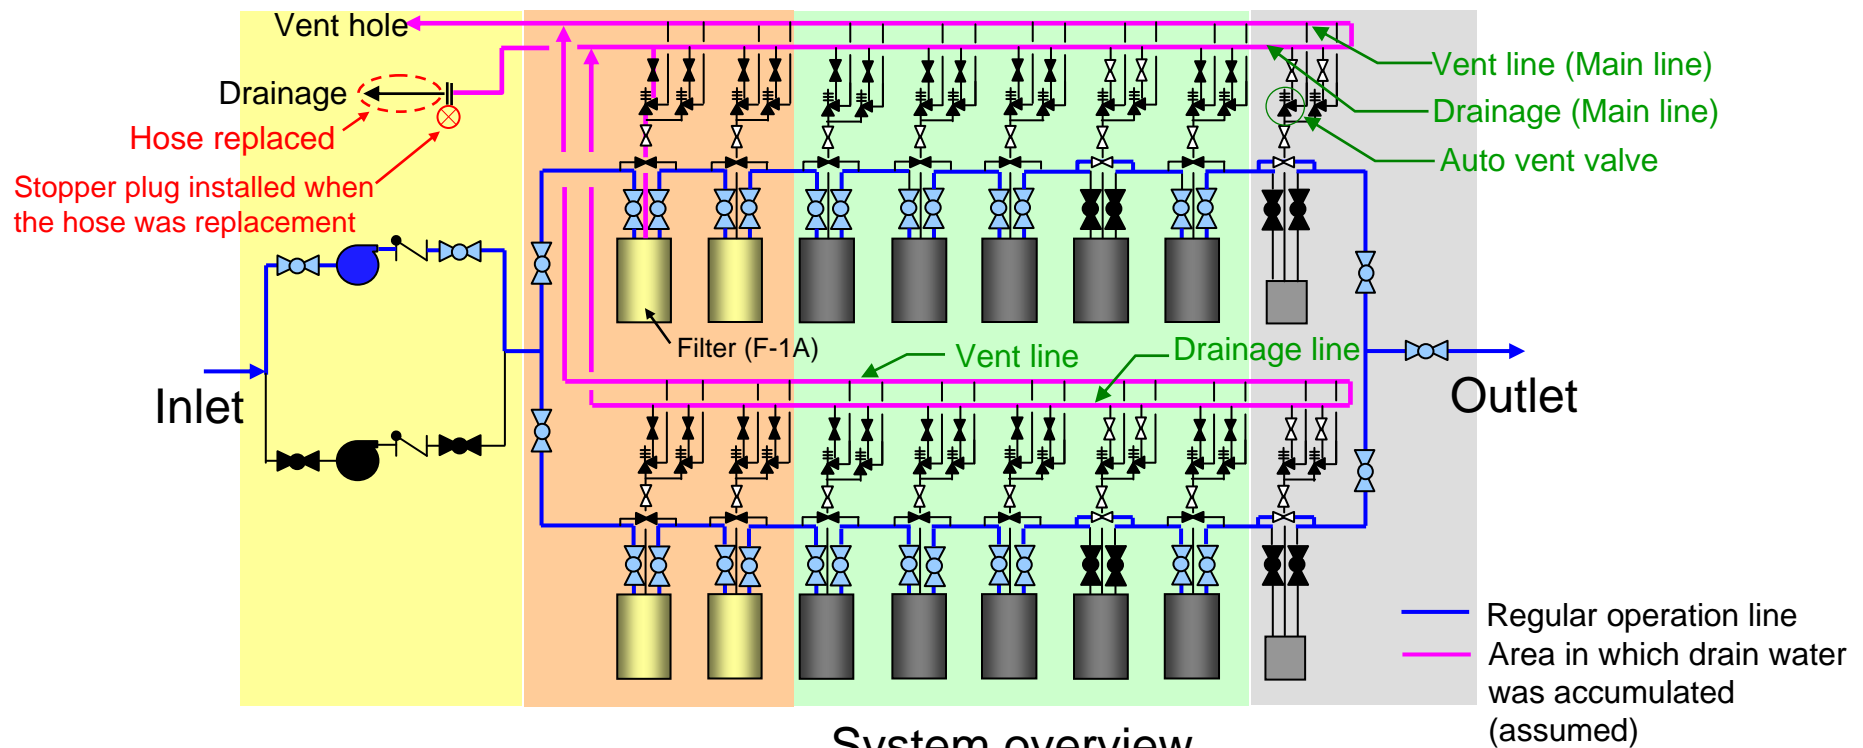
System overview

- Pressure hose replacement was done for reliability improvement starting from November 16.
- Though there was no significant leakage when the hose was removed on November 16, a stopper plug was temporarily installed on the drainage line to prevent work area contamination in the case of water leakage as the system was in operation.
- With the stopper plug installed for hose replacement, the drain water from the auto vent valves was accumulated in the drainage and vent lines (main lines) which led to the water leakage from the vent hole to the outside.

(When the drain water from the filter (F-1A) auto vent valve leaks from the vent hole)

(1) As a result of site investigation, no abnormality in which water leaks from the vent hole was detected unless the drainage line is closed. For recurrence prevention, relevant workers are reminded not to close the drainage line and a sign “Do not close” will be installed at site.

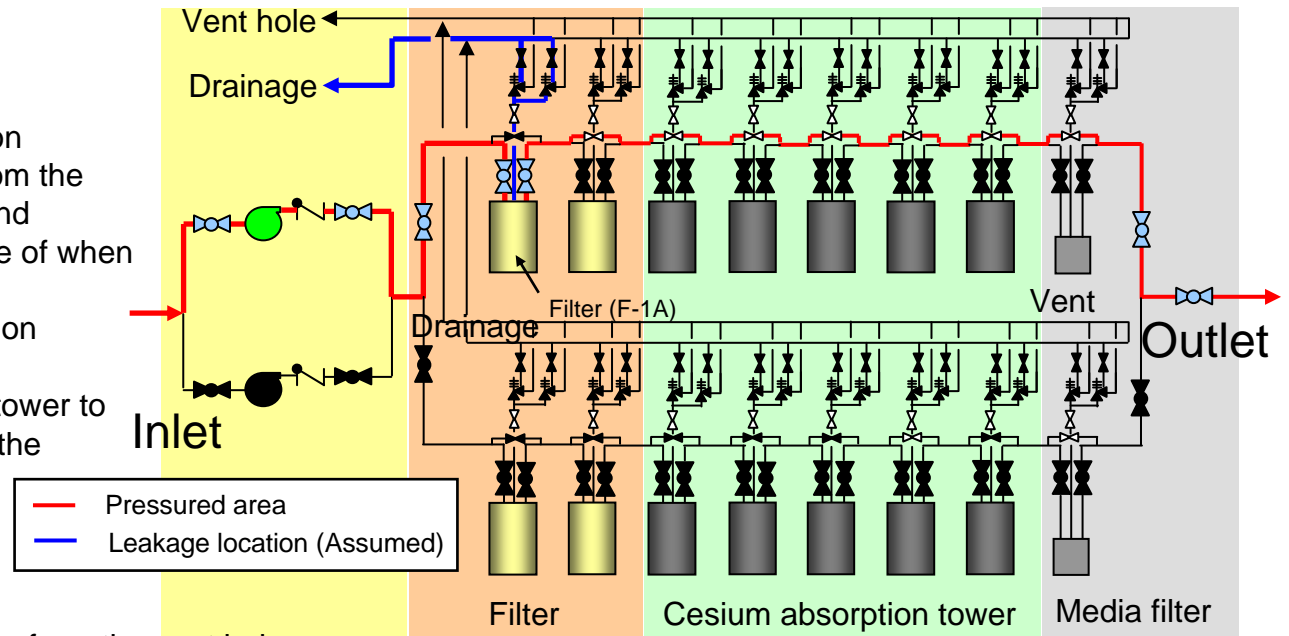
System structure when leakage from each absorption tower was tested (Example of "Investigation 2" F-1A)

Pressure was applied on each absorption tower to confirm the amount of water leakage from the drainage line.

Water which is assumed to come from the auto vent valves was found to be discharged from all the absorption towers. However, if the amount is equivalent to the flow in open channel\*3

(approx. 38,000mL/min) or less, the water discharge does not affect the drainage function. As a result of site investigation, the water discharge amount was found to be substantially lower than the above mentioned amount. Therefore there is no problem with the drainage function.
