Increase in the Reactor Injection Water Amount at Unit 3 of Fukushima Daiichi Nuclear Power Station

November 27, 2012
Tokyo Electric Power Company

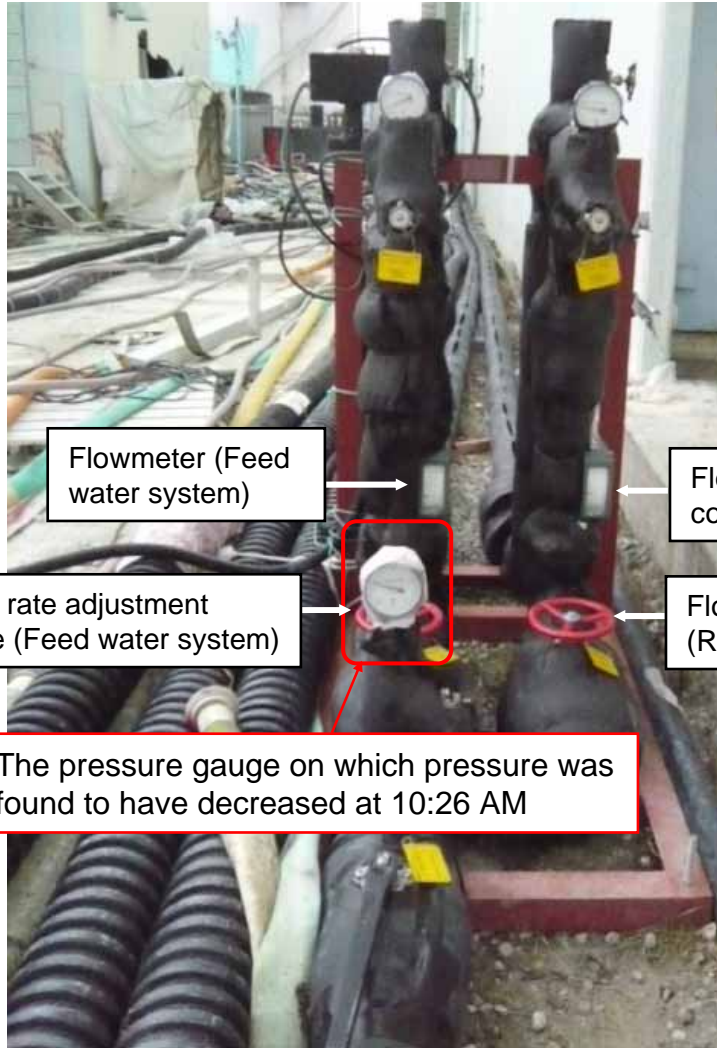
Unit 3 flow rate adjustment header (Before the heat insulating material removal: Photo taken on February 2012)

- The opening amount of the flow rate adjustment valve was found to be larger after the incident occurred.
- Although the heat insulating material removal was being carried out with a careful attention to the flow rate fluctuation (such as cutting the heat insulating material before removing), a worker unintentionally touched the flow rate adjustment valve while removing the heat insulating material for the following reasons, causing the flow rate to increase.
 1. The flowmeter and the flow rate adjustment valve of concern are located closely to each other.
 2. Heat insulating material removal was performed in a poor working environment (on the Eflex on the side of the flow rate adjustment valve).

Flowmeter (Feed water system)

Flowmeter (Reactor core spray system)

Flow rate adjustment valve (Feed water system)

Flow rate adjustment valve (Reactor core spray system)

The pressure gauge on which pressure was found to have decreased at 10:26 AM
