# Inspection Results of Unit 3PCV Gas Control System Duct at Fukushima Daiichi Nuclear Power Station

### ■ Purpose

Inspect the duct condition in Unit 3 Reactor Building in response to the duct damage found at the PCV gas control system.

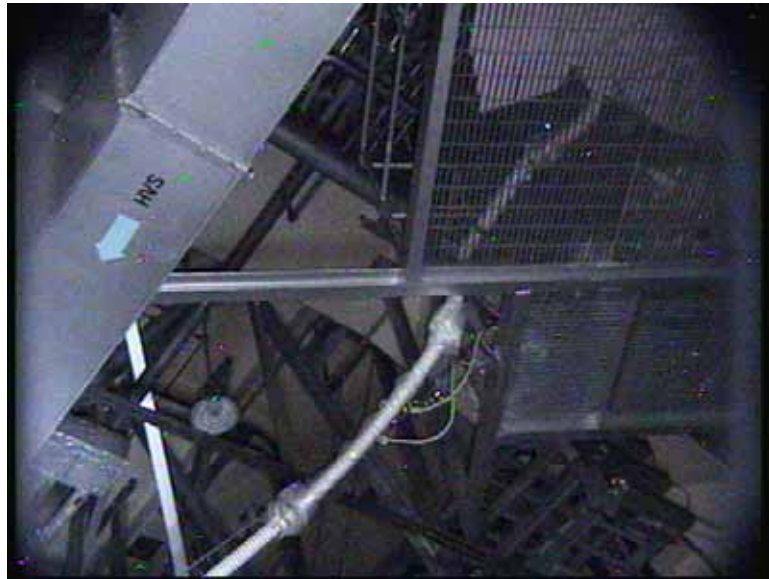
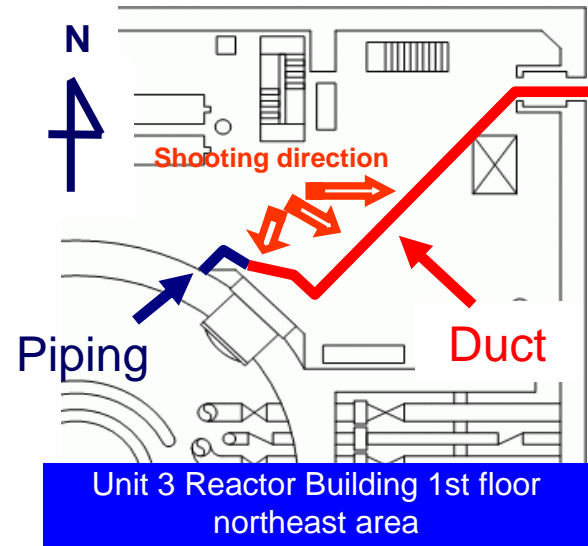
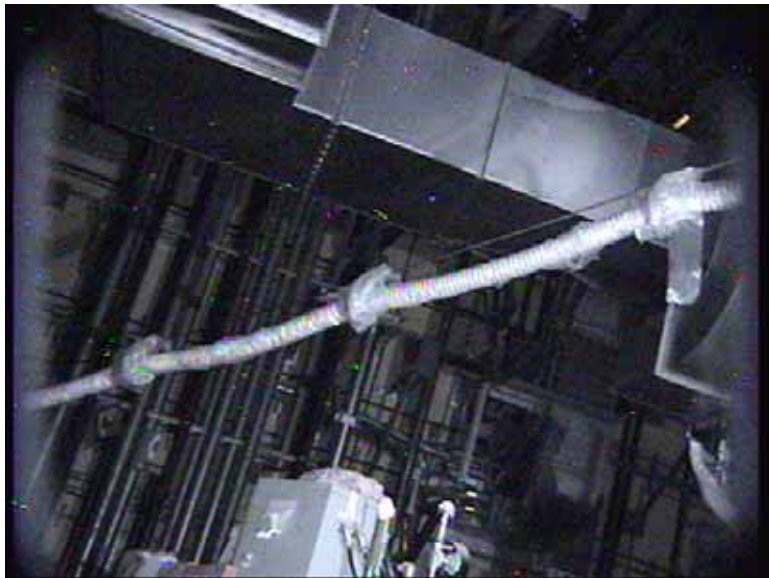
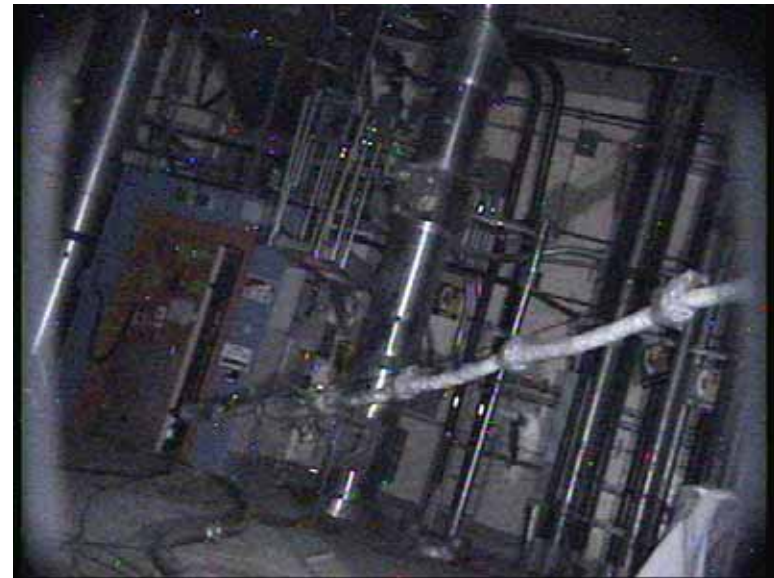
# Inspection Results of the PCV Gas Control System Duct

As a result of inspection, no abnormality was found.

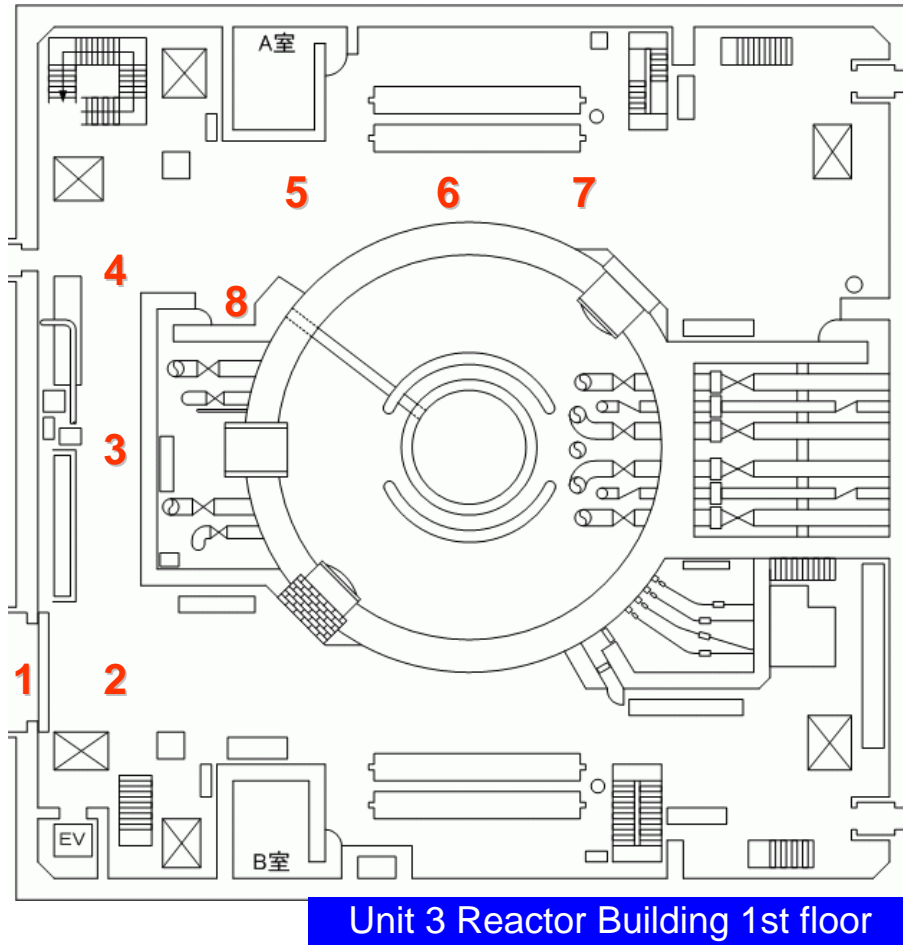
# Atmosphere Dose Rate Measurement on the First Floor of the Reactor Building

### Atmosphere dose rates along the robot access route

Point	Dose rate [mSv/h]
1	8.0
2	55.0
3	35.0
4	27.0
5	24.0
6	36.0
7	90.0
8	22.0

\*Near the PCV hatch, temperature: 14 ,  
Humidity: 40.8%

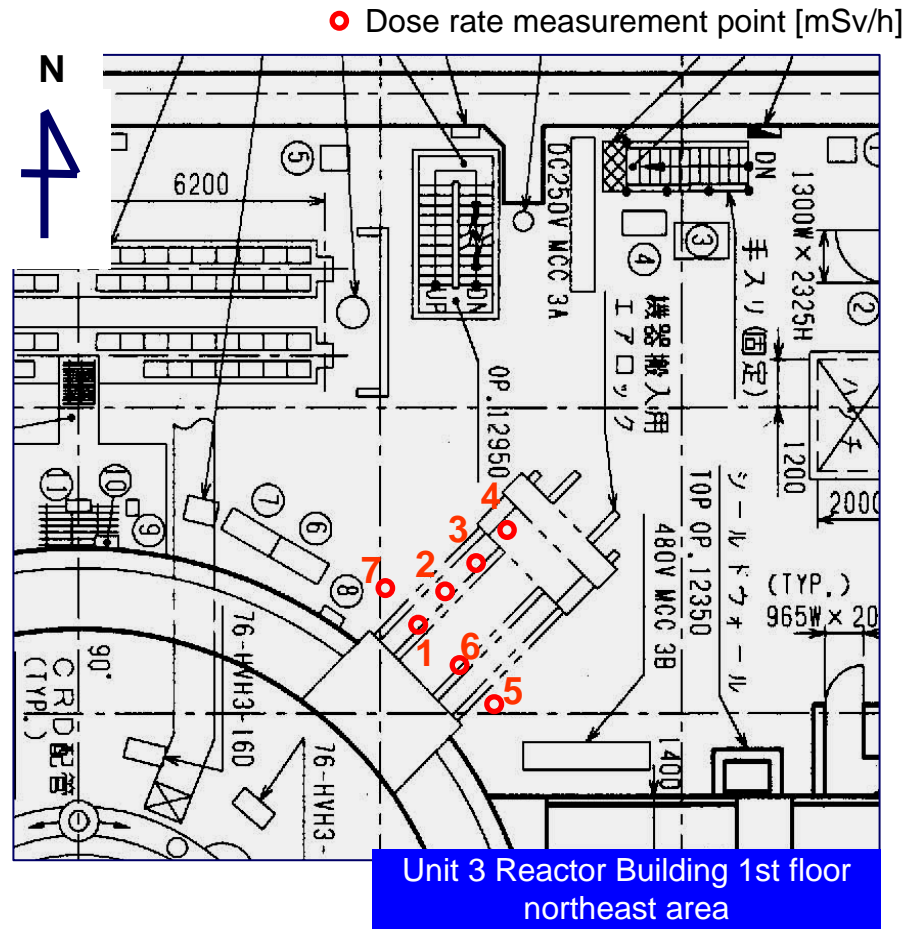
# Atmosphere Dose Rates in the Northeast Area of the Reactor Building First Floor

Atmosphere dose rates in the northeast area

Point	Measurement height [0.4m] [mSv/h]	
	This time (Nov. 27, 2012)	(Reference) Previous measurement (Nov. 14, 2012)
1	2290	870
2	1740	800
3	1510	750
4	580	650
5	170	180
6	200	120
7	98	180
1 (Floor surface)	4780	1300*

\* Measured on the rail surface when inspecting the area near the rail.
