Results of the Third Soundness Inspection of Unit 4 Reactor Building at Fukushima Daiichi Nuclear Power Station

November 29, 2012

Tokyo Electric Power Company

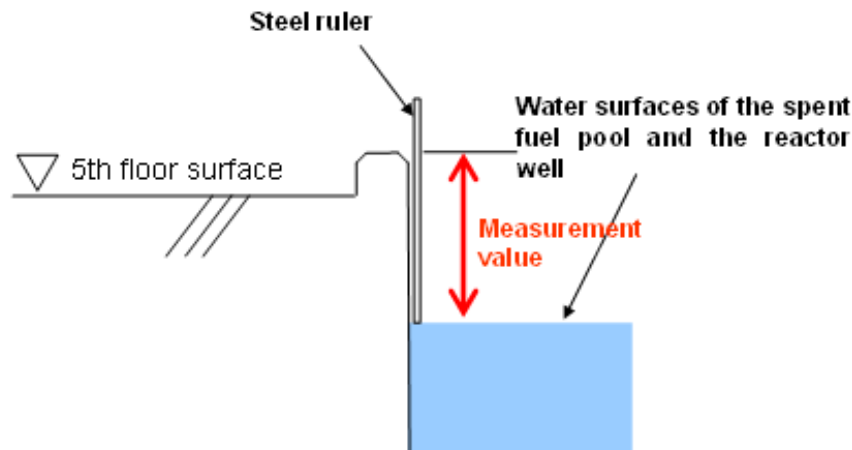
Measurement method*1

Considering that the water level measurement values on the four corners were about the same, it has been concluded that the 5th floor surface and the water levels of the spent fuel pool and the reactor well are parallel similarly to the past results.

Reactor well	Measurement date				
	Feb. 7, 2012	Apr. 12, 2012	May 18, 2012	Aug. 21, 2012	Nov. 20, 2012 (This time)
	462	476	492	462	463
	463	475	492	462	464
	462	475	492	461	463
	464	475	492	461	463

Spent fuel pool	Measurement date				
	Feb. 7, 2012	Apr. 12, 2012	May 18, 2012	Aug. 21, 2012	Nov. 20, 2012 (This time)
	- (*3)	468	461	453	443
		468	461	453	444
		468	461	452	442
		468	461	452	443

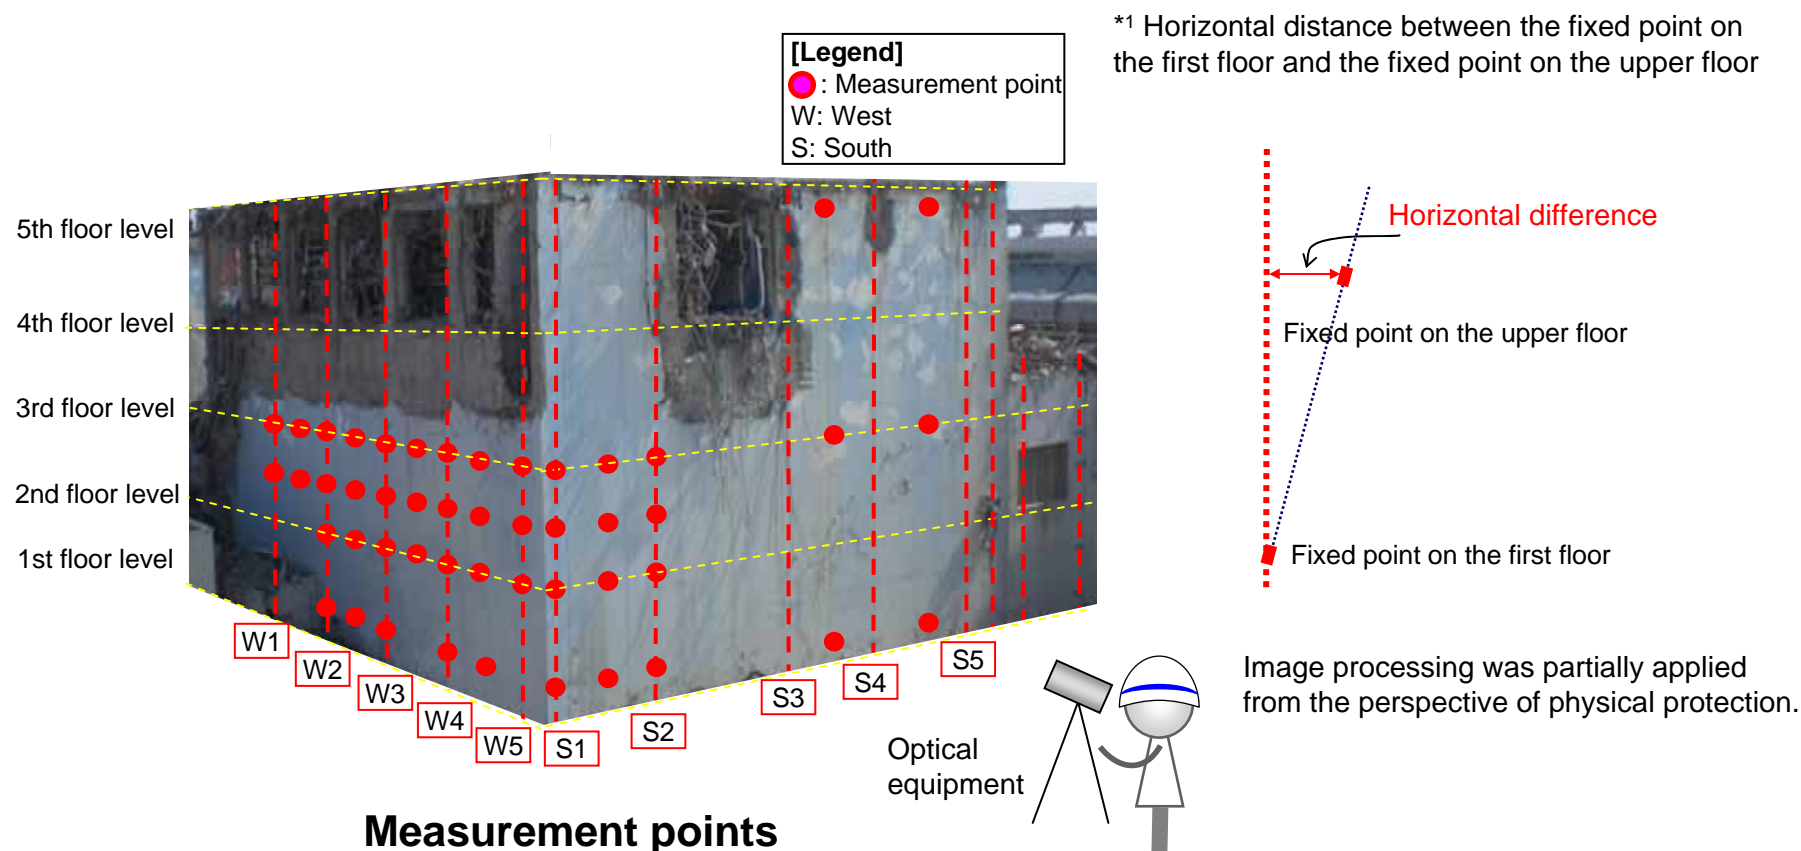
Though partial bulge was found on the exterior walls, it has been confirmed that the building itself is not tilted based on the results of the first regular inspection (May 2012), the detailed inspection of exterior walls (June 2012) and the second regular inspection (August 2012).

- The horizontal differences measured this time were about the same as those in the first inspection (May 2012) the detailed inspection of exterior walls (June 2012) and the second inspection (August 2012), and the deformation characteristics on the measurement points were also similar.
- The small difference from the previous measurement results may be due to factors such as error of the optical equipment (Measurement error of $\pm 2\text{mm}$ may cause approx. 4mm (Max.) error in horizontal difference) and thermal expansion of concrete (thermal expansion coefficient: Approx. $7-13 \times 10^{-6}/$) which may cause approx. 5-9mm error because of the difference of average monthly temperatures of August and November.

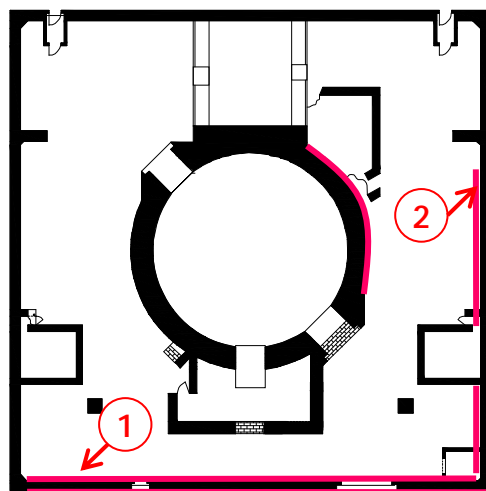
First floor

As a result of visual inspection, no crack of a width of 1mm or more or with possible rebar corrosion was found (similarly to the past results).

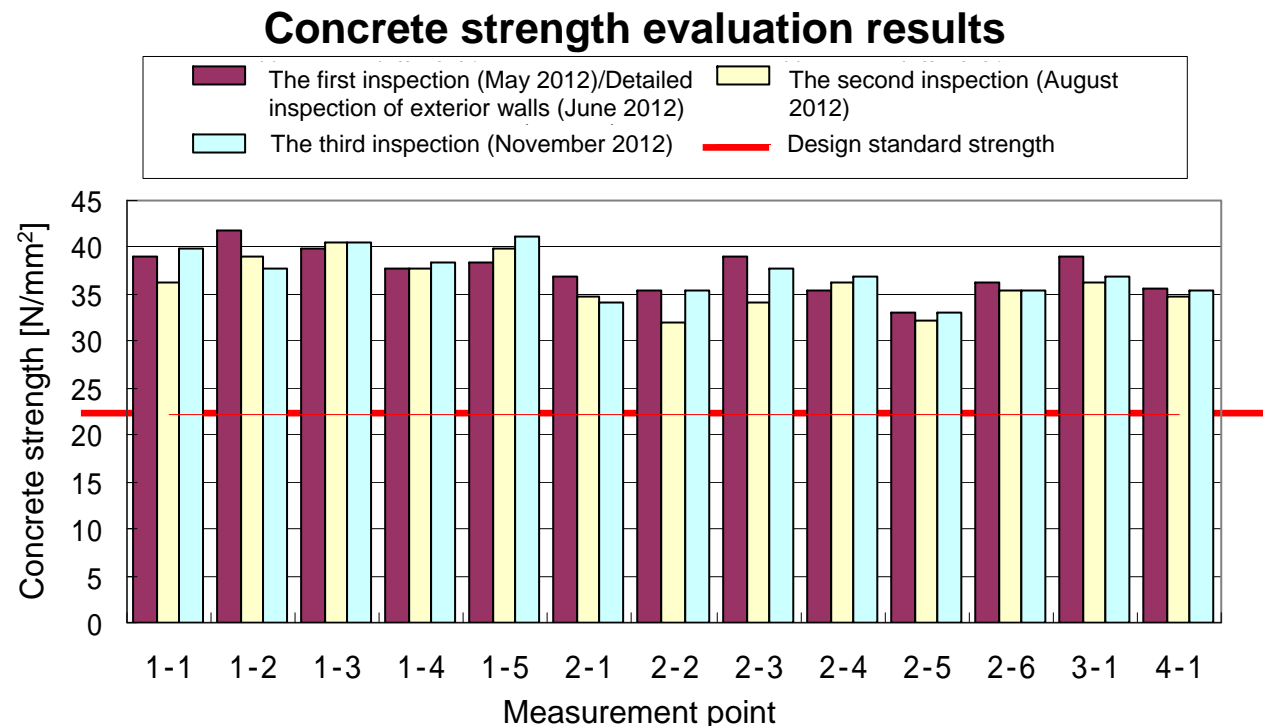
As a result of measurement, the concrete strengths on all the measurement points were above the design standard (22.1N/mm²) similarly to the past results. The results obtained this time are considered to be about the same as the previous results taking into consideration the error of Schmidt Hammer*¹ and that the measurement points were set at slightly different locations from the previous ones.

*¹ Error of approx. 3N/mm² is assumed for the experimental value and the strength criterion formula according to the “Guidelines for evaluation of concrete compressive strength by Schmidt Hammer” (August 1958, Material Testing Research Association of Japan).
