## **Water Leakage from the Desalination System (RO3) at Fukushima Daiichi Nuclear Power Station**

**Date and time:** December 26, 2012 at around 10:10 AM

**Location:** In the temporary warehouse of the desalination system (RO3)

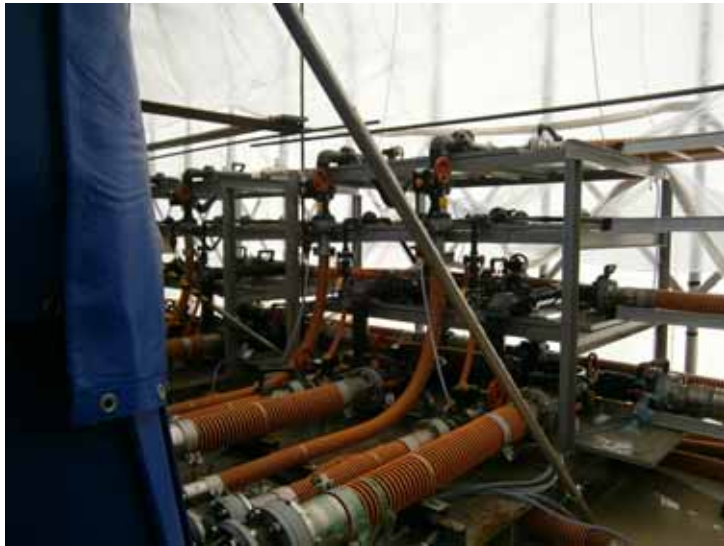
Leakage area (Full view)

1. At around 10:10 AM, a cooperative company worker accidentally had the anti-freeze sheet contact the vent pipe while repairing the sheet in RO3 temporary warehouse. The vent pipe was damaged and water leaked from the damaged part as a result. The damaged part was immediately isolated by closing the valves located in the front and back. After confirming that the leakage had stopped, the worker reported the incident to TEPCO.

**Cause:** Anti-free sheet accidentally contacted and damaged the vent pipe

Anti-freeze sheet

**Countermeasure:** Installation of protection cover on small diameter branch lines is being considered.

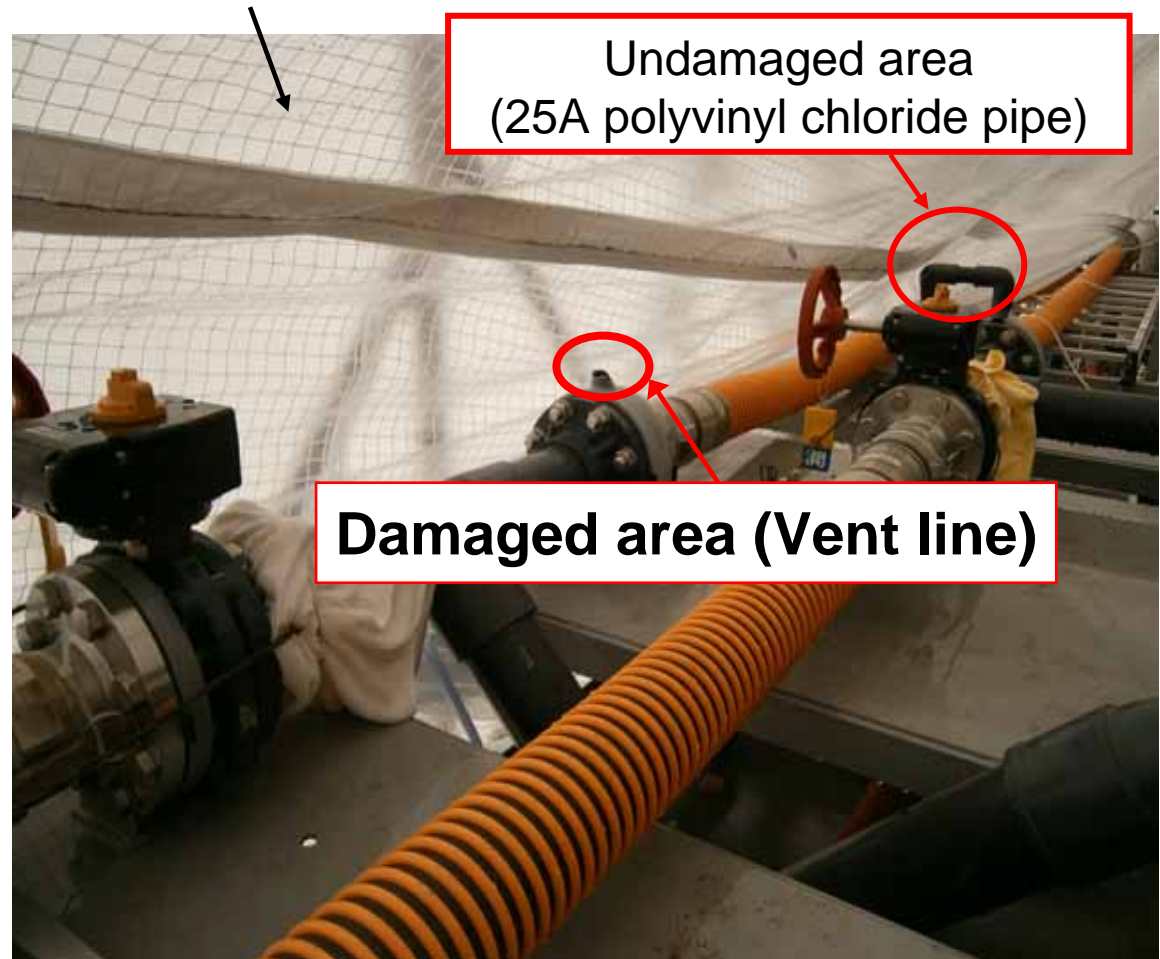
**Leakage location:** RO3 UF (Ultra Filter) cassette vent line

Undamaged area  
(25A polyvinyl chloride pipe)

Damaged area (Vent line)

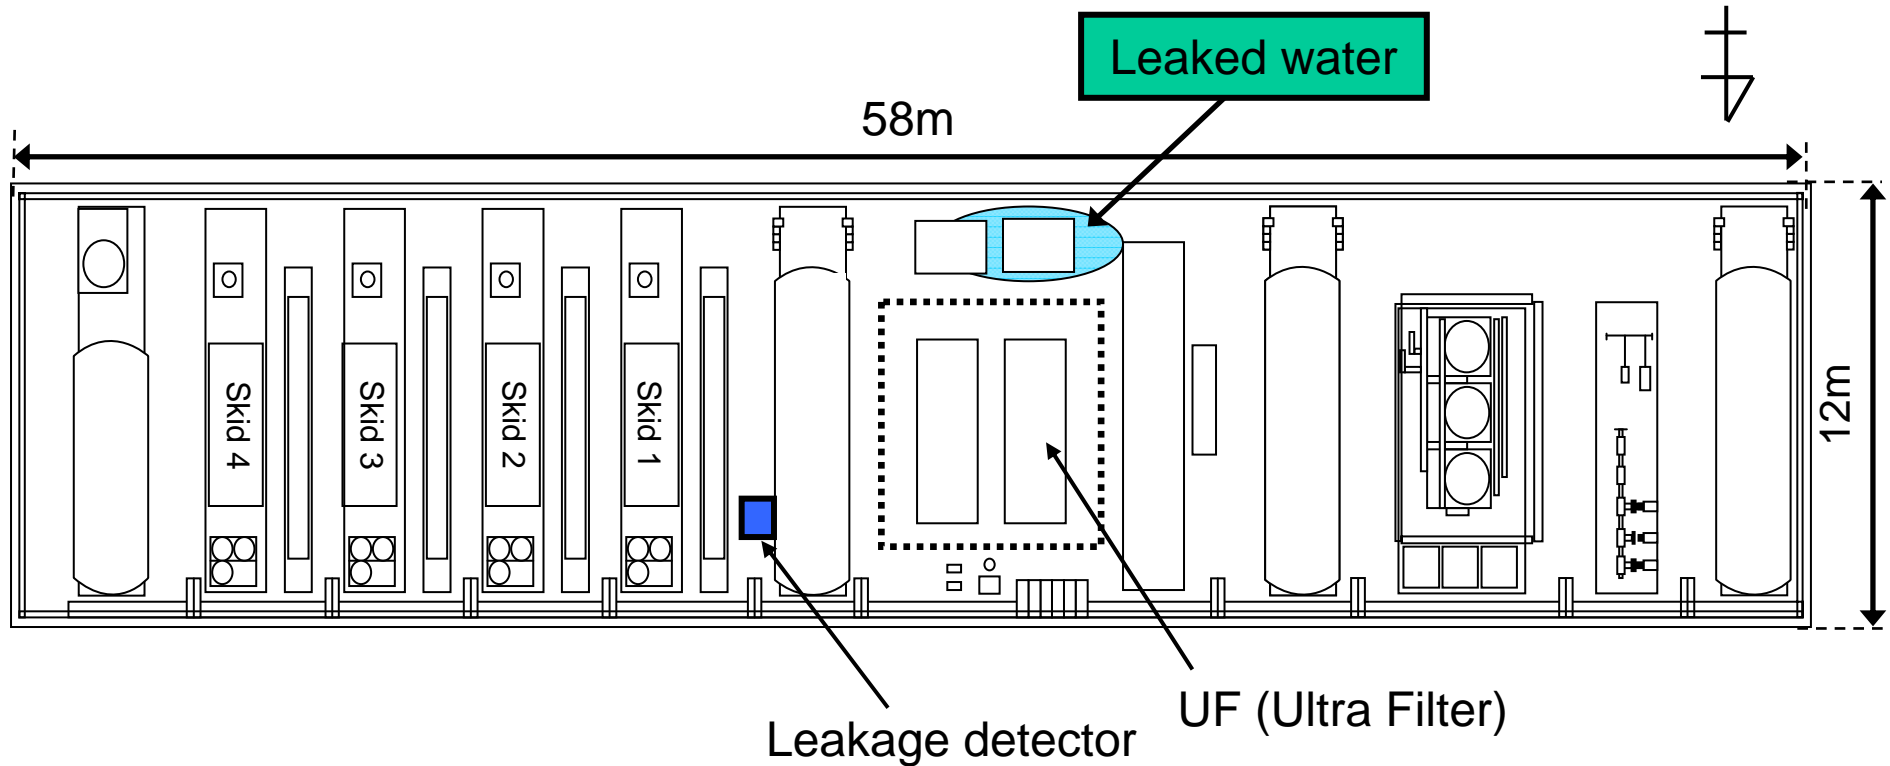
Desalination system (RO3) temporary warehouse

[Area affected by the leakage]

Approx. 5m x 1m x 2mm (Depth)

[Estimated leakage amount]

Approx. 10L
