Progress Status and Future Challenges of the Mid-and-Long-Term Roadmap towards the Decommissioning of TEPCO's Fukushima Daiichi Nuclear Power Station Units 1-4 (Outline)

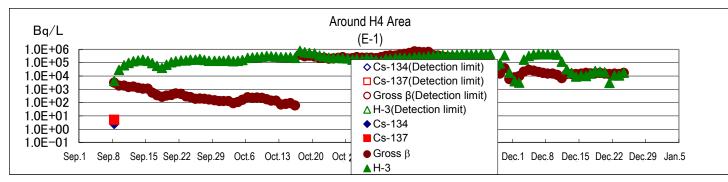
Figure 1: Radioactive material density of Observation Hole E-1

- Responding to the increase in gross β density at the observation hole E-1 near the tanks, the contaminated soil around E-1 and test water pumped from the well points installed around E-1 was removed to confirm a decrease in both total β and tritium density. As a result of intermittent operation since December 10, it was confirmed that the gross β density remains low (approx. 10,000 to 20,000 Bq/L) and the tritium density had decreased (from approx. 400,000 to approx. 10,000 Bq/L). (See Figure 1)
- Intermittent operation will continue while checking the density.

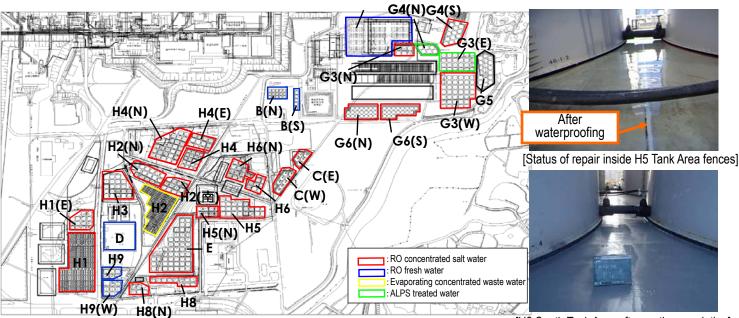
Figure 2: Countermeasures to rainwater at Tank Areas

- Rainwater leaks from the fences were detected at H5 and G6 Tank Areas (December 21 and 22). In addition, declining water levels inside the fences at H4 and H4 East Tank Areas (December 24), and leaking rainwater from the fences at H4 Tank Area (December 25) was also detected. In each of these cases, rainwater inside the fences was promptly pumped up, while joints regarded as prone to leakage were waterproofed. In addition to the waterproofing applied at similar points as an emergency measure (to be continued until December 27), urethane is being applied by painting onto the concrete foundation according to the plan. (Scheduled for completion in early February) (See Figure 2)

- To prevent the overflow of rainwater from the Tank Area, <u>steel plates are being added to increase the height of existing concrete fences by 30 cm (scheduled for completion on December 28). The inner surface of the fences are being painted by urethane resin to increase their waterproofing.</u>

- Gutters are being installed on the top plate of tanks in places where significant contamination was detected inside the fences previously (scheduled for completion on December 27).
