(1) Current Situations Concerning Contaminated Water

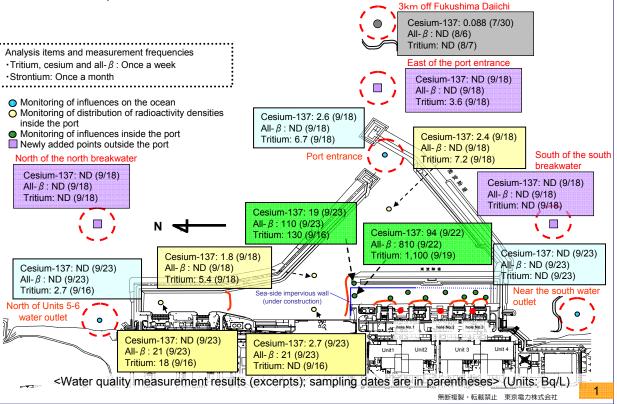
<Situations of seawater monitoring>

- At the locations in front of the Units 1-4 water intakes (Φ), the all-β and tritium densities in seawater have been showing repeated ups and downs.
- At the locations inside the port (O), the densities in seawater have been almost below the detection limit values.
- At the locations near the boundary of the port (○), the densities have been at the same levels or lower levels than
 those inside the port.
- At the locations 3km and 15km off shore of the power station, and 3km off shore of Ukedo River, the all- β and tritium densities have been below the detection limit values.
- Cesium densities are below detection limit values or far below the density limit by the announcement of reactor regulation, and have not been on continuous increasing trends. (the cesium-137 density limit by the announcement: 90)
