(5) Contaminated Water Leakage from a Tank / Measures for Risk Reduction

Measures implemented and started to be implemented (in August)

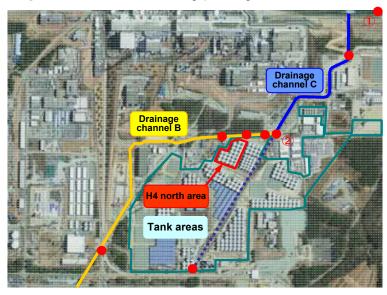
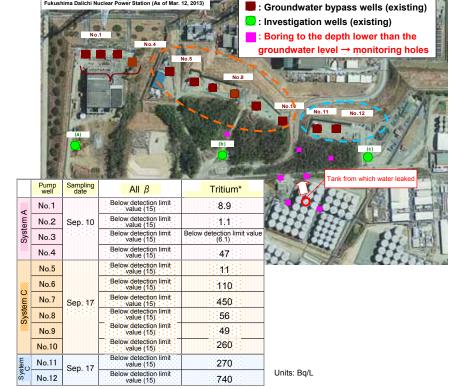
Positional relations with groundwater bypass and pump wells

[Measure 5] Intensification of monitoring (Investigation as to outflow to the ocean)

[Values obtained in monitoring (excerpts)] (Units: Bg/L) 1. Seawater near the Fukushima Daiichi south water outlet (sampled on

September 24)

- ·Cesium-137: 2.1
- •All β : Below detection limit value (20)
- 2. Water at the junction of the drainage channels B and C (sampled on September 24)
 - ·Cesium-137: Below detection limit value (26)
 - All β: Below detection limit value (13)
