Replacement of Floor Mat in the Main Anti-Earthquake Building (Plane)

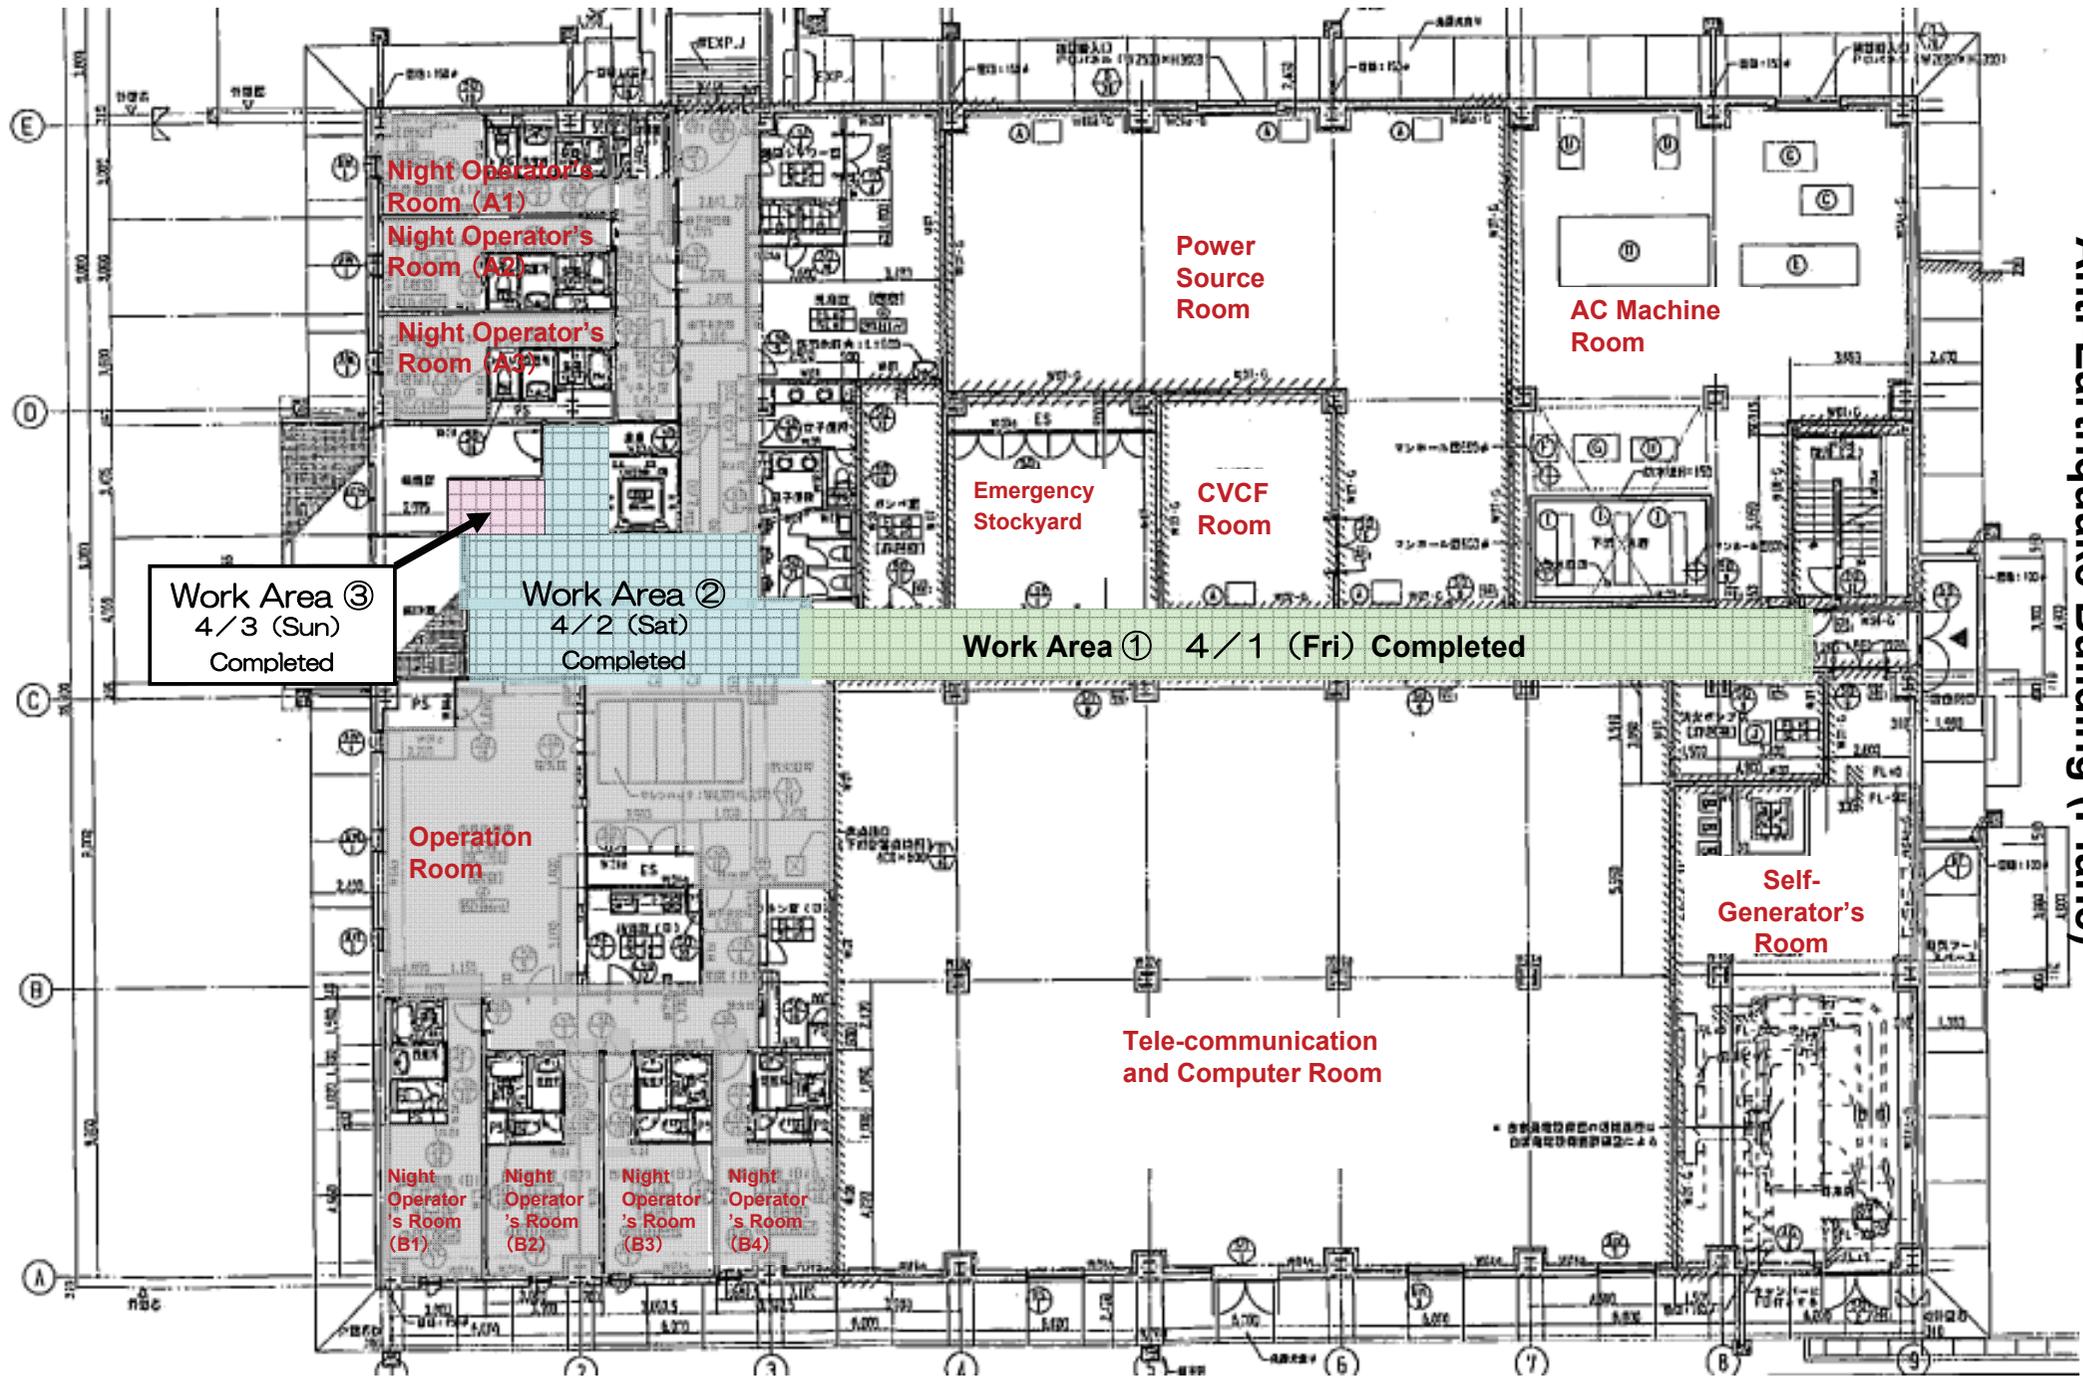
1st Floor (Plane)

Phase I: Work area where floor tiles have been replaced

Work Area ③
4/3 (Sun)
Completed

Work Area ②
4/2 (Sat)
Completed

Work Area ① 4/1 (Fri) Completed

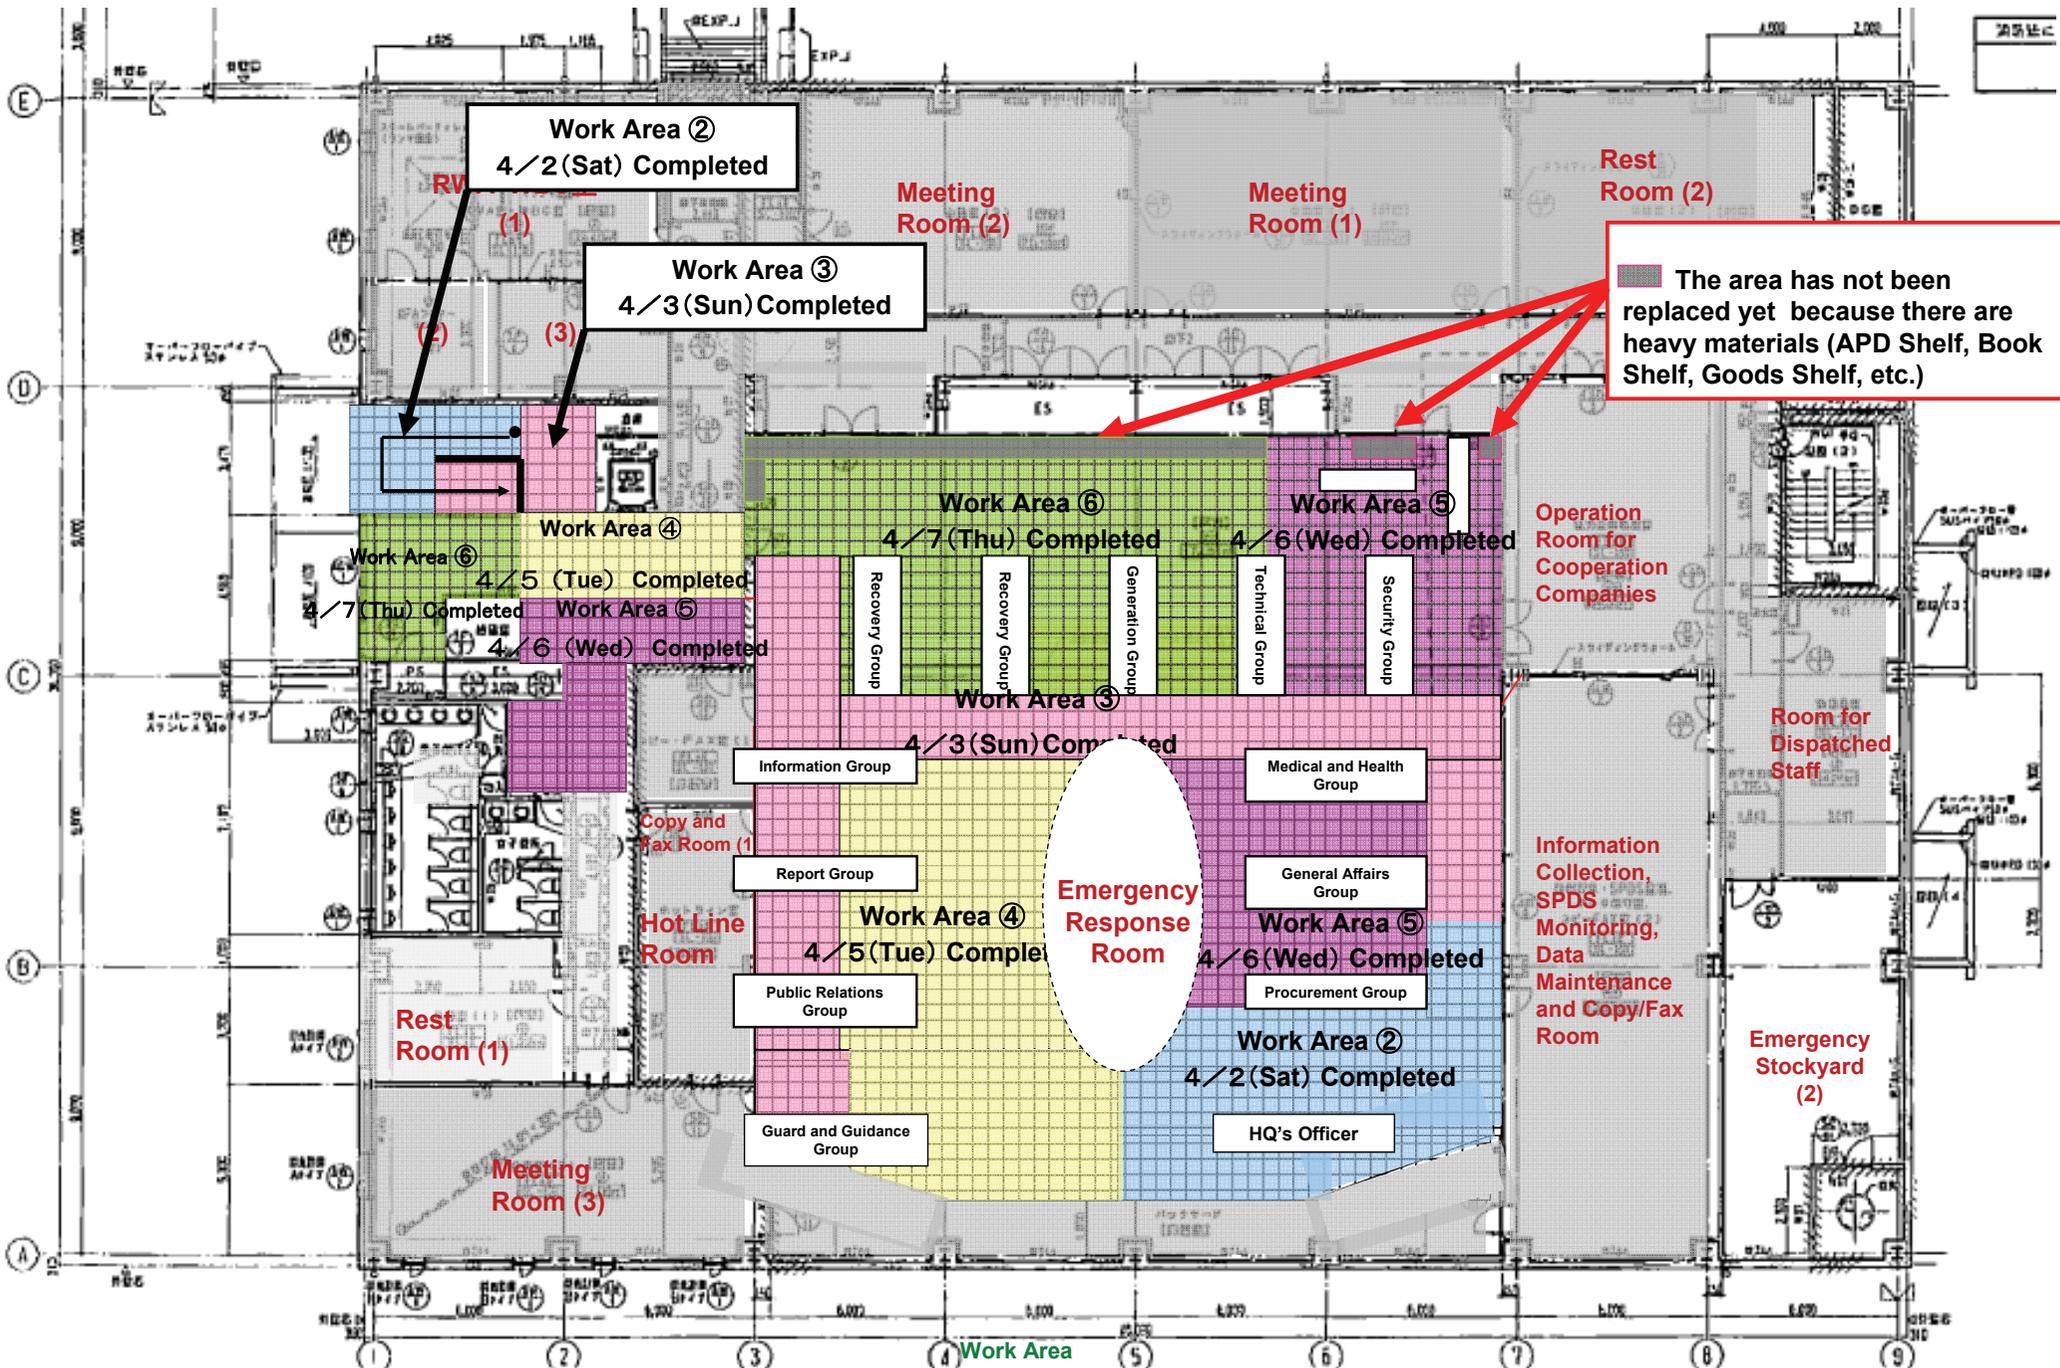
2nd Floor (Plane)

Phase I: Work area where floor tiles have been replaced

Work Area ②
4/2 (Sat) Completed

Work Area ③
4/3 (Sun) Completed

The area has not been replaced yet because there are heavy materials (APD Shelf, Book Shelf, Goods Shelf, etc.)

Work Area ④
4/5 (Tue) Completed

Work Area ⑥
4/7 (Thu) Completed

Work Area ⑤
4/6 (Wed) Completed
