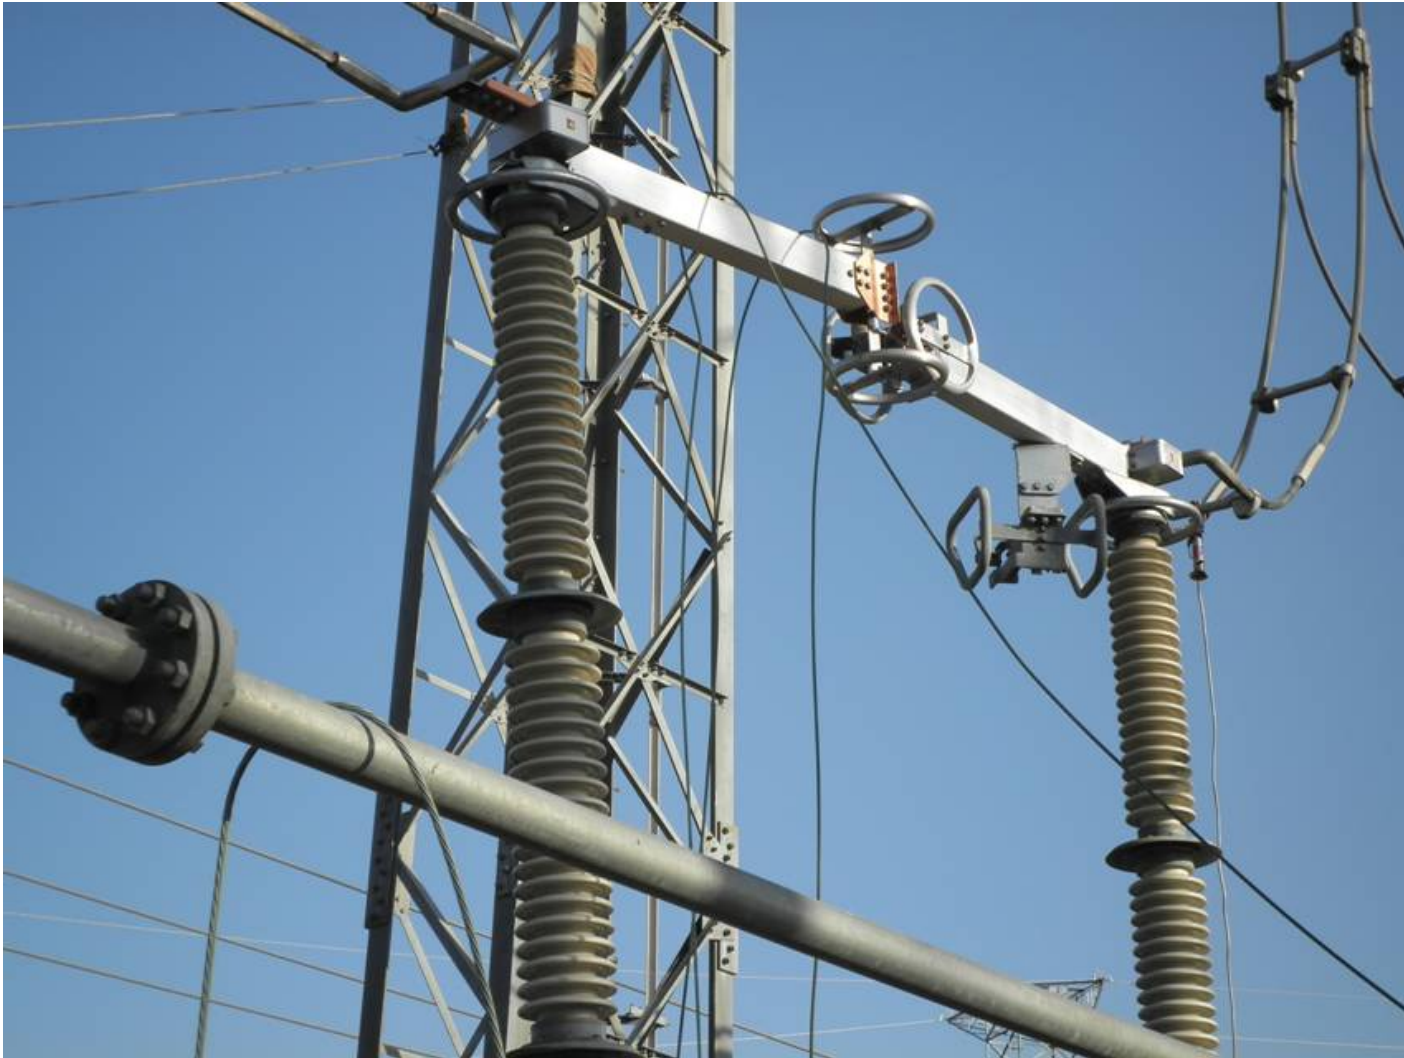
(1) Ohkuma Line 3L, Ground wire (disconnected)

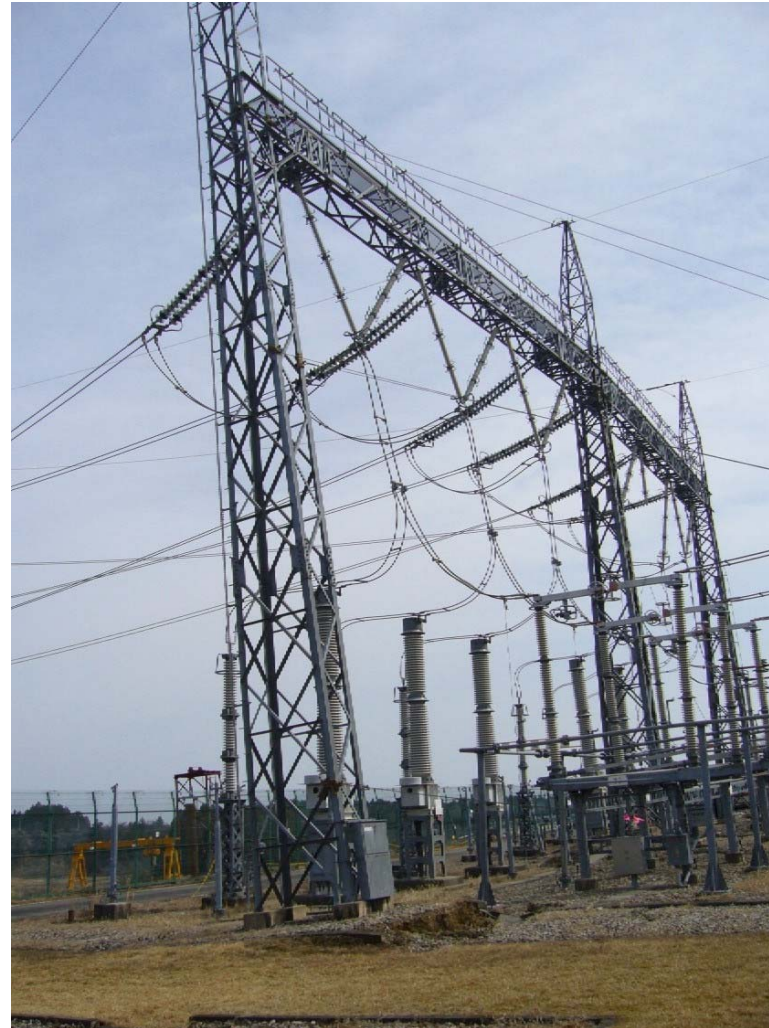
(2) Ohkuma Line 3&4L, Steel structure for lead-in (tilted)

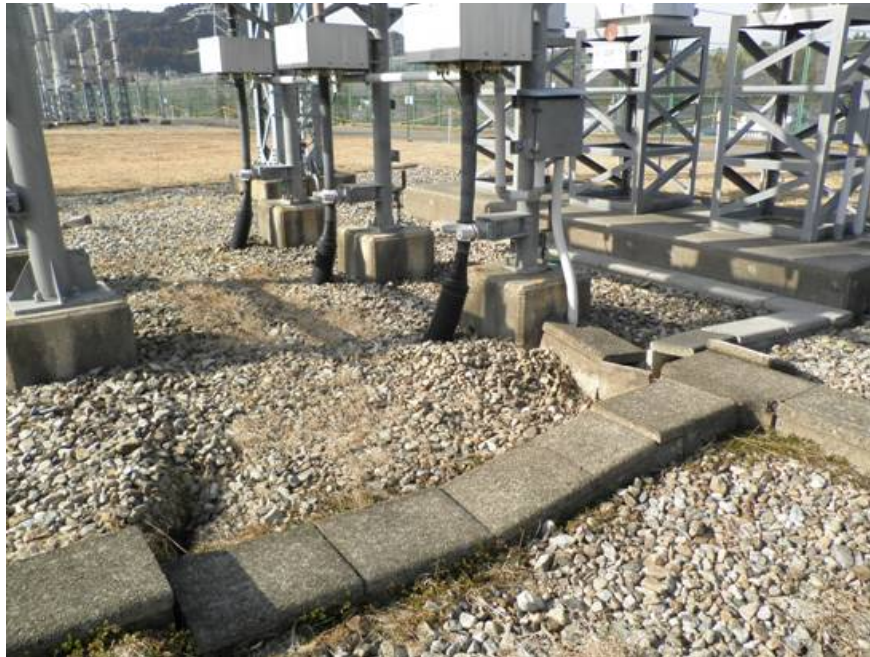
Yonomori Line 1L

(3) Yonomori Line, Cable in substation (subsidence)

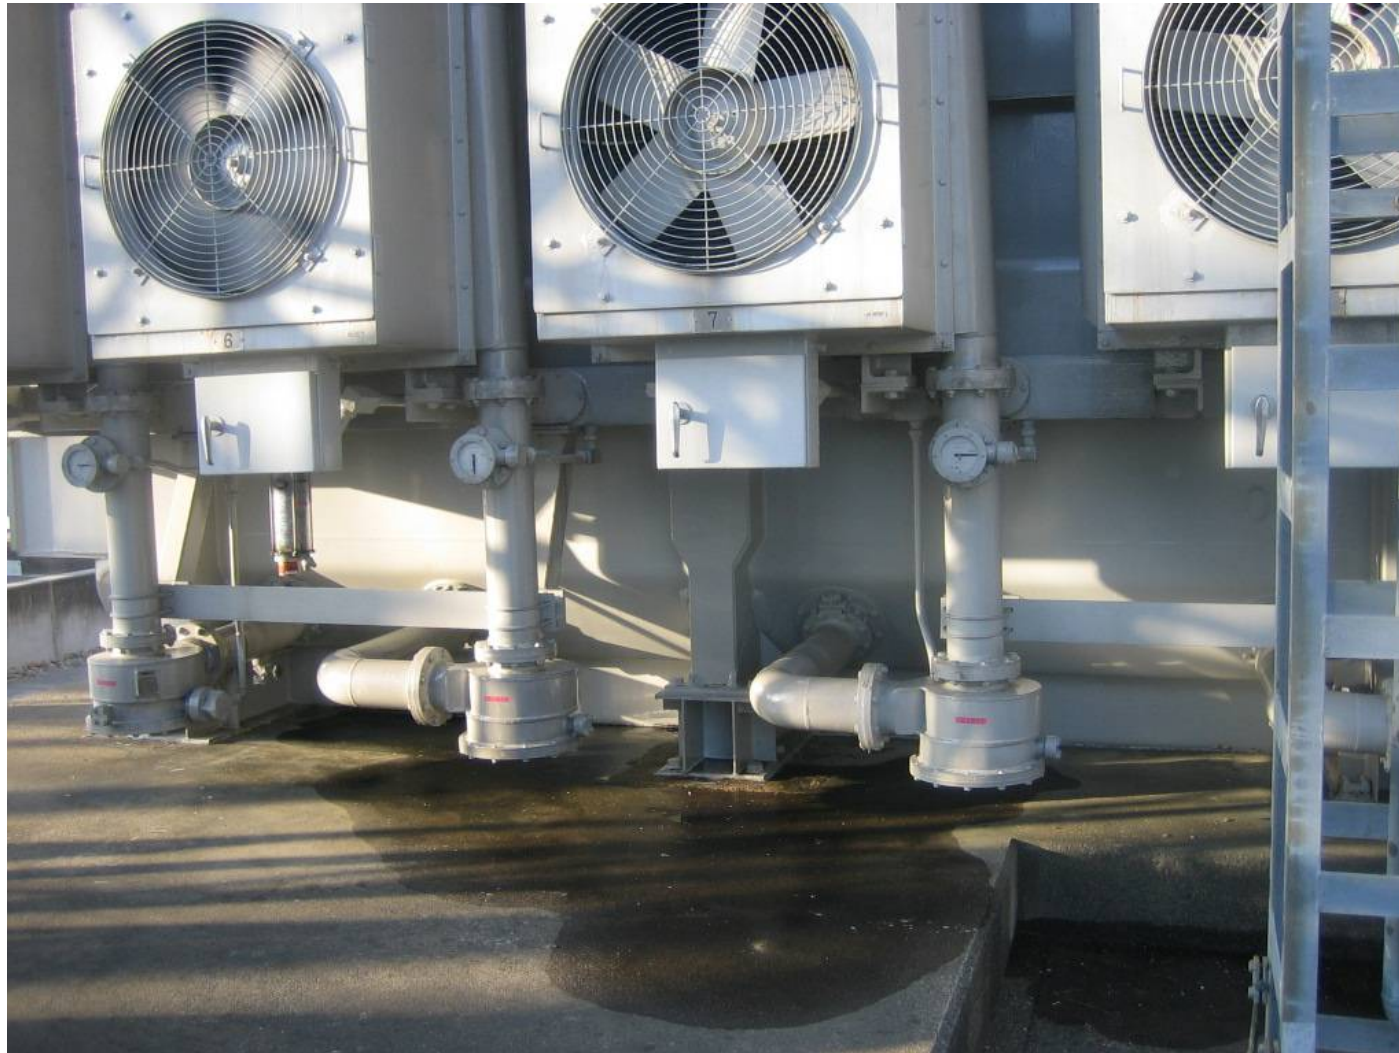
(4) Main transformer No.2 (oil leakage)

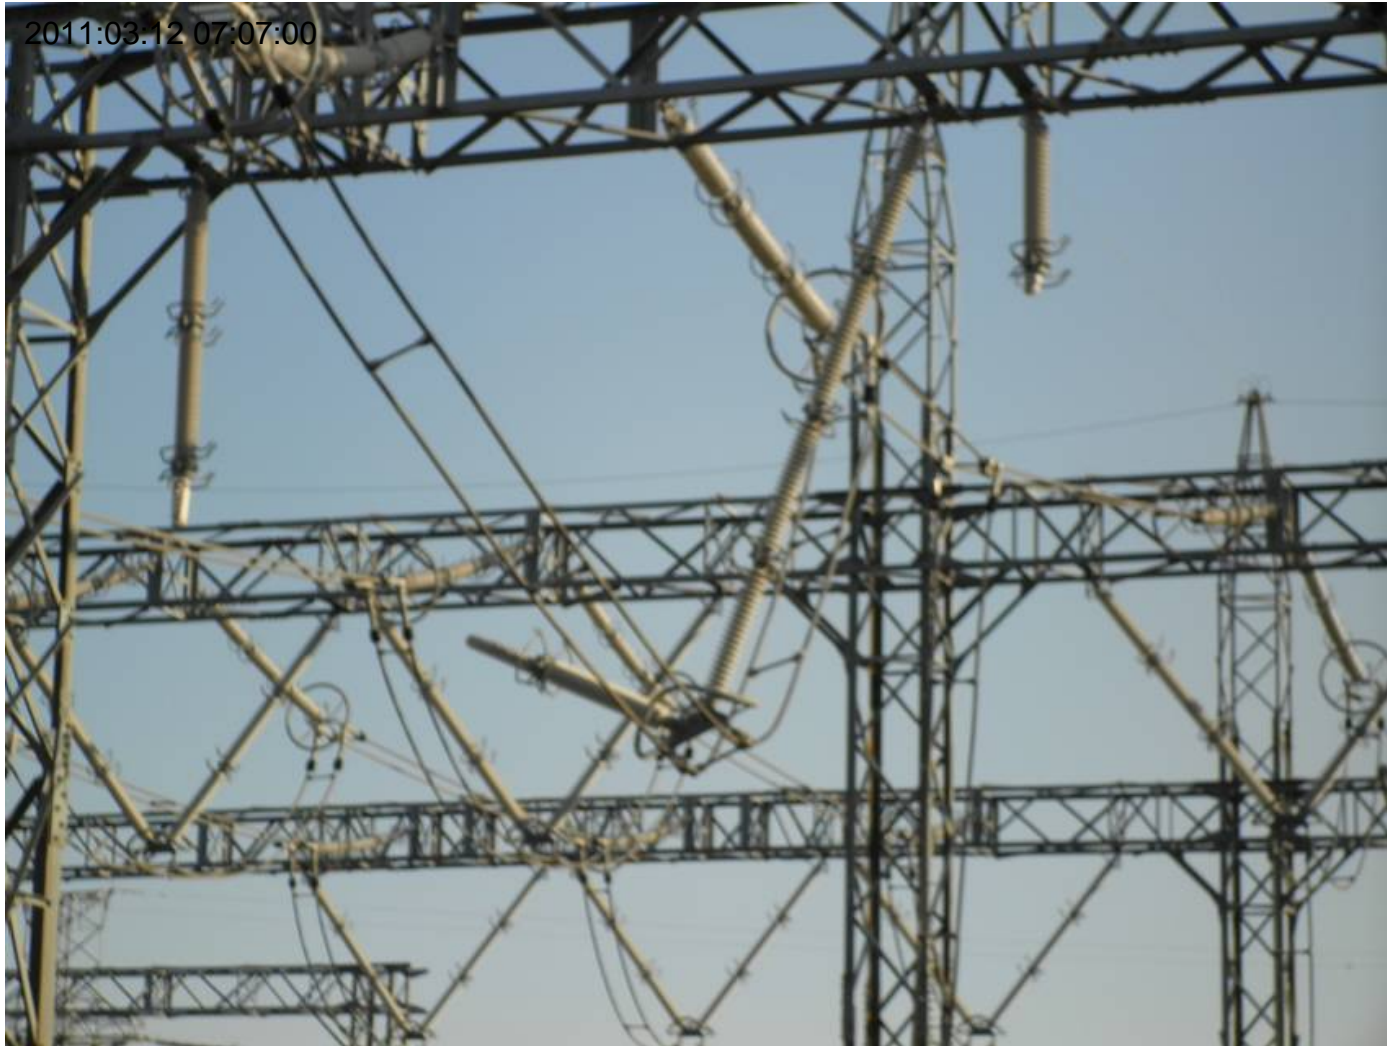
(5) Main transformer No.4 : V-suspended insulator (damaged)

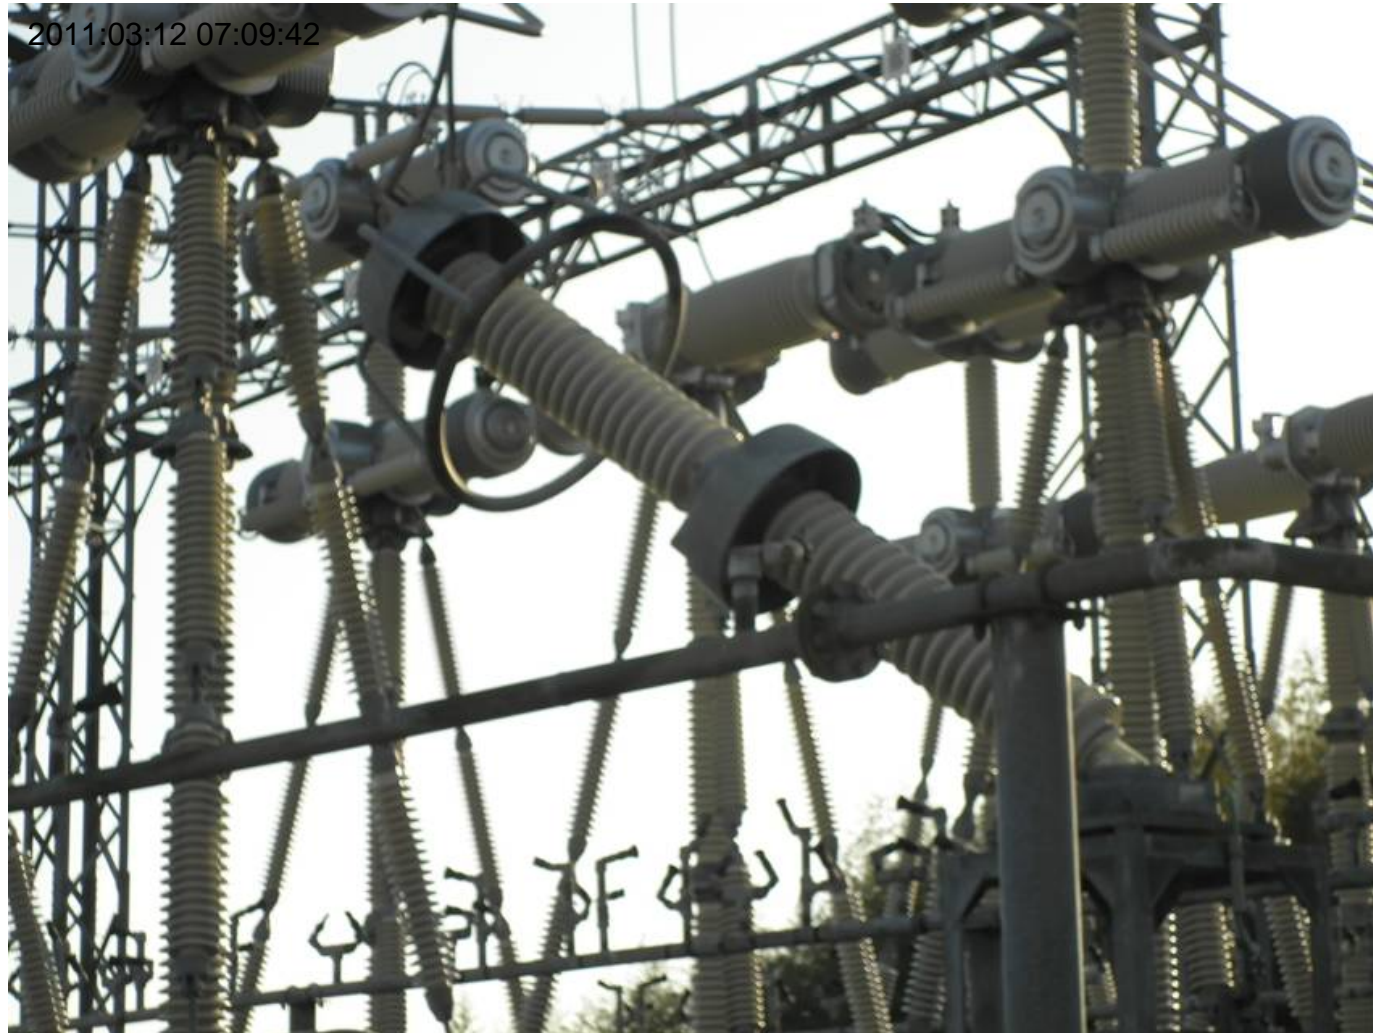
(6) Circuit breaker O-24 (damaged)

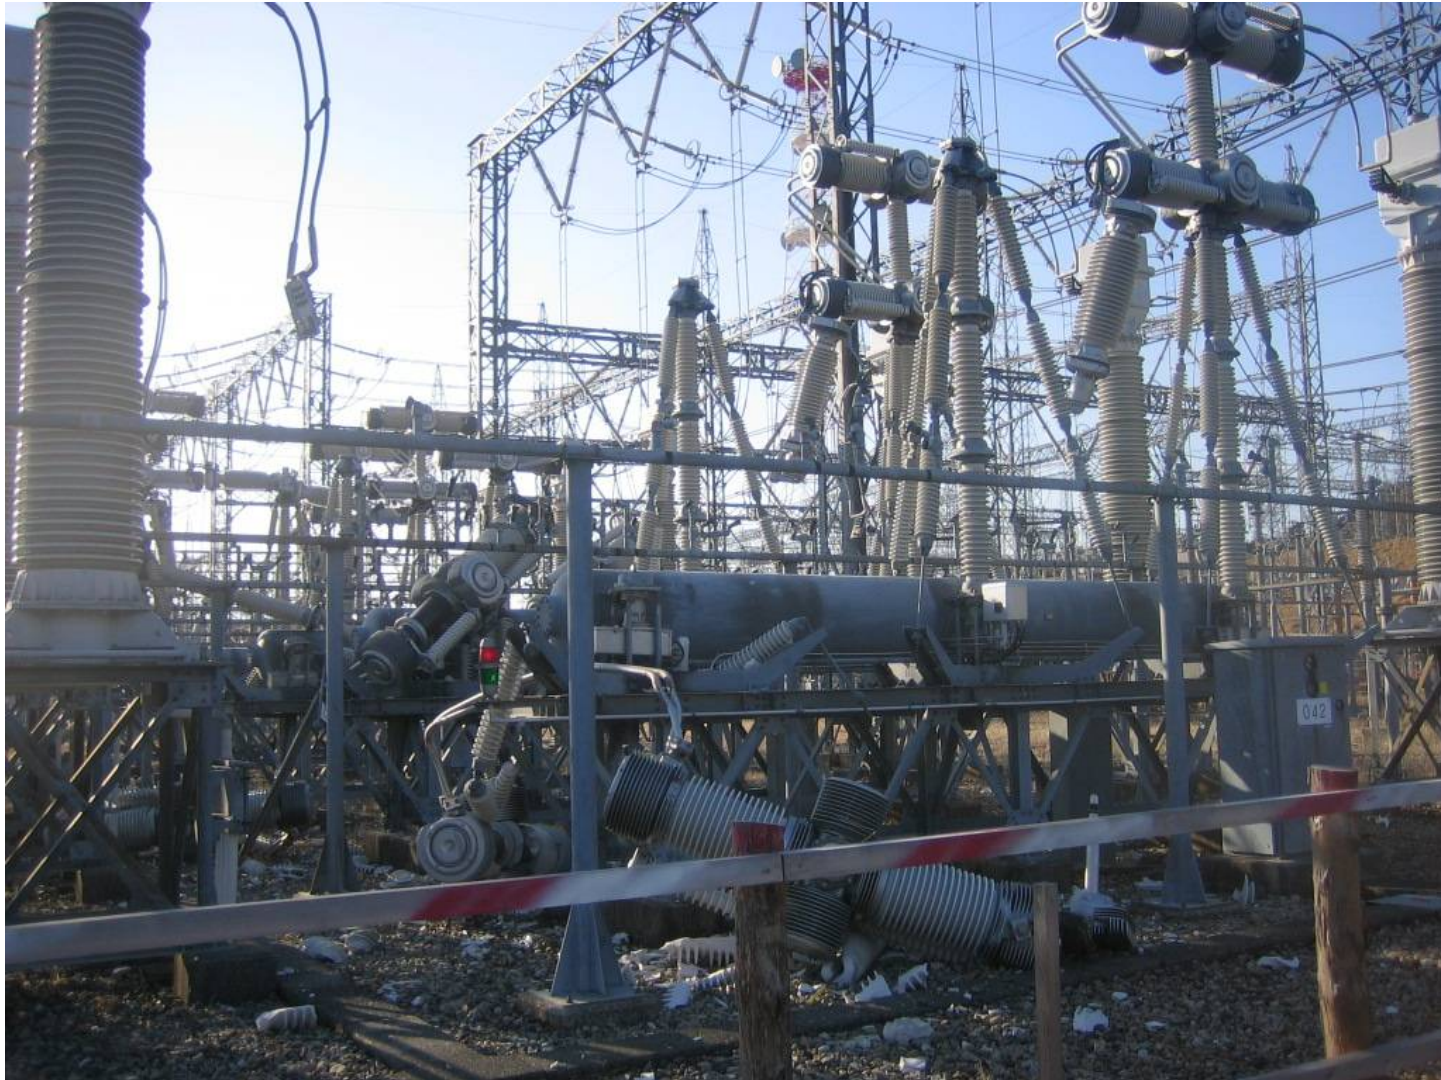
(7) Circuit breaker O-41, Iwaki Main Line 1L (damaged)

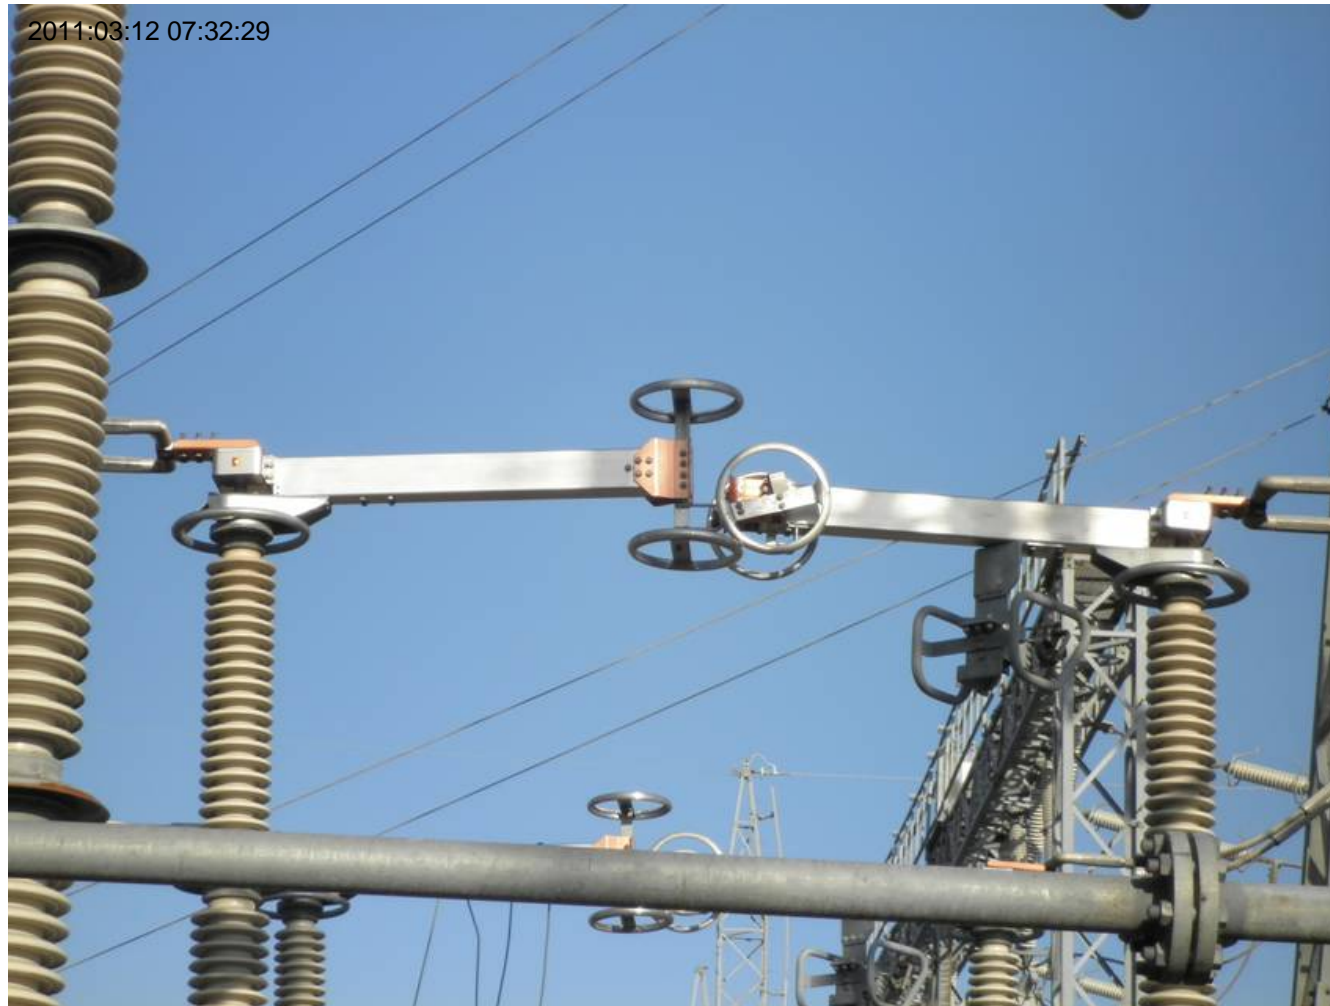
(8) Disconnecter 33, Ohkuma Line 3L (damaged)

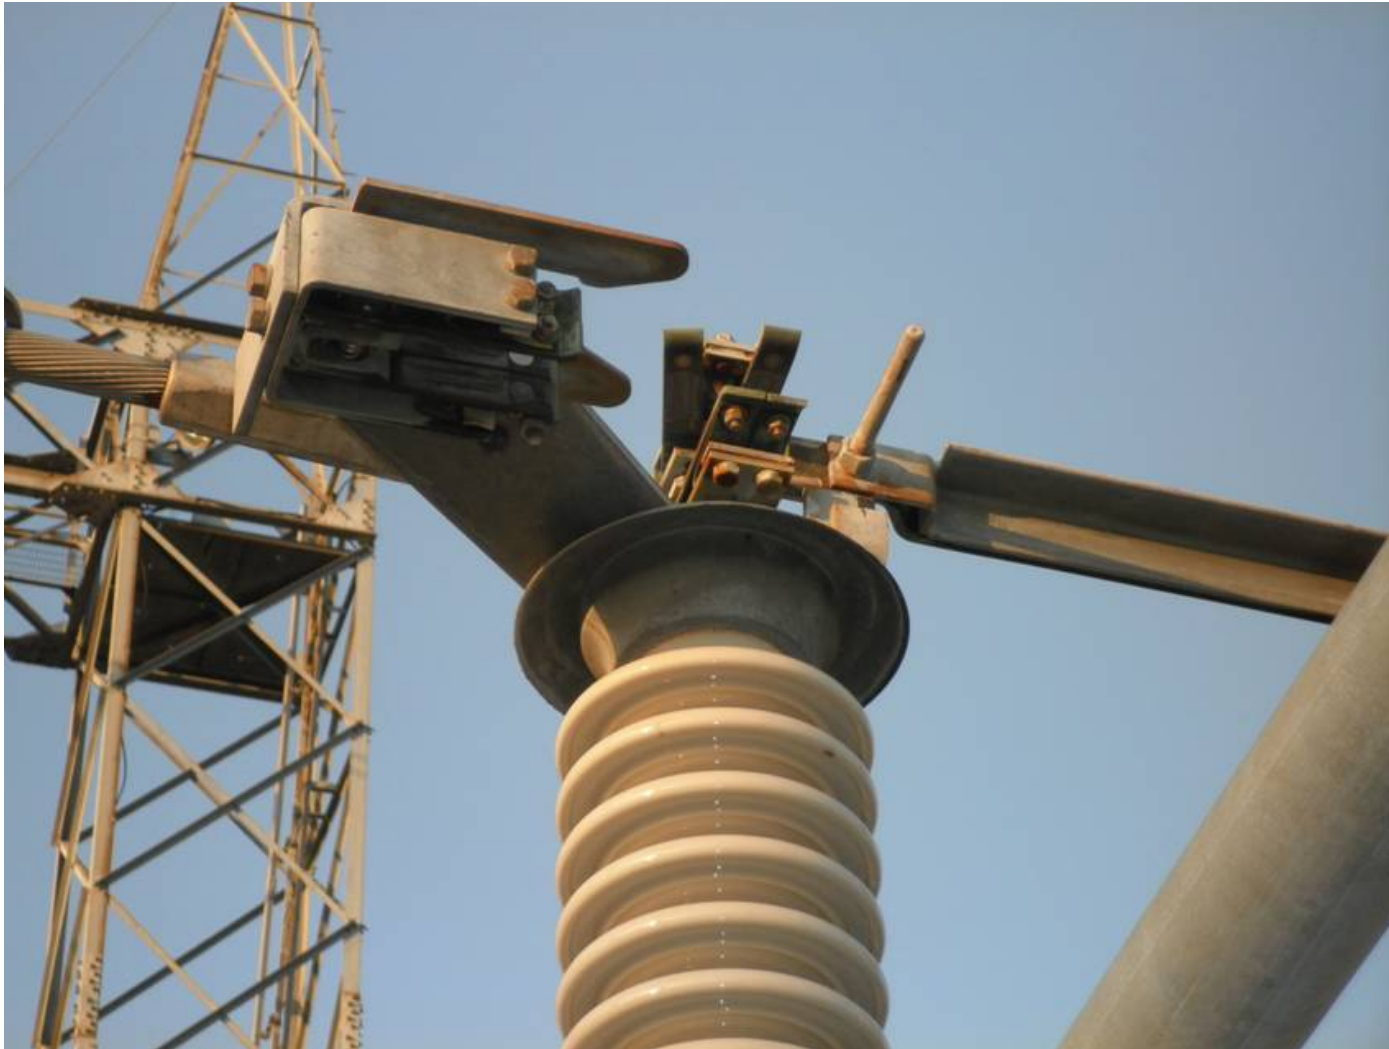
(9) Disconnecter 93, Yonomori Line 1L (damaged)

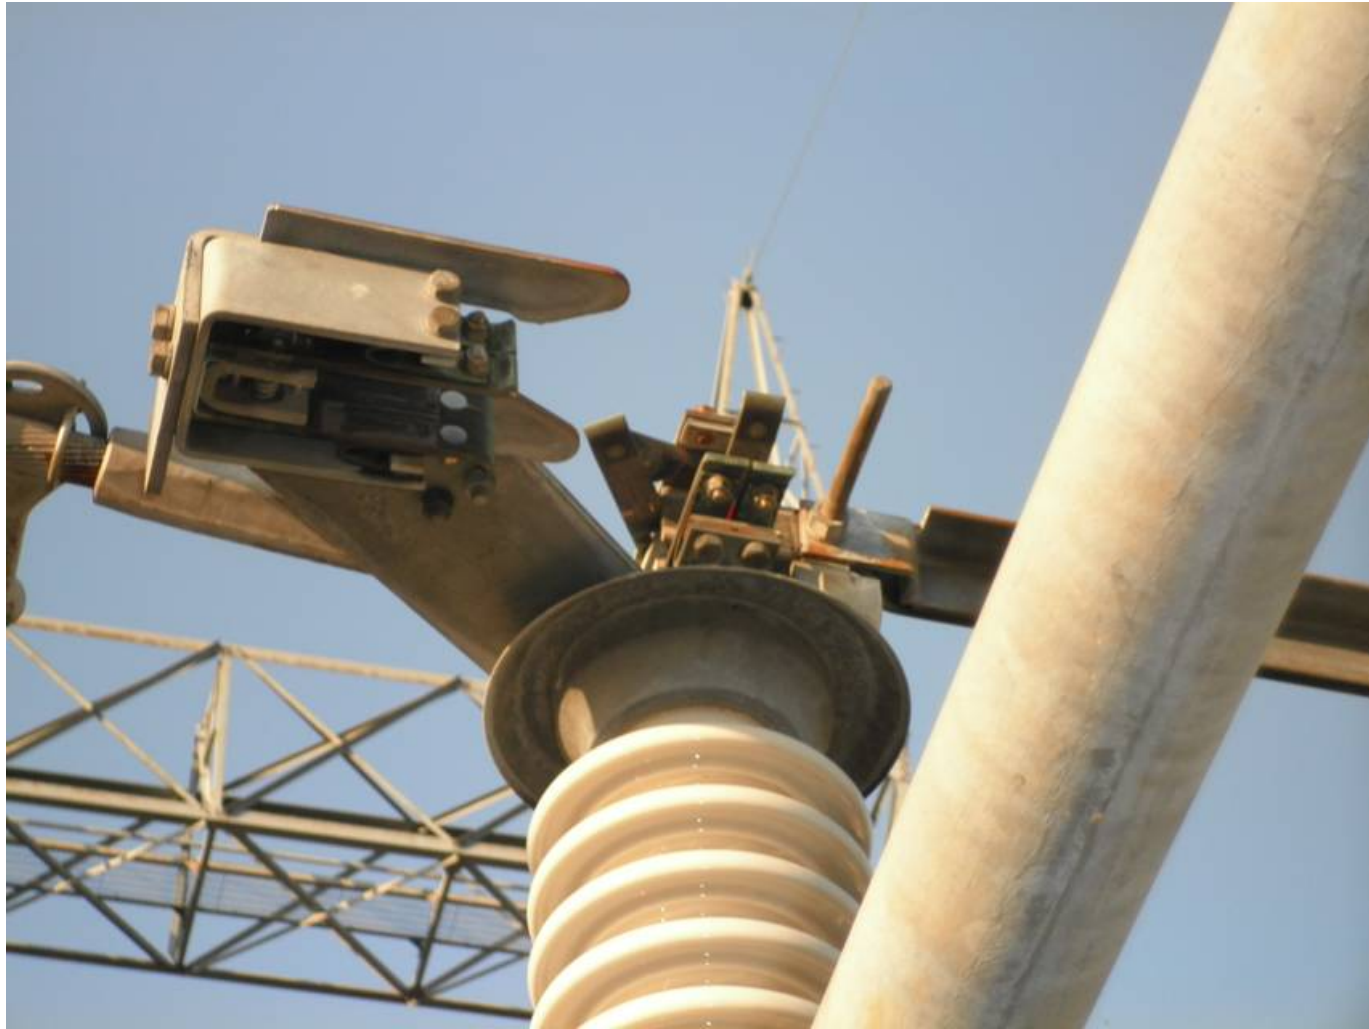
(10) Disconnecter 94, Yonomori Line 2L (damaged)

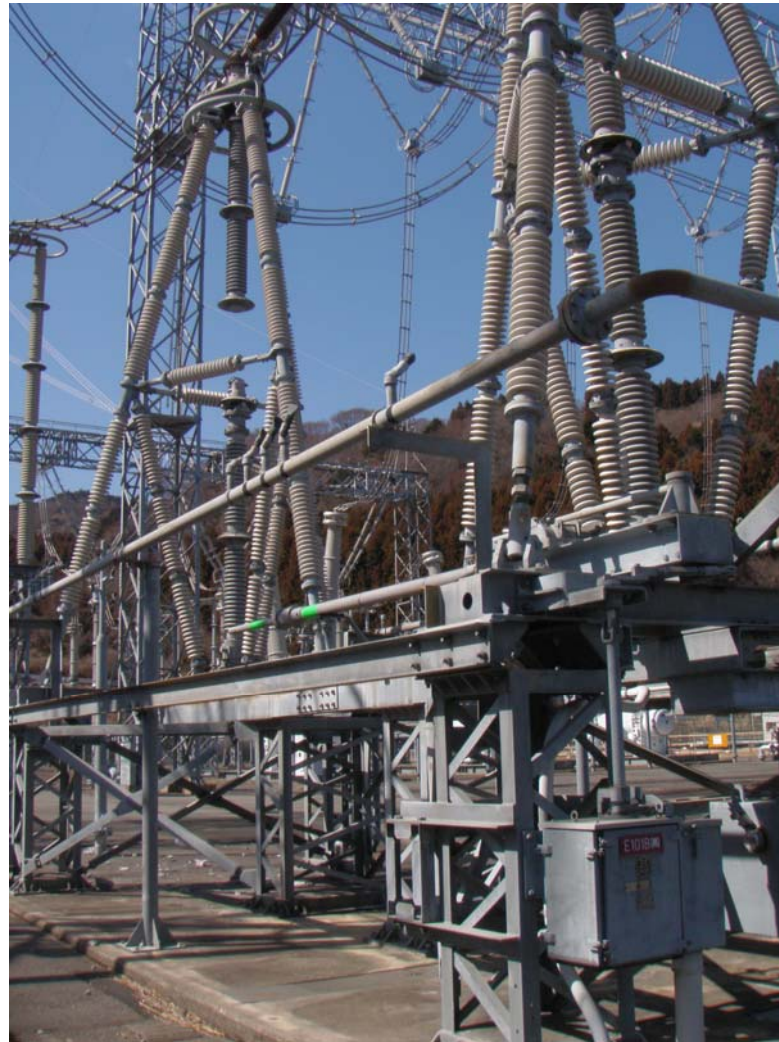
(1 1) Disconnecter 101 (damaged)

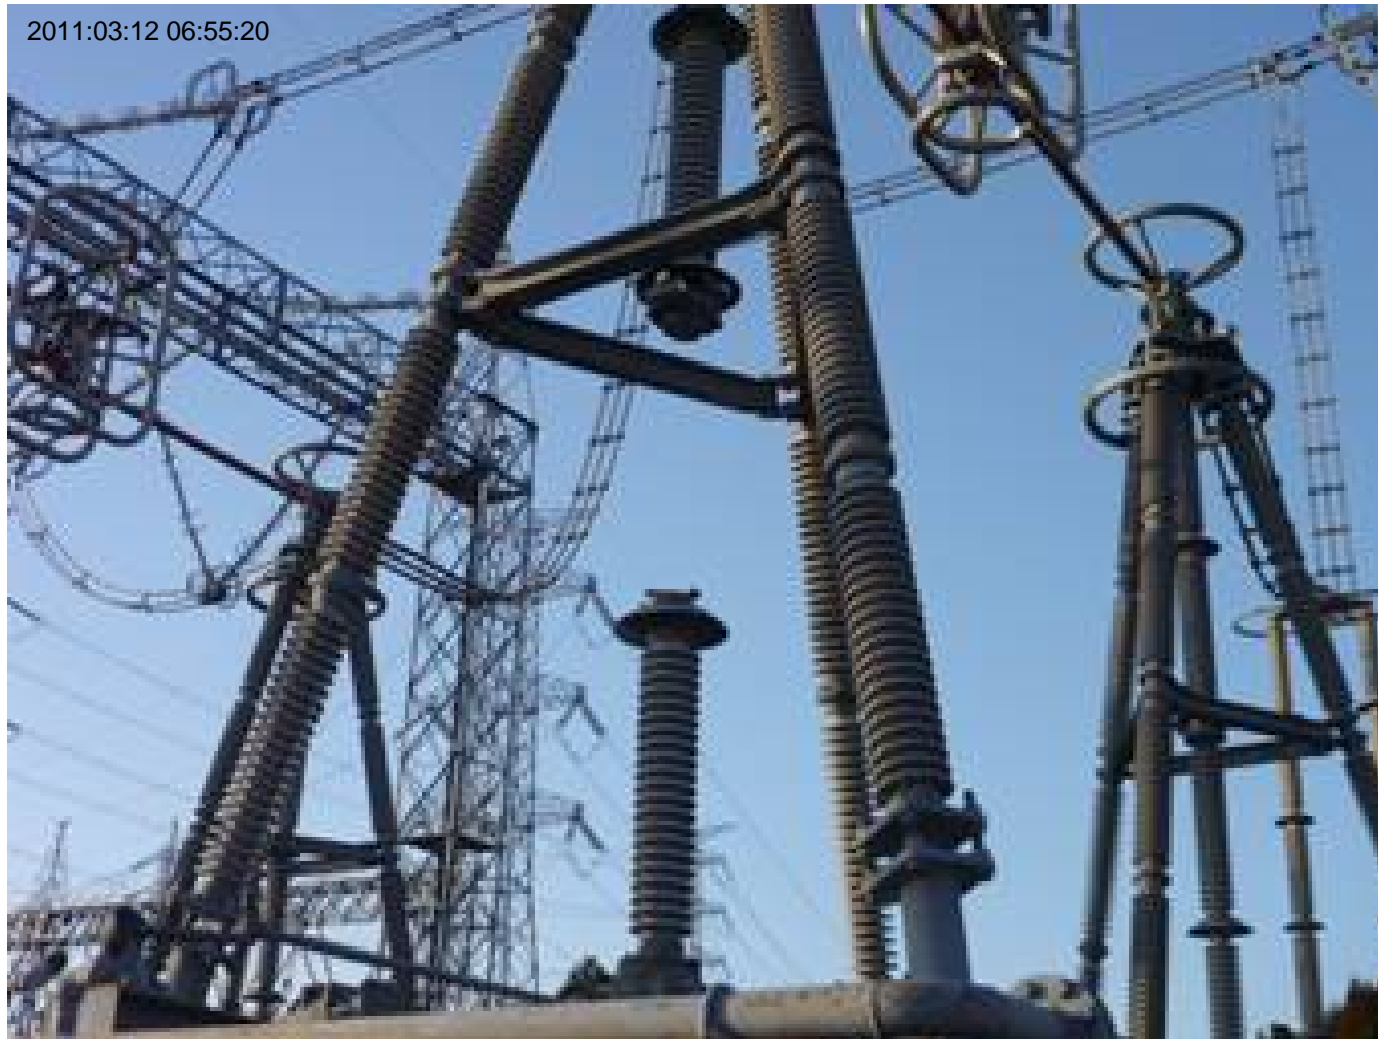
(1 2) Disconnecter 113 (damaged)

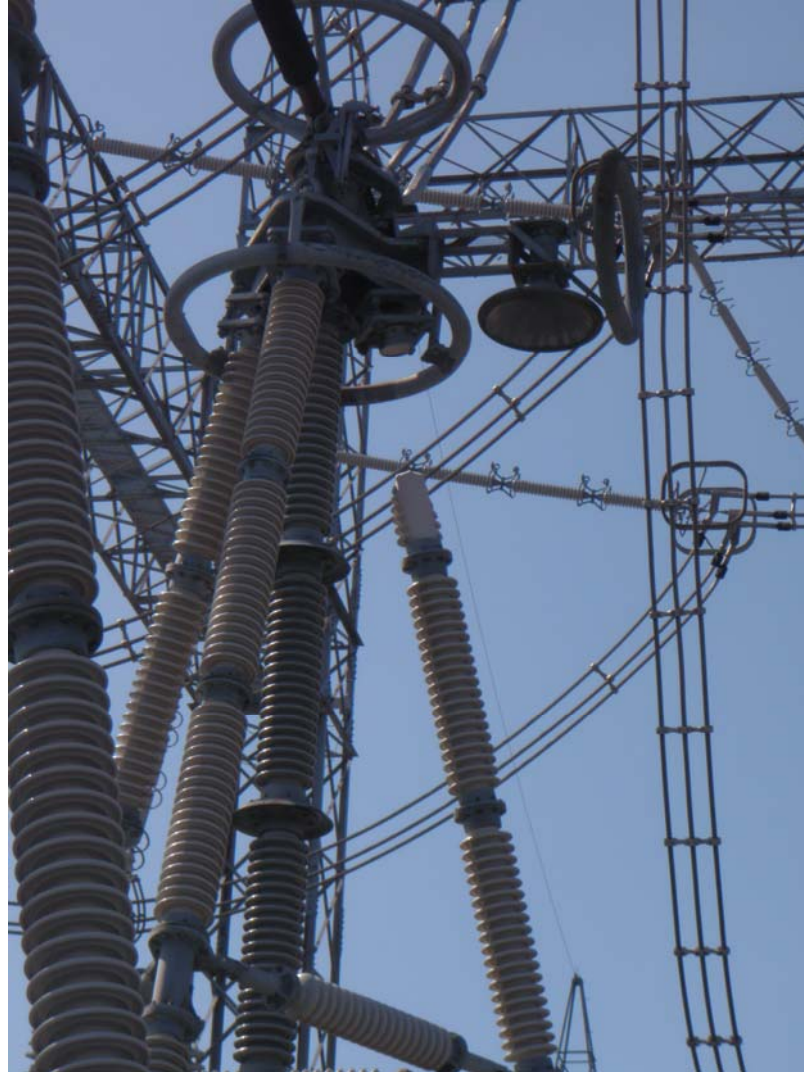
(1 3) Disconnecter 210 (damaged)

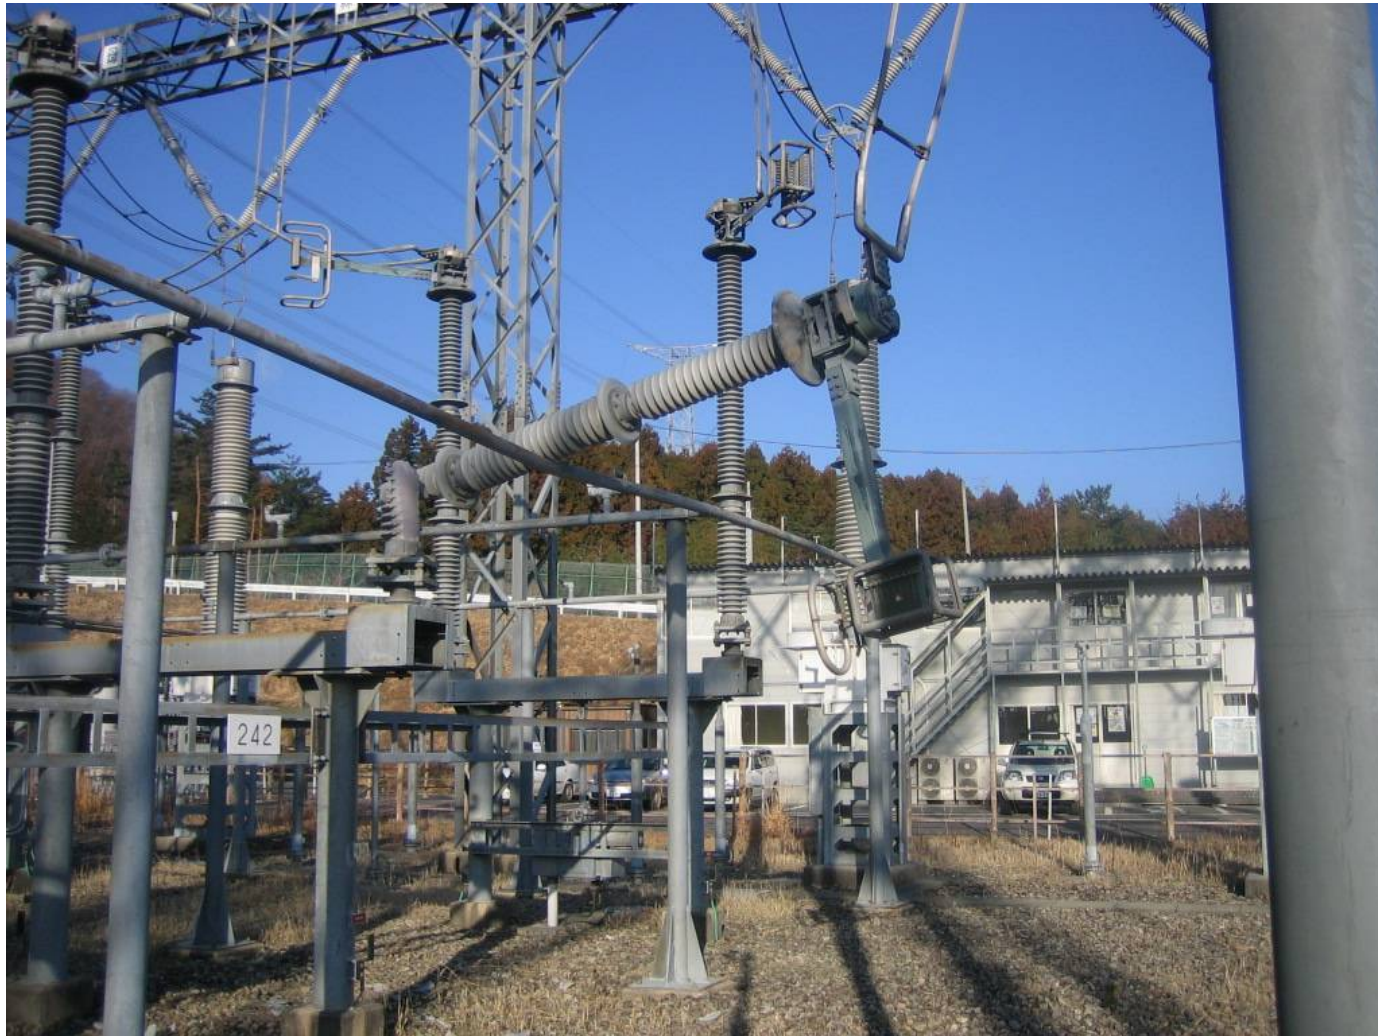
(1 4) Disconnecter 242 (damaged)

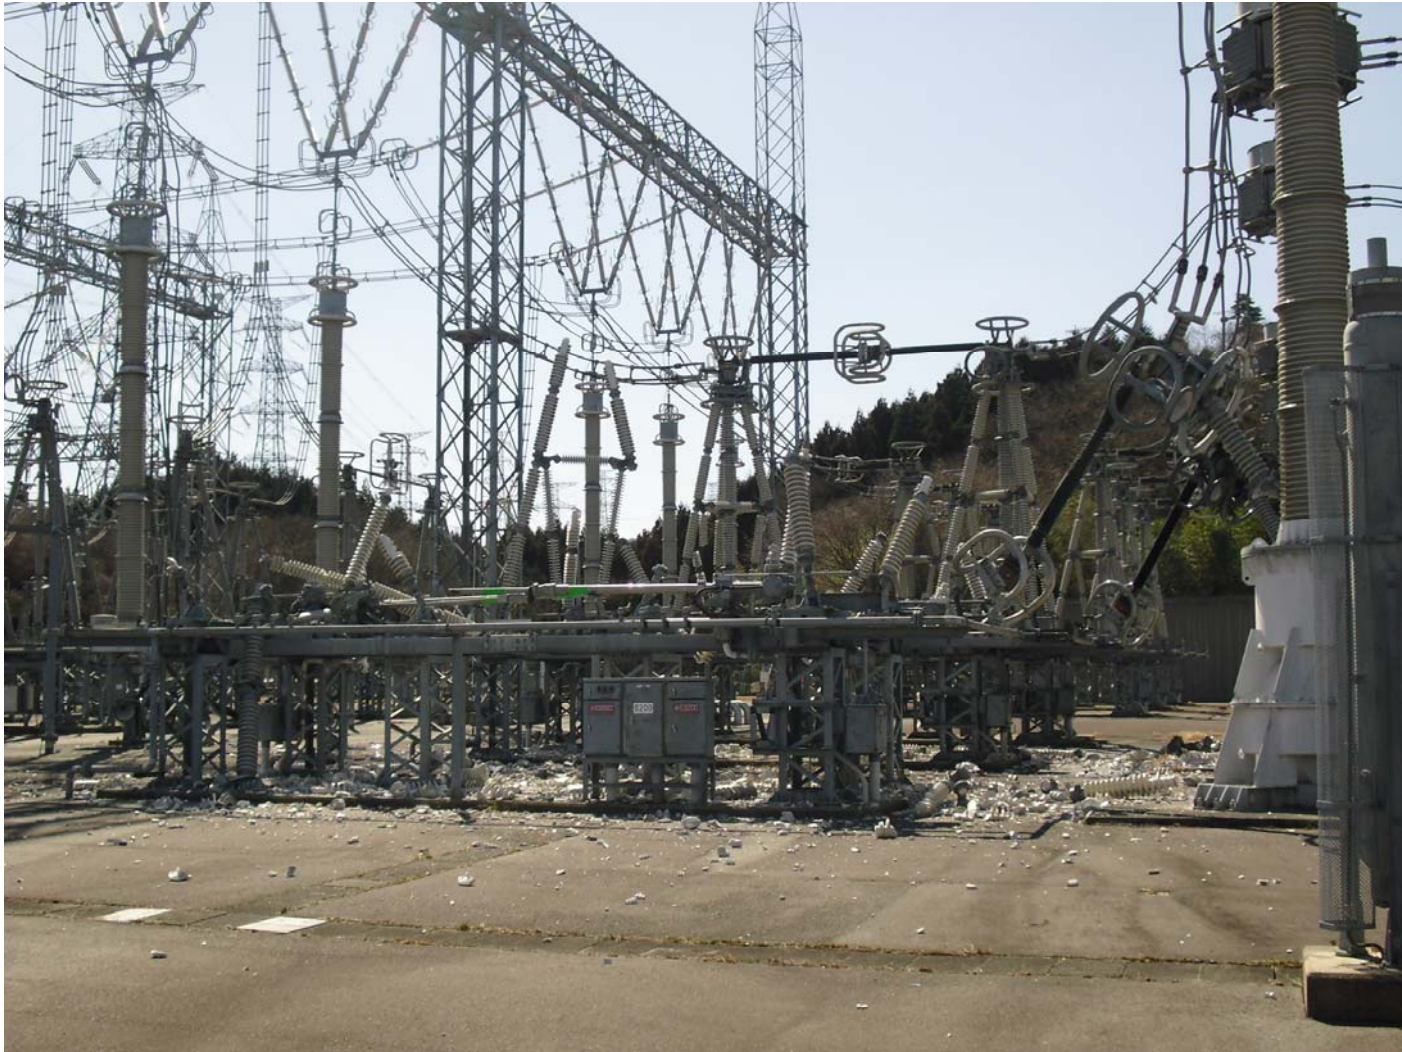
(15) Disconnecter S200 (damaged)

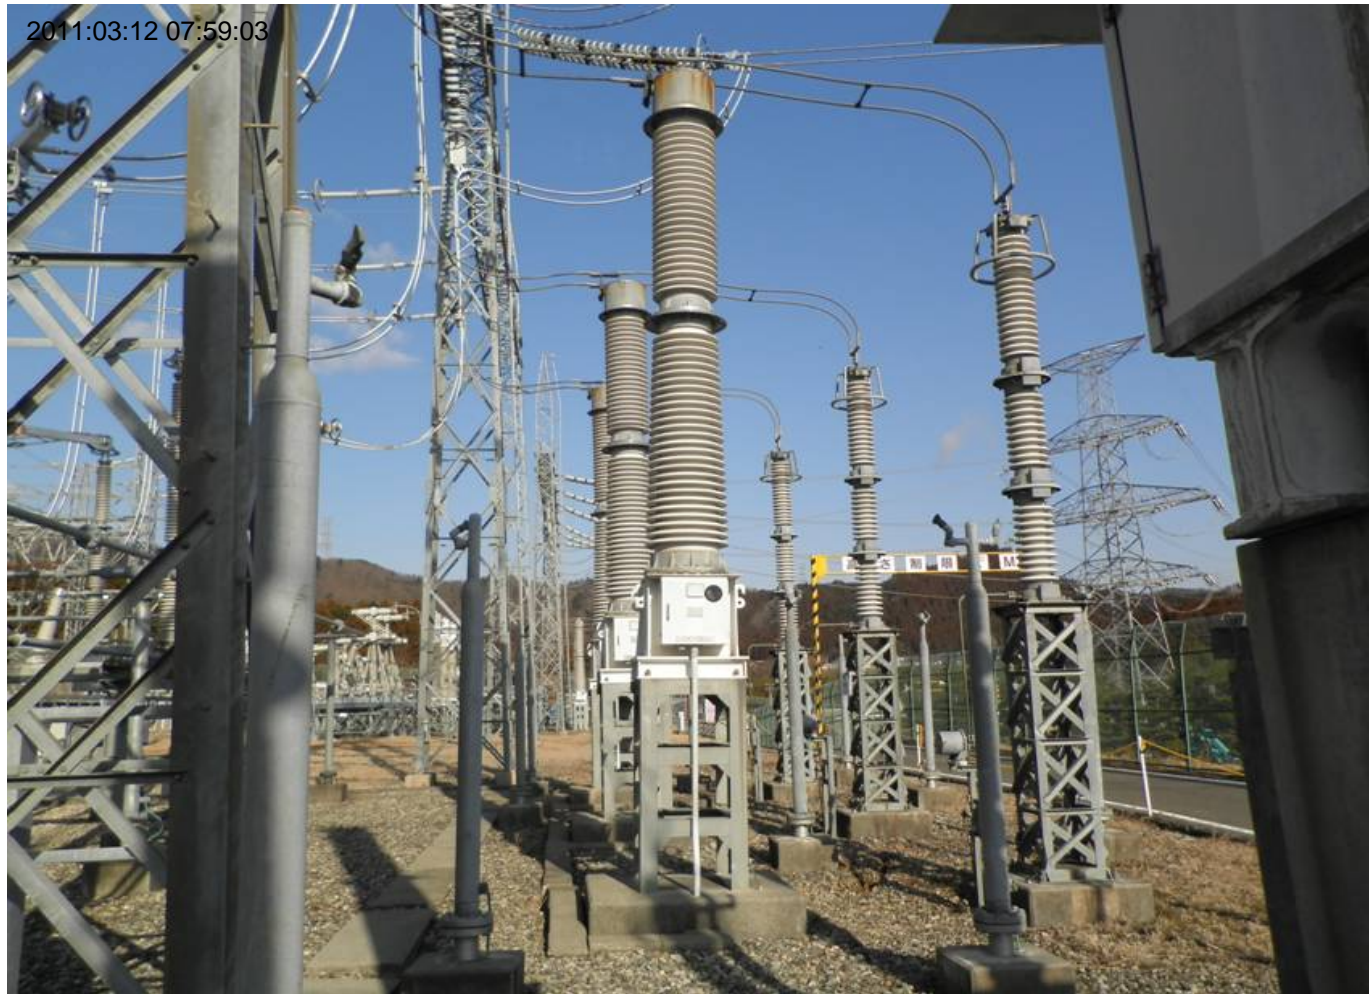
(16) Potential transformer, Ohkuma Line 1L (tilted)

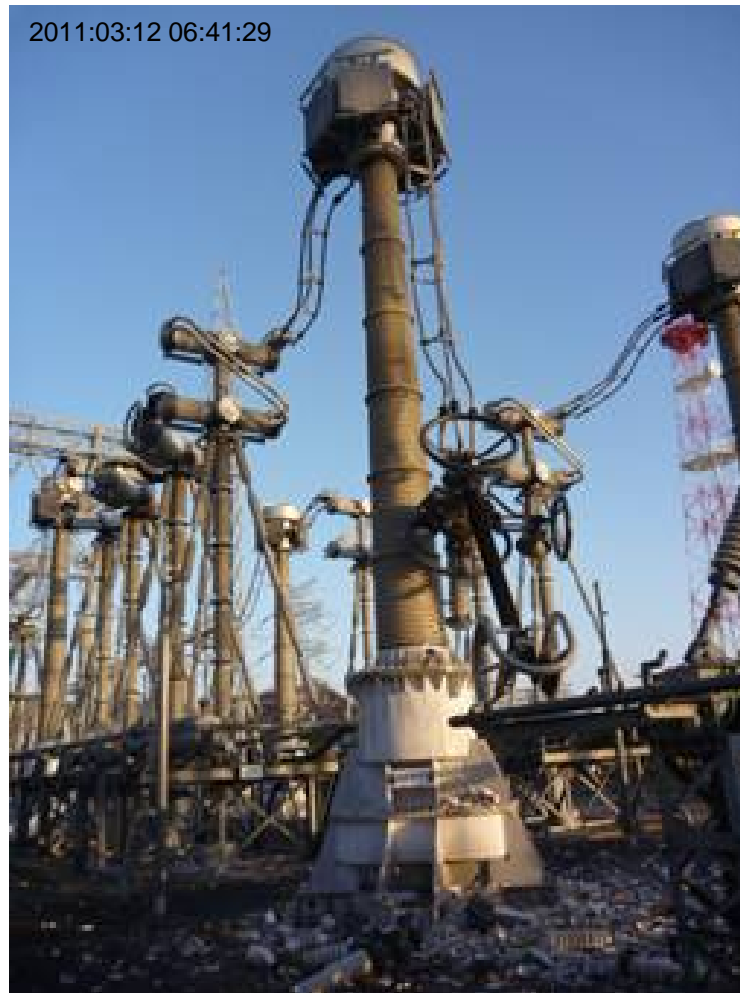
(17) Current transformer, 500kV Section bus (damaged)

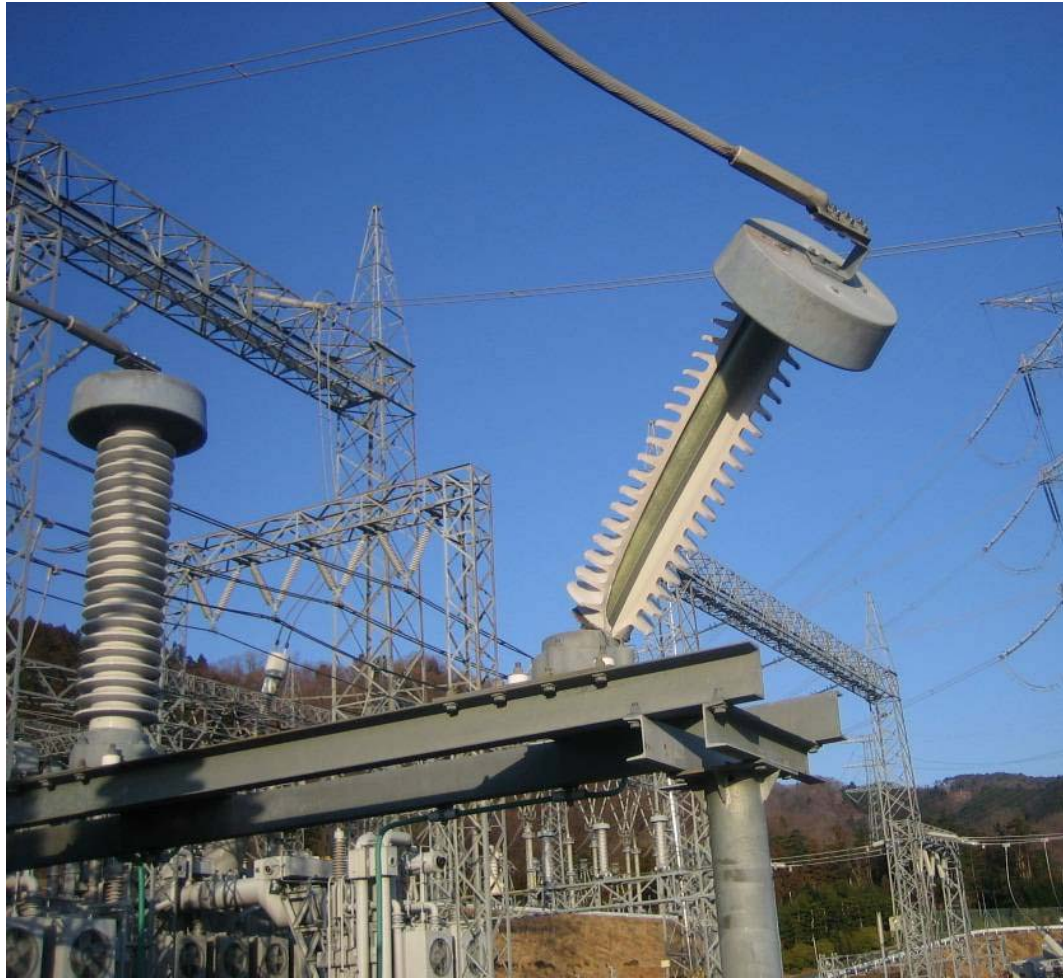
(1 8) Lighting arrester, Iwaido Line 2L (bus side) (damaged)
