Table 7 Evaluation of Faults which does not Consider in the Anti-earthquake Design (faults around the site)

Kashiwazaki Kariwa Nuclear Power Station

Figure 3 Distribution Map of Fault within the site

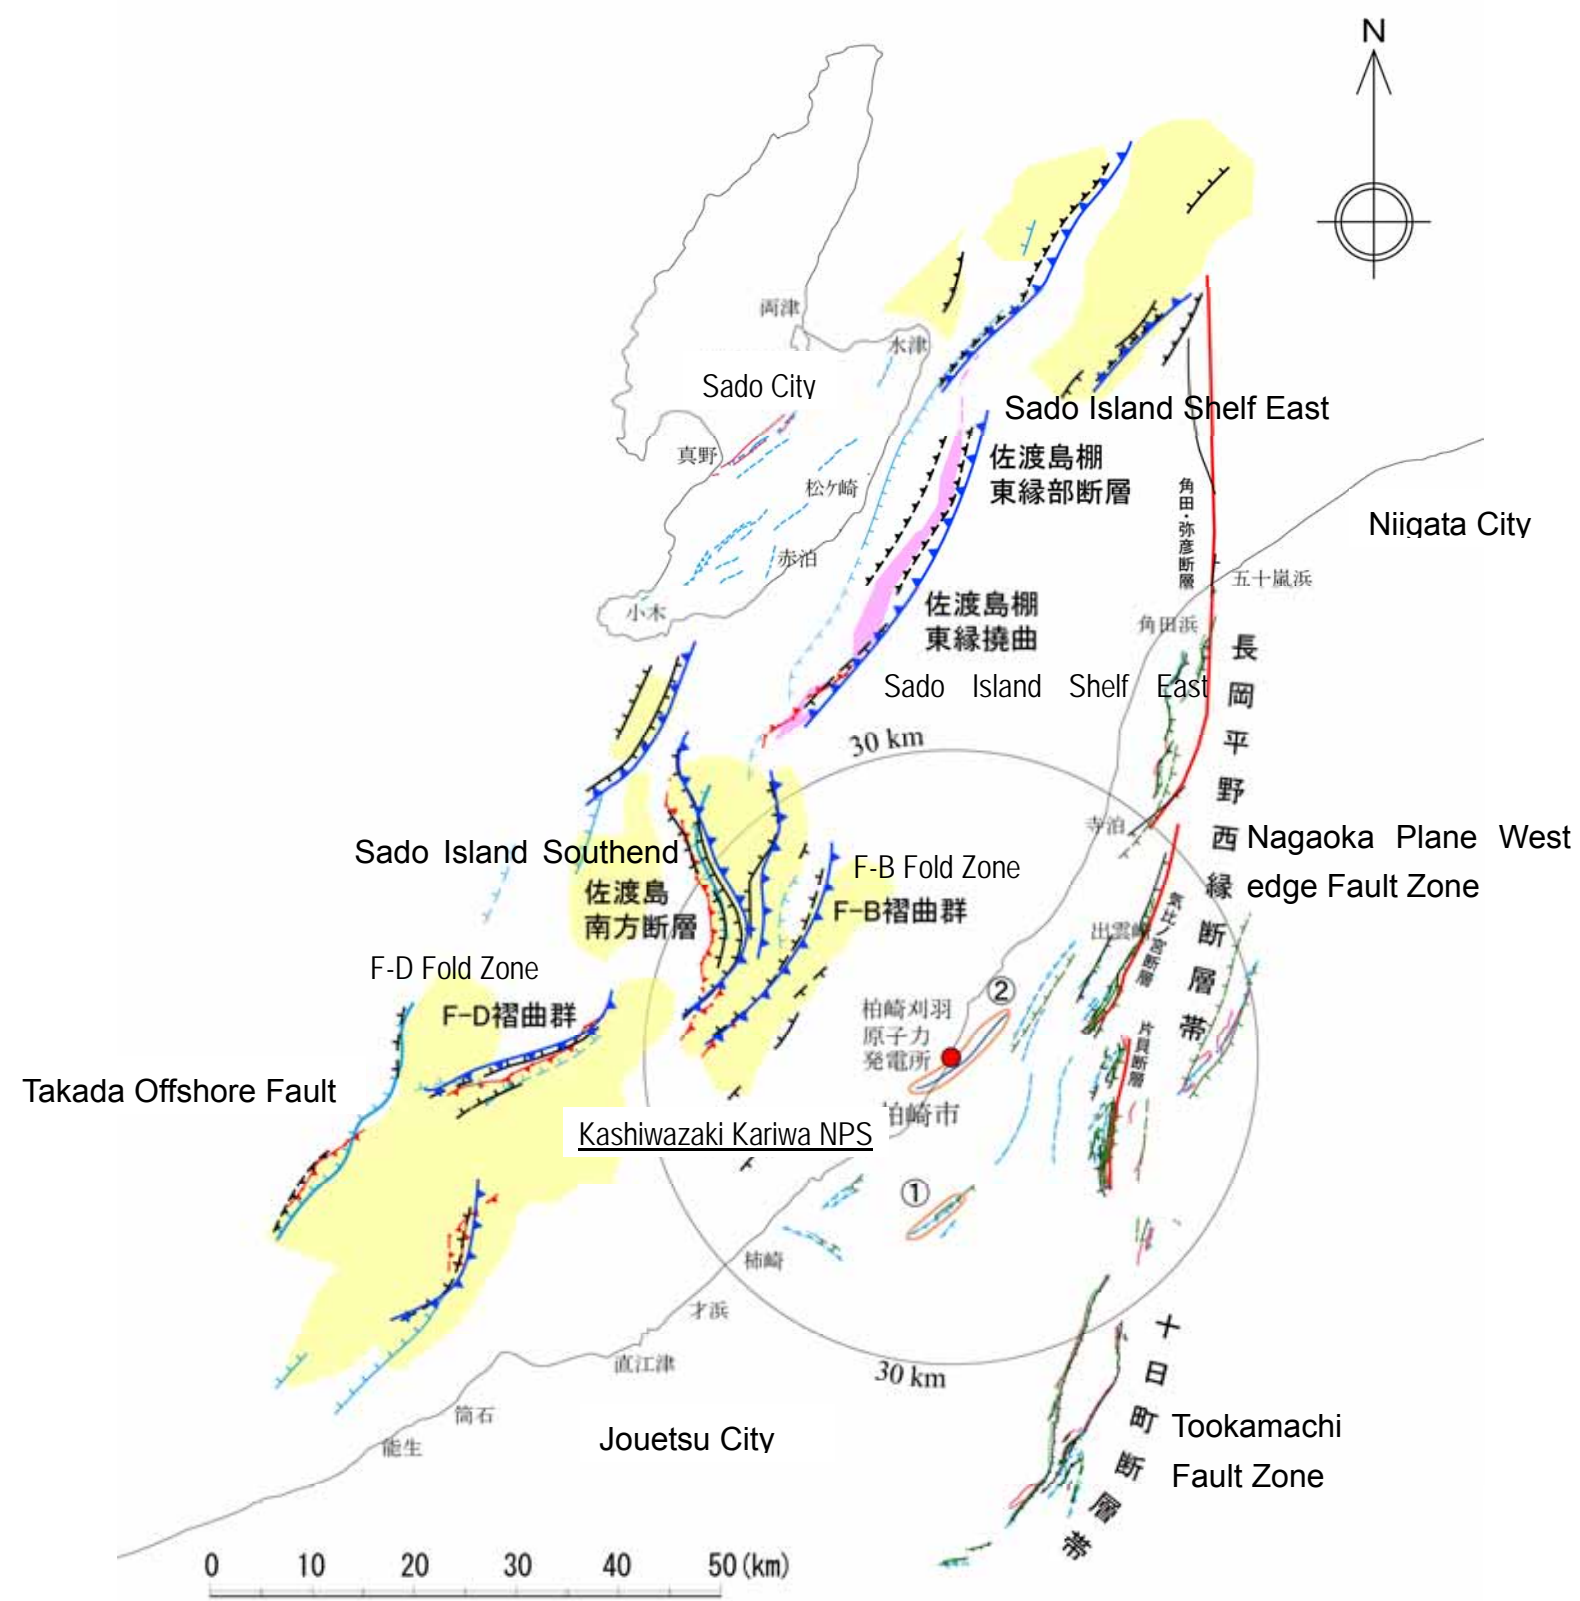
Figure 2 Map of Faults and Lineament around the Site of KK Nuclear Power Station

No.	Name	Area	Length	Distance from the Site ^{□3}	Reason which Denies Activeness of the Fault	Remark
	Hosogoe Fault	On-shore	7 km ^{□1}	15.5 km	Erosion land, No displacement and transformation in Kume layer	Figure 2 and Attachment 12
	Madonosaka Syncline	On-shore	11.5 km ^{□2}	1.5 km	No displacement and transformation in Yasuda layer, Ohminato sand layer and Tefla layer distributed in Yasuda layer	Figure 2 and Attachment 13

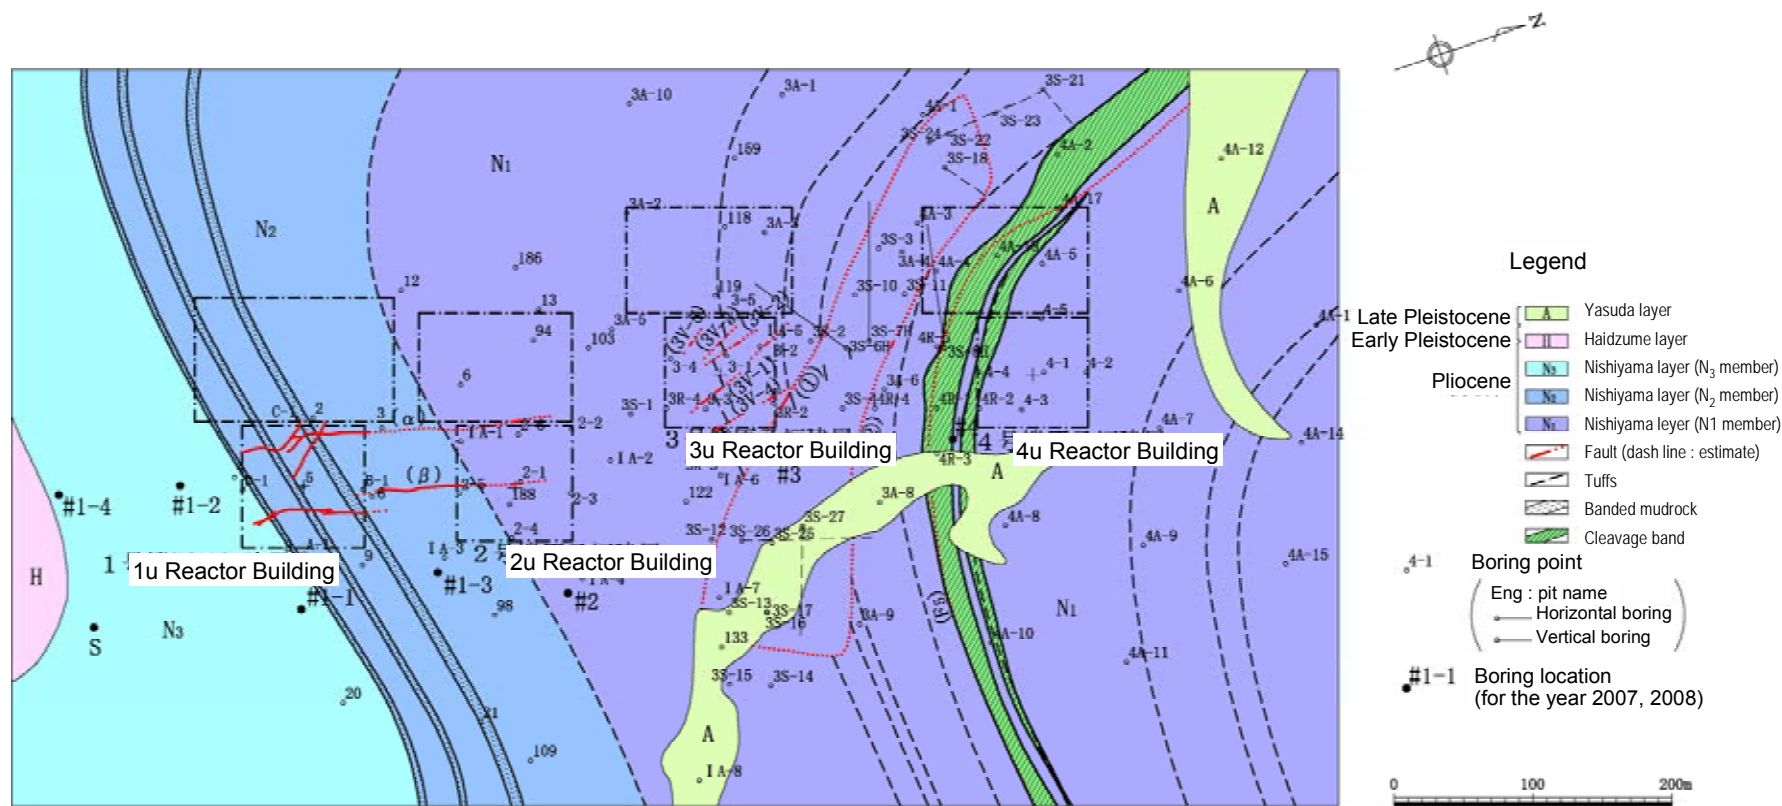
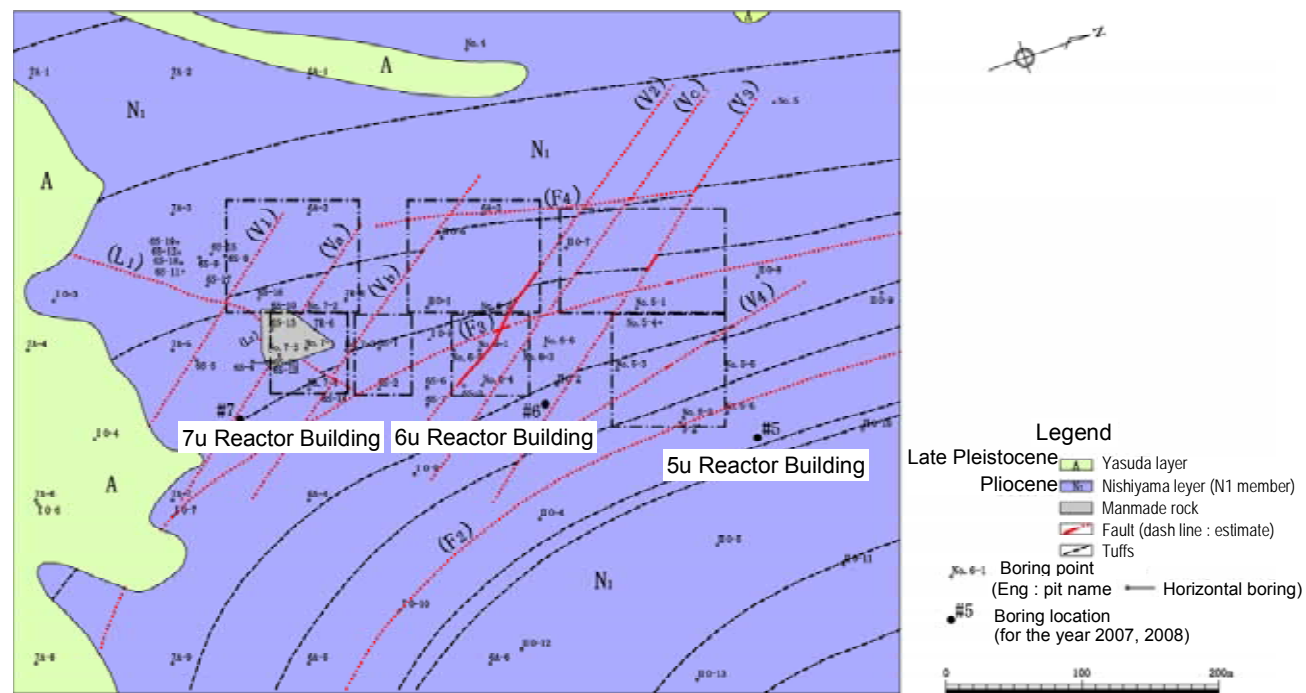
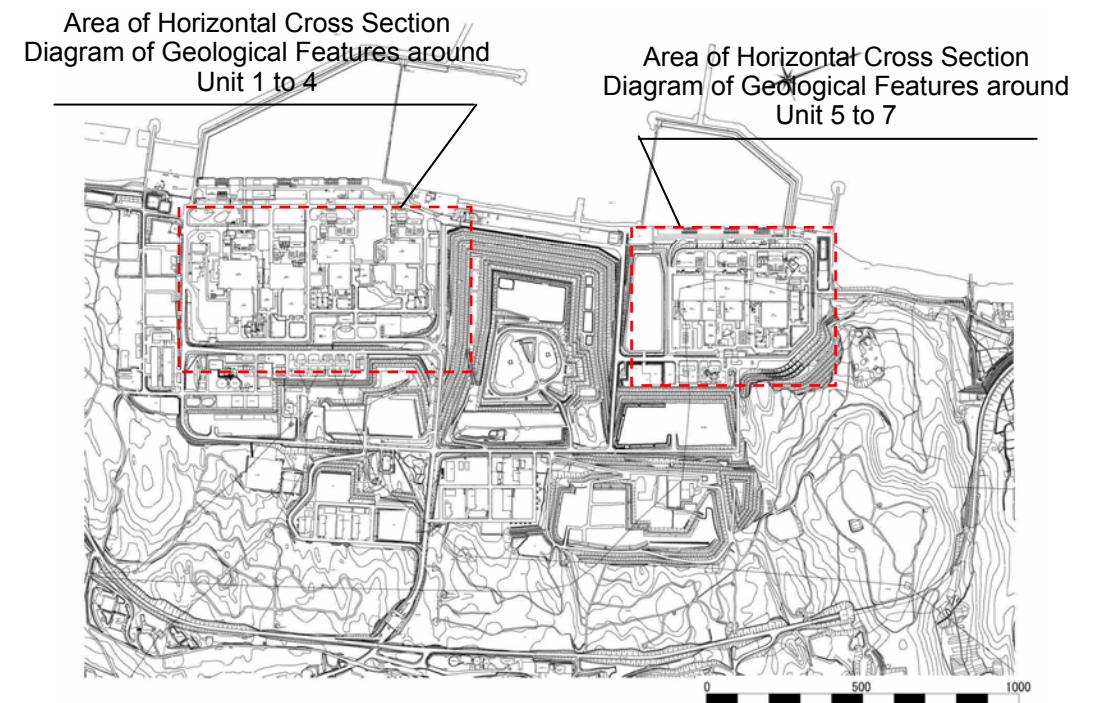
No.	Name	Reason which Denies Activeness of the Fault	Remark
	α · β Faults	The fault exists in only the low angle small fault in Yasuda layer. The fault does not extend to the upper part.	Table 9, Figure 3 and Attachment 14
	V System Fault	There is no displacement in the boundary between Yasuda layer and Nishiyama layer. The fault does not extend to Yasuda layer.	Table 9, Figure 3 and Attachment 15
	F System Fault	The fault gives some displacement in the upper face of Nishiyama layer. However, the displacement disappears when it comes in Yasuda layer. F system fault and V system fault are crossed each other.	Table 9, Figure 3 and Attachment 16

• Fault	It is a land sliding fault and there is no displacement in the boundary between Yasuda layer and Nishiyama layer. The fault does not extend to Yasuda layer.	Table 9, Figure 3 and Attachment 17
	L ₁ · L ₂ Fault	The fault does not extend to Yasuda layer.	Table 9, Figure 3 and Attachment 18

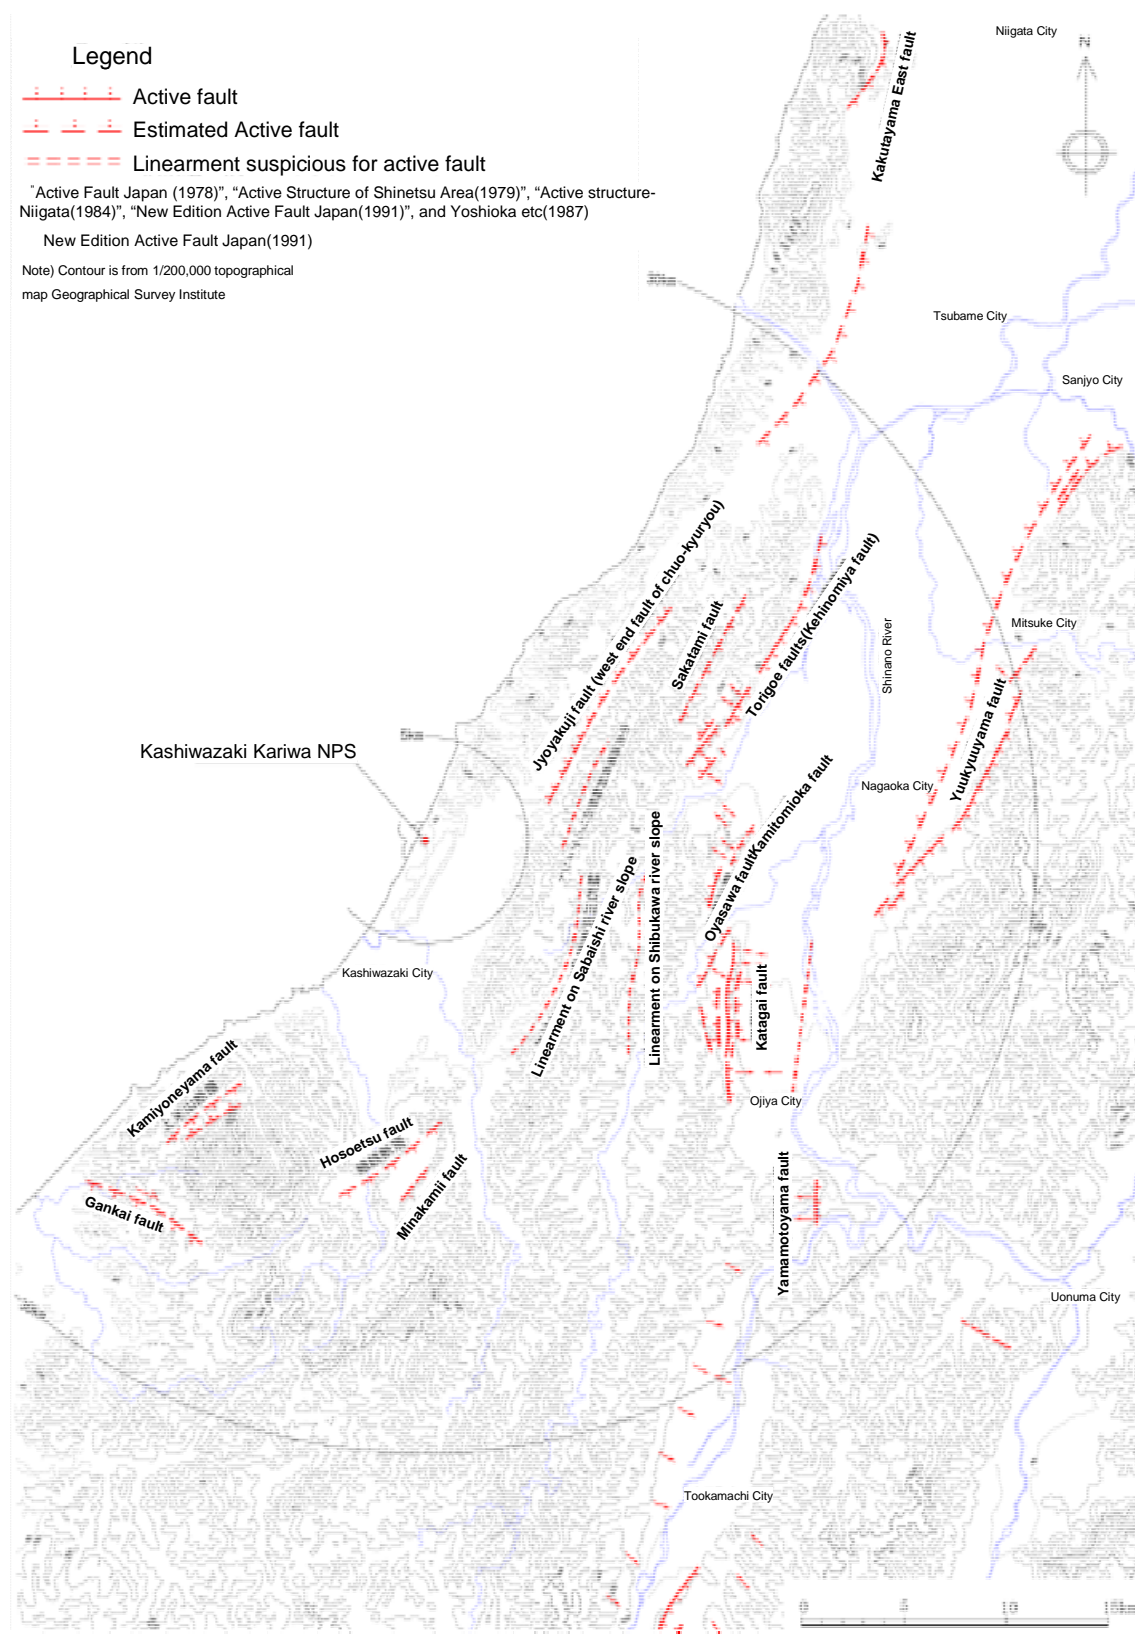
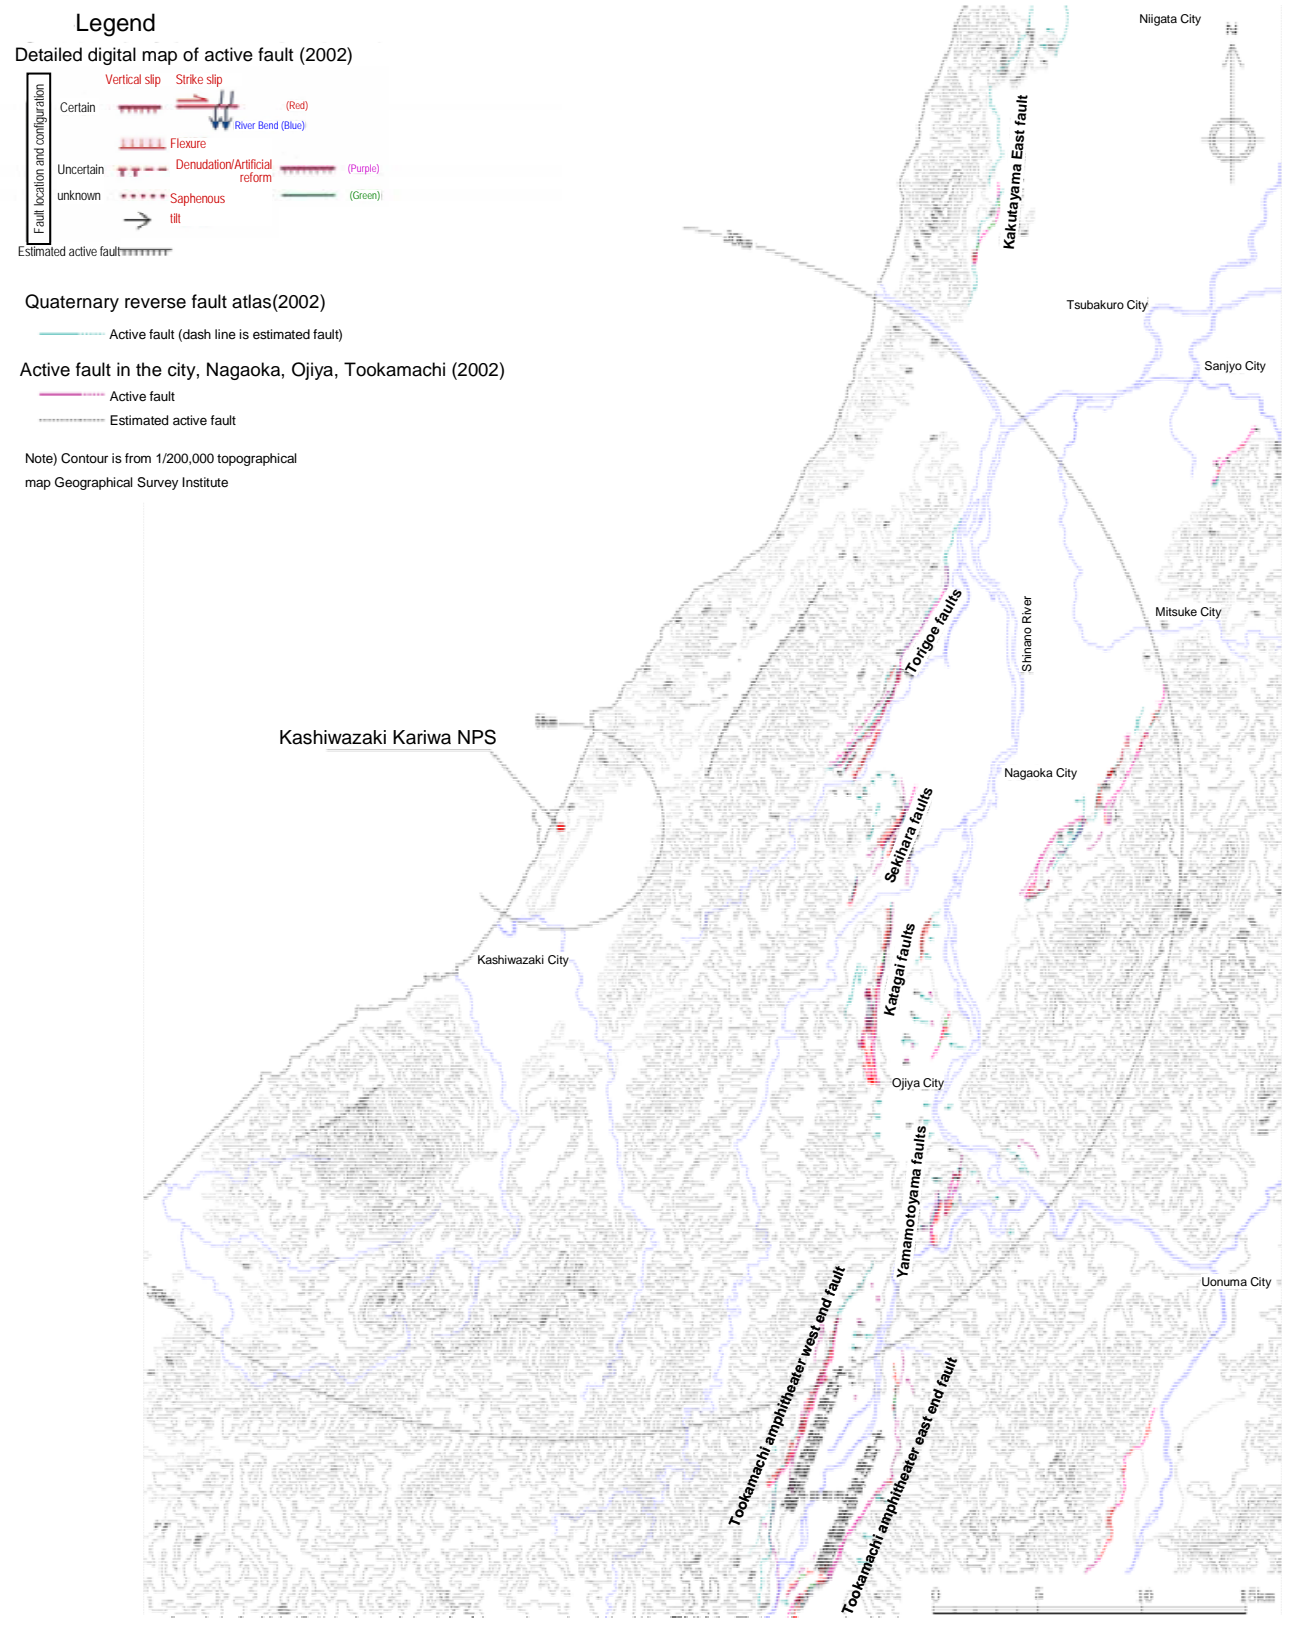
Appendix Figure 12-1 Active Fault Distribution Map of Neighboring Terrestrial Area according to Literature

Items	Research Method	Research Results	Remarks
Literature search	—	[New] Active Faults in Japan (1991): Length: Approx. 7km, Likelihood: □, Activity: Class B	Attachment 1 Figure 12 - 1
		Detailed Digital Maps of Active Faults (2002) : N/A	
		Active Structure Map- Niigata (1984) : N/A	
Geomorphological Research	Aerial Photographic Interpretation	Lineament□ : Length Approx. 2, Direction: NE-SW, Category: L _C · L _D	Attachment Figure 12 - 2
Surficial geology research	Ground Surface Exploration	- A part of lineament is erosive. - North-western upper flexure structure on the Haizume layer is identified In the south-east side of the fault shown in the literature. However, the Kume layer widely distributing on the ground surface with the same structure has almost flat structure.	Attachment Table 12
Comprehensive evaluation	<p>A part of lineament is erosive.</p> <p>North-western upper flexure structure on the Haizume layer is identified in the south-east side of the fault shown in the literature. However, the Kume layer widely distributing on the ground surface with the same structure has almost flat structure.</p> <p>It is judged from the above that it has not been active at least after the sedimentation of the Kume layer.</p>

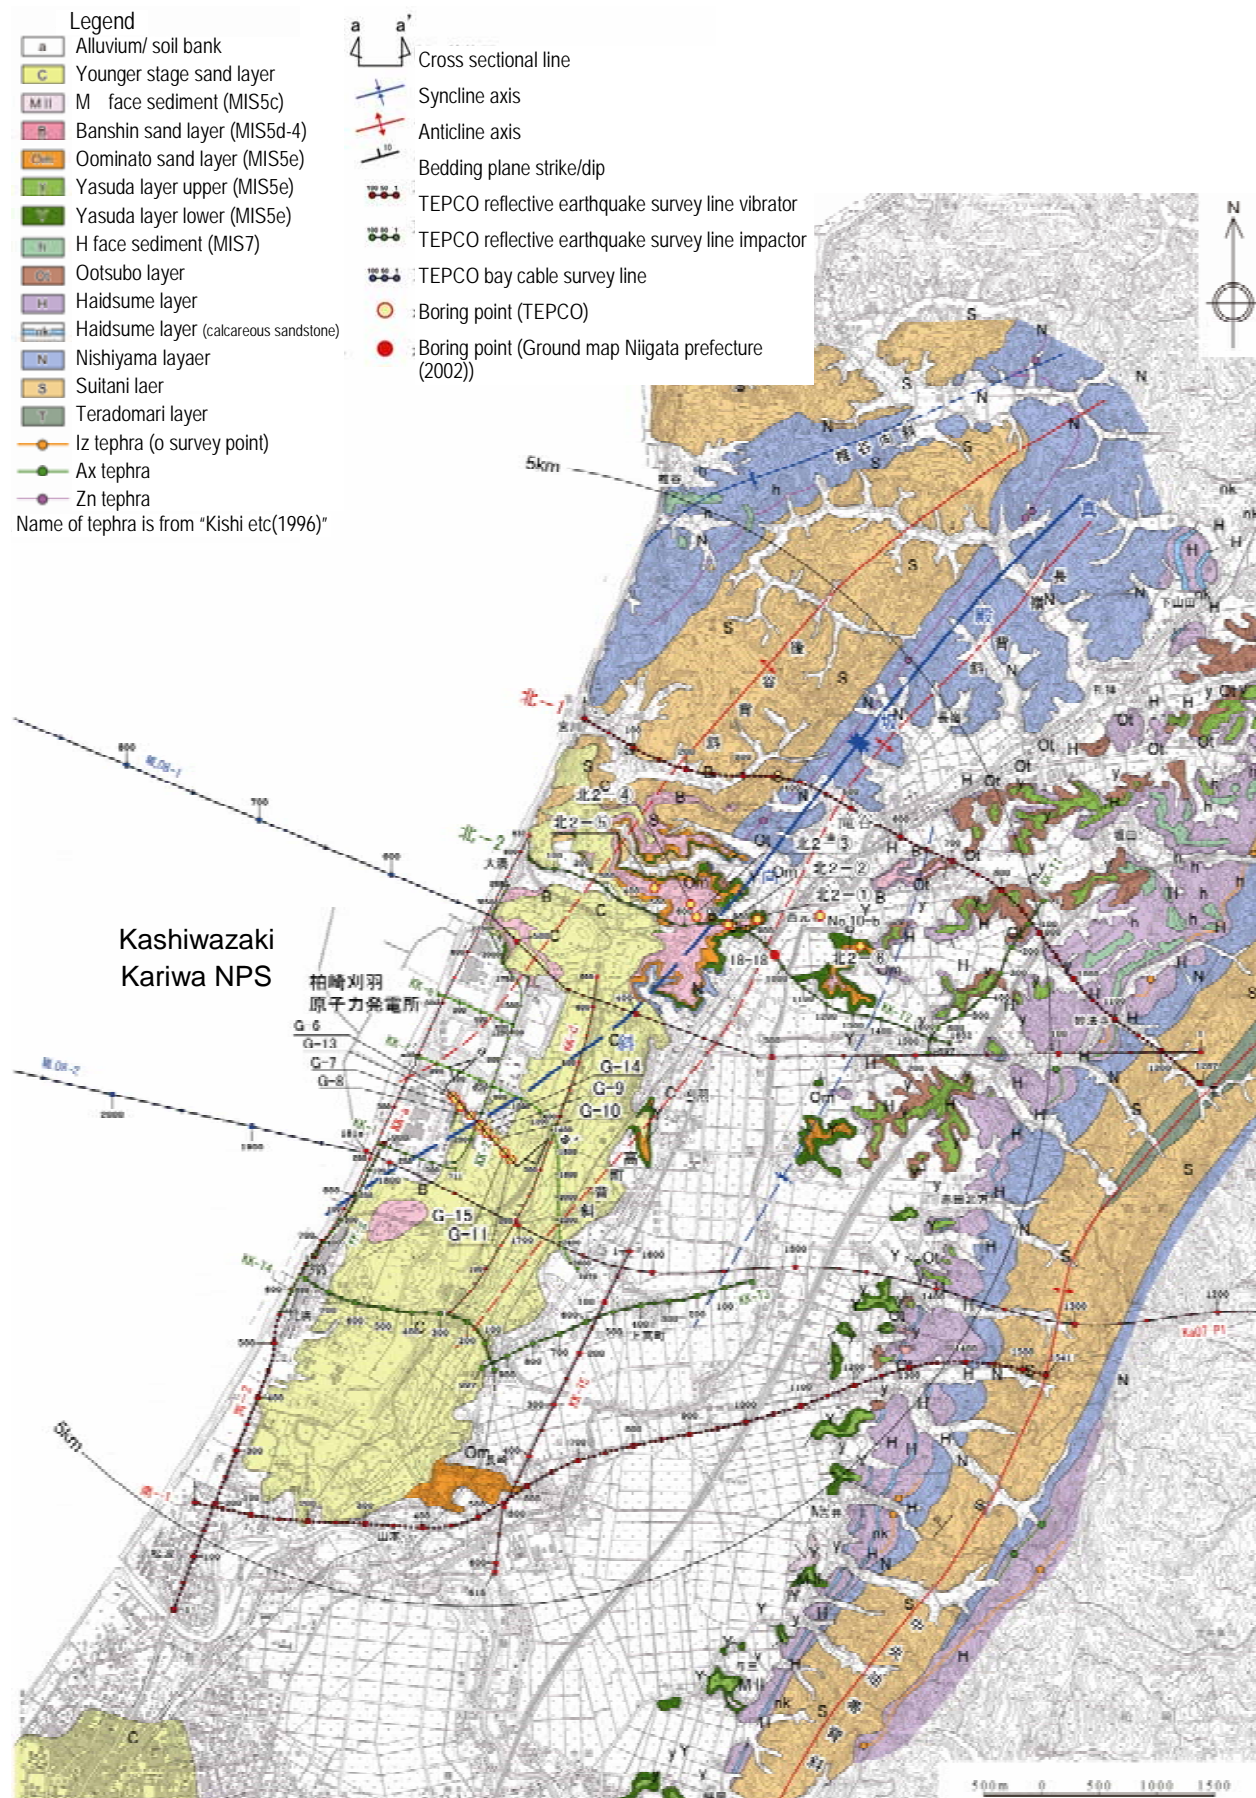
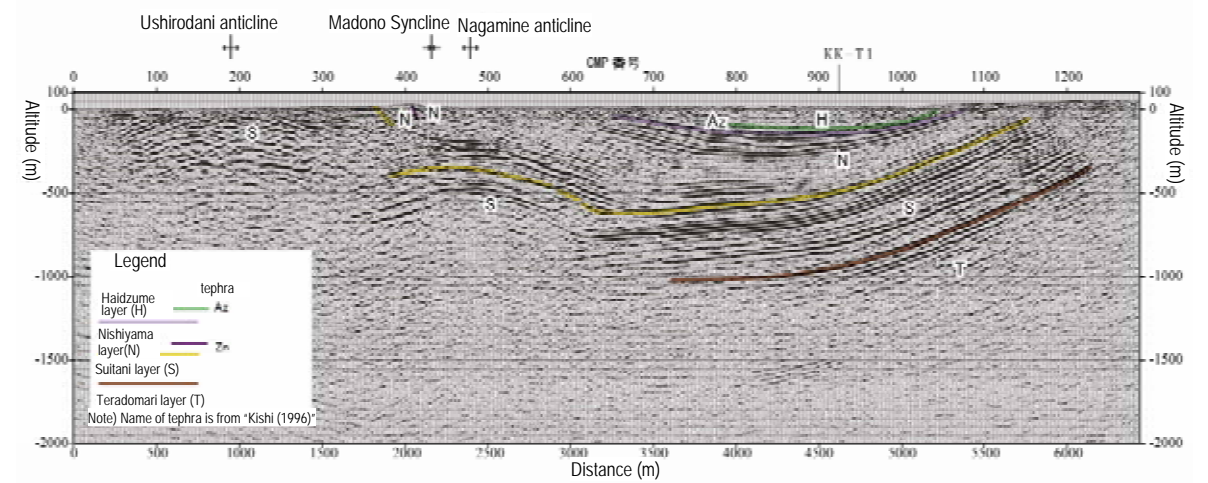
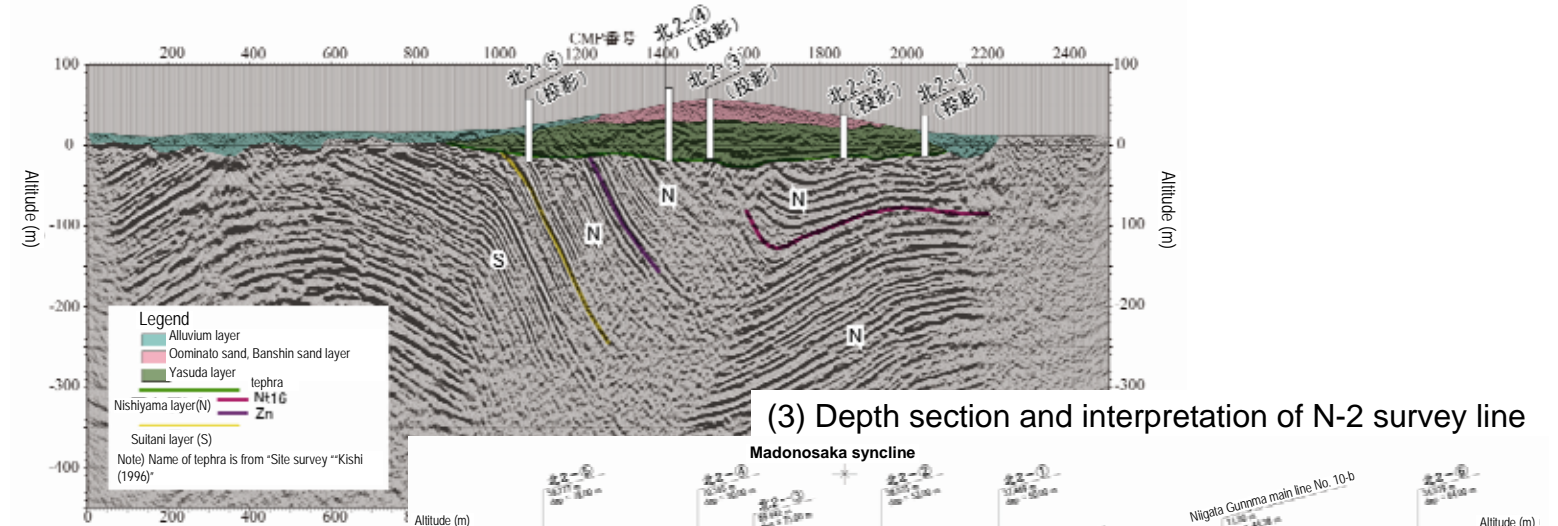
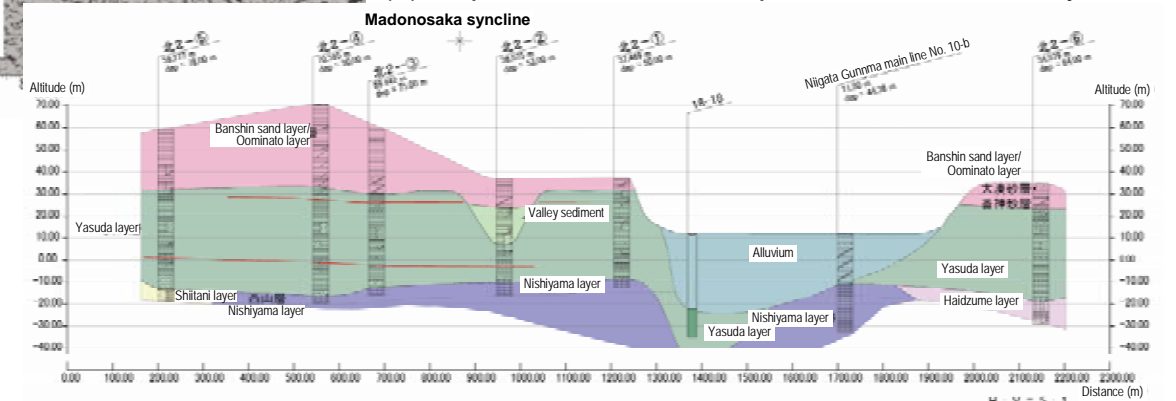
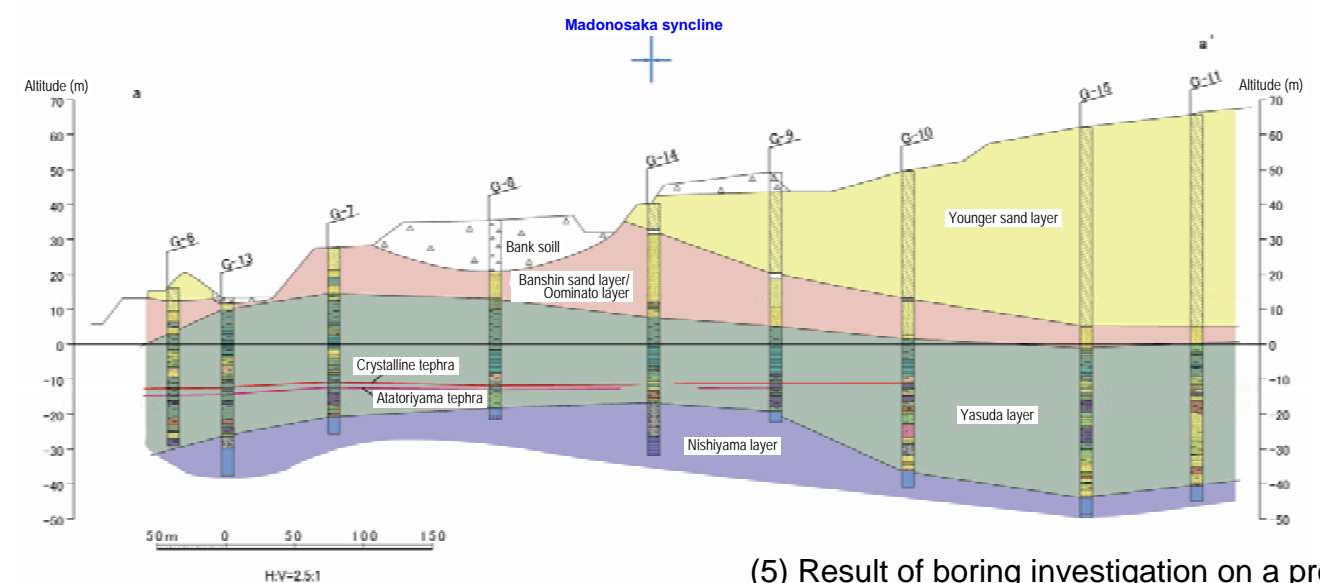
Appendix Figure 13-3 Investigation Result of Madonosaka Syncline

Items	Research Method	Research Results	Remarks
Literature search	—	[New] Active Faults in Japan (1991) : N/A	Attachment Figure 12 - 1
		Detailed Digital Maps of Active Faults (2002) : N/A	
		Active Structure Map- Niigata (1984) : N/A	
		Komatsu, Watanabe (1968) : West-upper Reverse fault of the frame of the Madonosaka syncline (No mention of the length)	
Geomorphological Research	Aerial Photographic Interpretation	Lineament: N/A	Attachment Figure 13-1
	geomorphic analysis by DEM	No relation between flexure structure (syncline and anticline) and terrain	Attachment Figure 13-2
Surficial geology research	Ground Surface Exploration	There are north-western upper reverse fault in the Nishiyama layer and the Shiitani layer or asymmetrical syncline structure (the Madonosaka Syncline) whose geological layer of the frame I steep slope.	Attachment Table 13 Attachment Figure 13-3
Geophysical research	Seismic exploration by reflection method

Surficial geology research	Drilling survey	The Yasuda layer unconformably covering the Madonosaka syncline, layers' boundaries of the Ominato sand layer, etc., the Atatorihama Tephra narrowly existing in the Yasuda layer has slight slope toward the east. However, they accumulated almost horizontally and do not have deformation according to flexure structure before the Nishiyama layer or other old layers.	
Comprehensive evaluation	<p>The Nishiyama layer and the Shiitani layer have asymmetrical syncline structure (the Madonosaka Syncline) of steep slope, however the tephra layer narrowly existing in the Yasuda layer and the Ominato sand layer, which unconformably cover the syncline, do not have deformation.</p> <p>north-western upper reverse fault in the Nishiyama layer and the Shiitani layer or asymmetrical syncline structure (the Madonosaka Synclin</p> <p>It is judged from the above that asymmetrical syncline structure which the Madonosaka is estimated to have has not been active at least after the sedimentation of the Yasuda layer.</p>

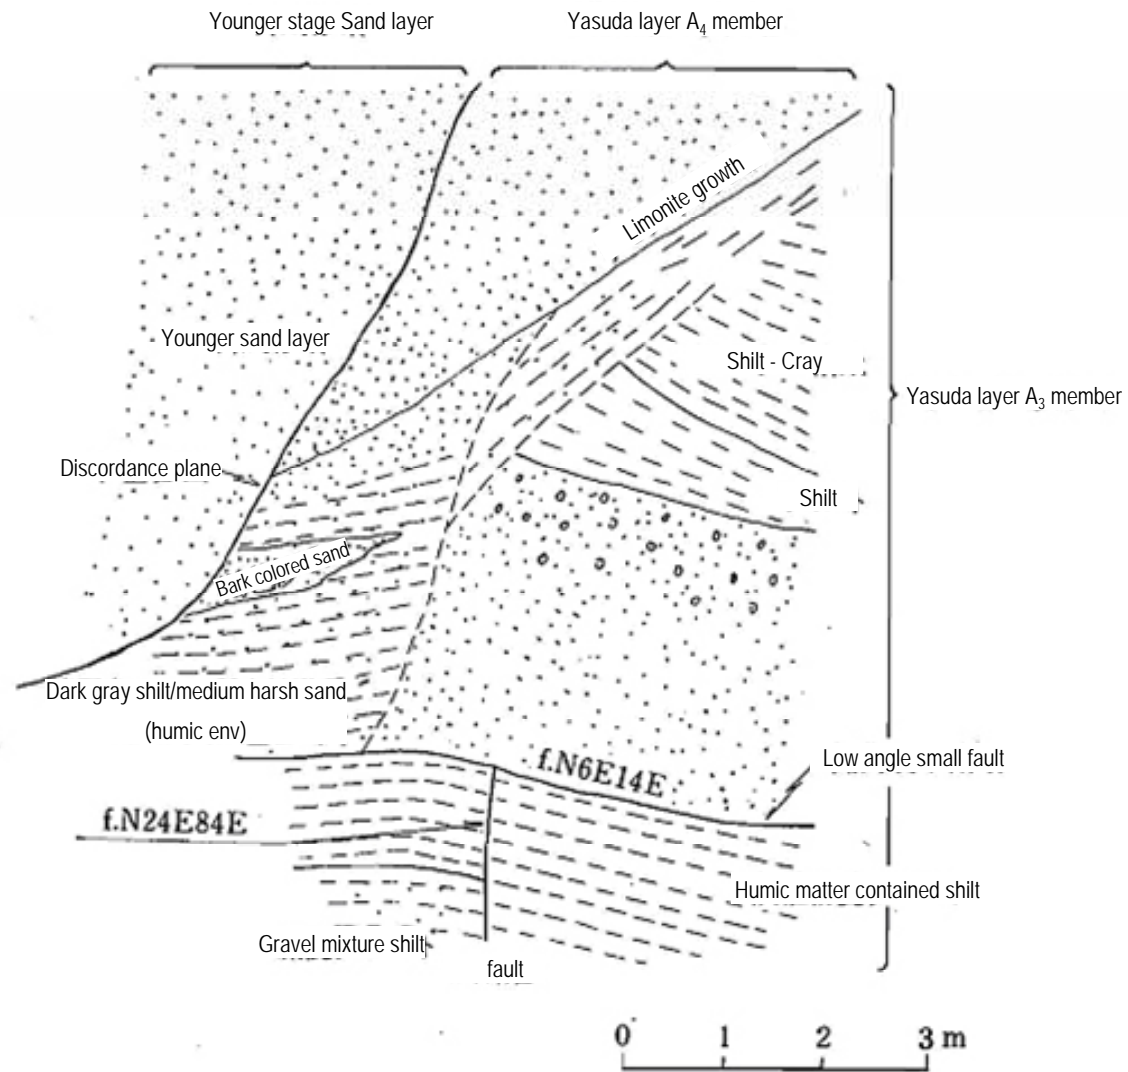
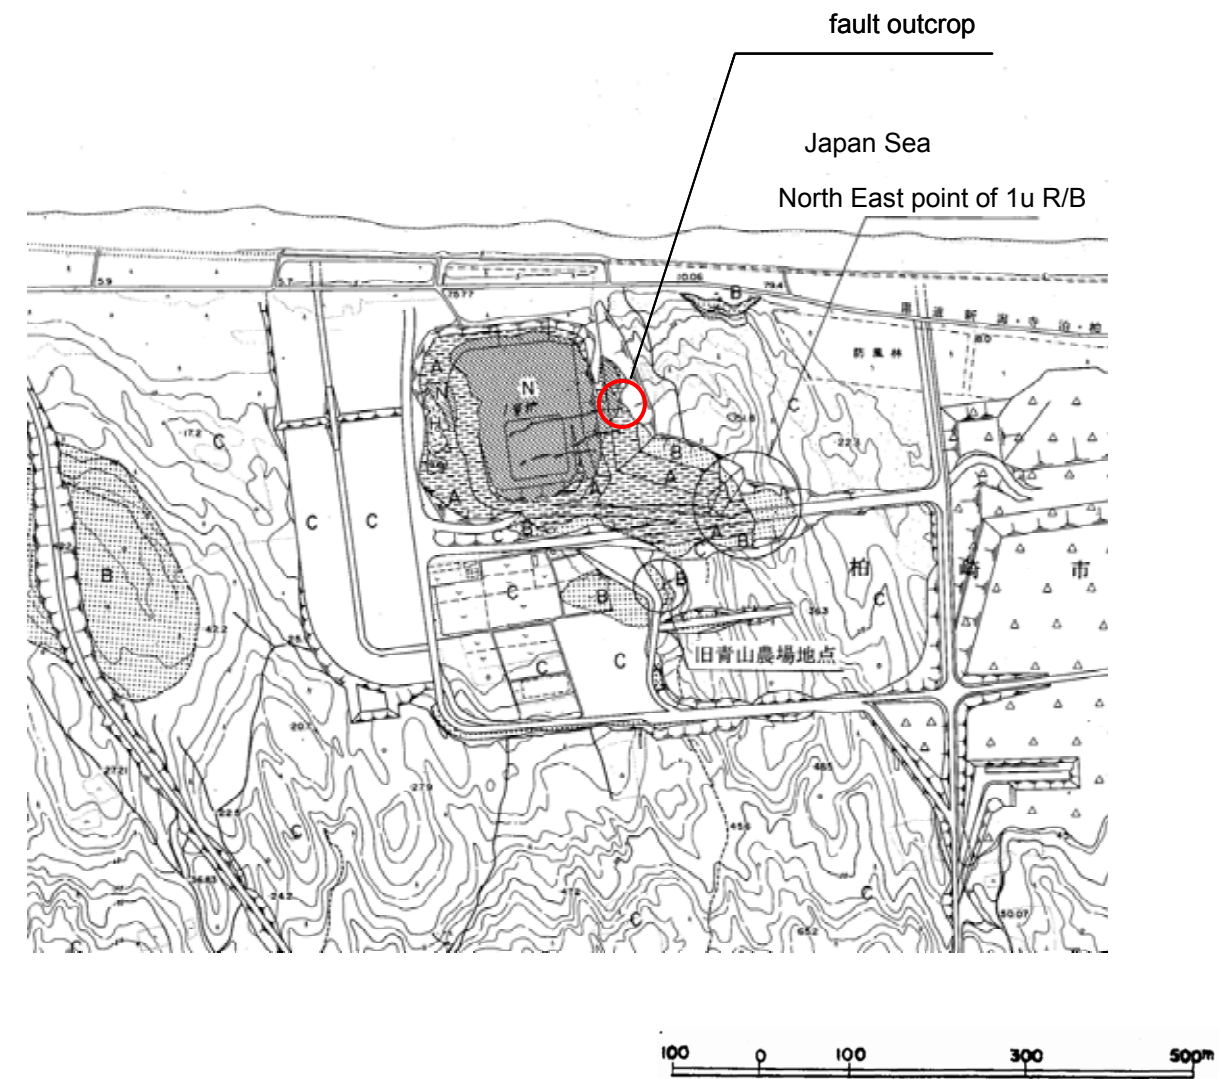
(1) Outcrop Sketch of α Fault (Northern developed slope of Unit 1 Reactor)

Survey Item	Survey Method	Survey Result	Remarks
Bibliographic Survey	—	Fault Description : N/A	
Geomorphological Survey	Aerial Photograph Interpretation	Lineament : N/A	
Ground Surface Geological Survey	Ground Surface Exploration	Fault Outcrop : N/A	
Developed Slope Survey	Slope Geological Observation	Stopped at low angle fault of Yasuda Layer, no upper continuation	Attachment Drawing 14-1 Attachment Drawing 14-2
Vertical Shaft Survey	Shaft Wall Geological Observation	On β fault, no slip in the crushed stone or asphalt of the temporary yard for construction at the time of Chuetsu Oki earthquake	Attachment Drawing 14-3
General Evaluation	<p>α fault is stopped at low angle fault of Yasuda Layer and no upper continuation is recognized, so we evaluated that at least there is no activity after the deposition of Yasuda Layer.</p> <p>β fault is stopped at low angle fault of Yasuda Layer and no upper continuation is recognized, so we evaluated that at least there is no activity after the deposition of Yasuda Layer.</p>

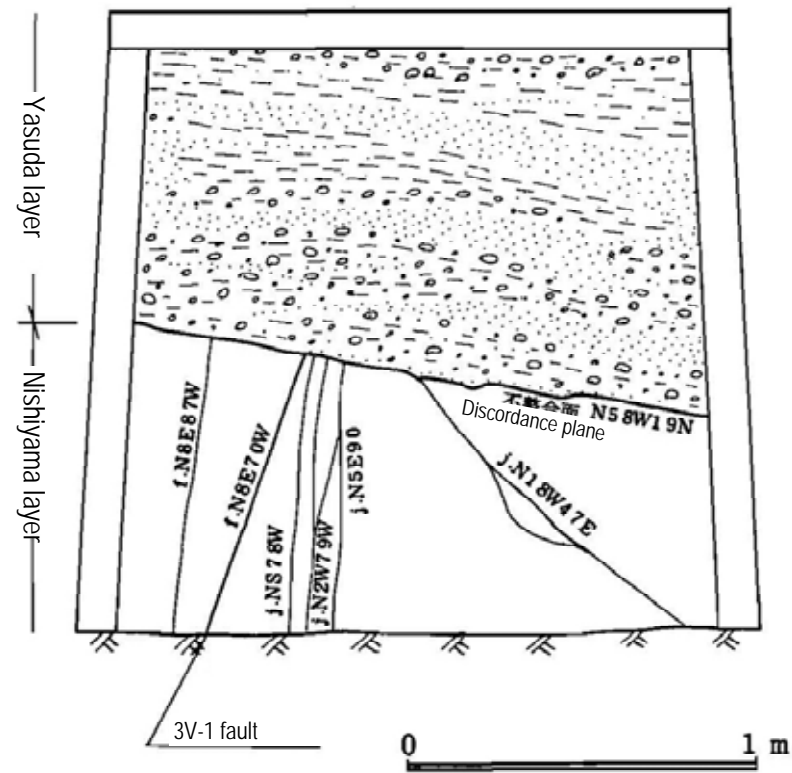
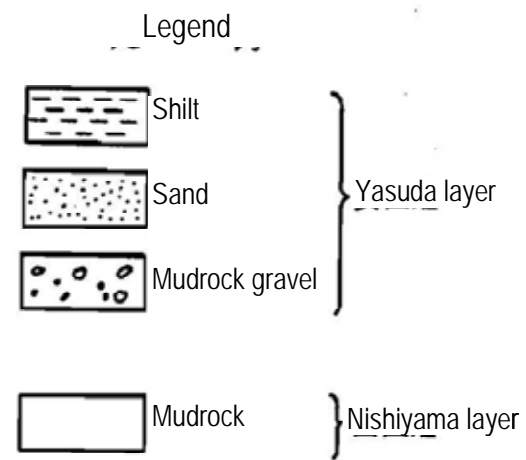
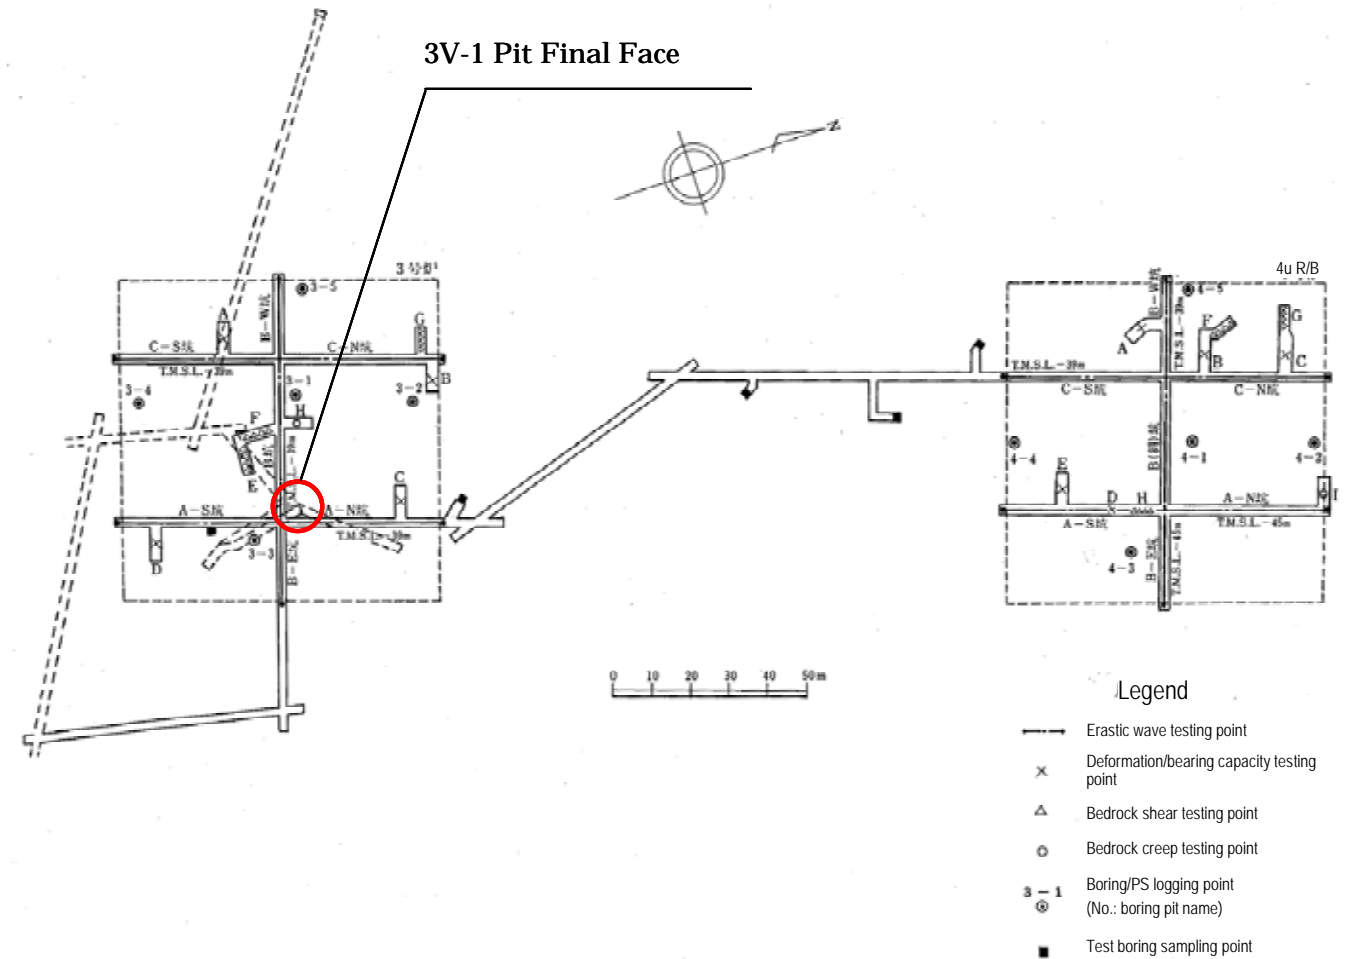
Attachment drawing 15-1: Result of Test Pit Survey of 3V-1 Fault

Survey Item	Survey Method	Survey Result	Remarks
Bibliographic Survey	—	Fault Description : N/A	
Geomorphological Survey	Aerial Photographic Interpretation	Lineament : N/A	
Ground Surface Geological Survey	Ground Surface Exploration	Fault Outcrop : N/A	
Test Pit Survey	Test Pit Geological Observation	As the result of the survey on 3V-1 and V ₂ layers where they have relatively wider fracture surface and greater drop, there is no displacement at the boundary face between Yasuda layer and Nishiyama Layer, and no continuation in Yasuda Layer.	Attachment Drawing 15-1 Attachment Drawing 15-2
Vertical Shaft Survey	Vertical Shaft Wall Geological Observation	There is no displacement at macadam and asphalt in temporary yard for construction even at the time of Chuetsu Oki Earthquake.	Attachment 15-3
Comprehensive Evaluation	<p>3V-1Fault has no displacement at the boundary face between Yasuda and Nishiyama Layer, and no continuation in Yasuda Layer.</p> <p>V₂ Fault has no displacement at the boundary face between Yasuda and Nishiyama Layer, and no continuation in Yasuda Layer.</p> <p>From the above, we evaluated that at least there is no activity of V Faults after the deposition of Yasuda Layer.</p>
