Table 7 Evaluation of Faults which does not Consider in the Anti-earthquake Design (faults around the site)

Kashiwazaki Kariwa Nuclear Power Station

Figure 3 Distribution Map of Fault within the site

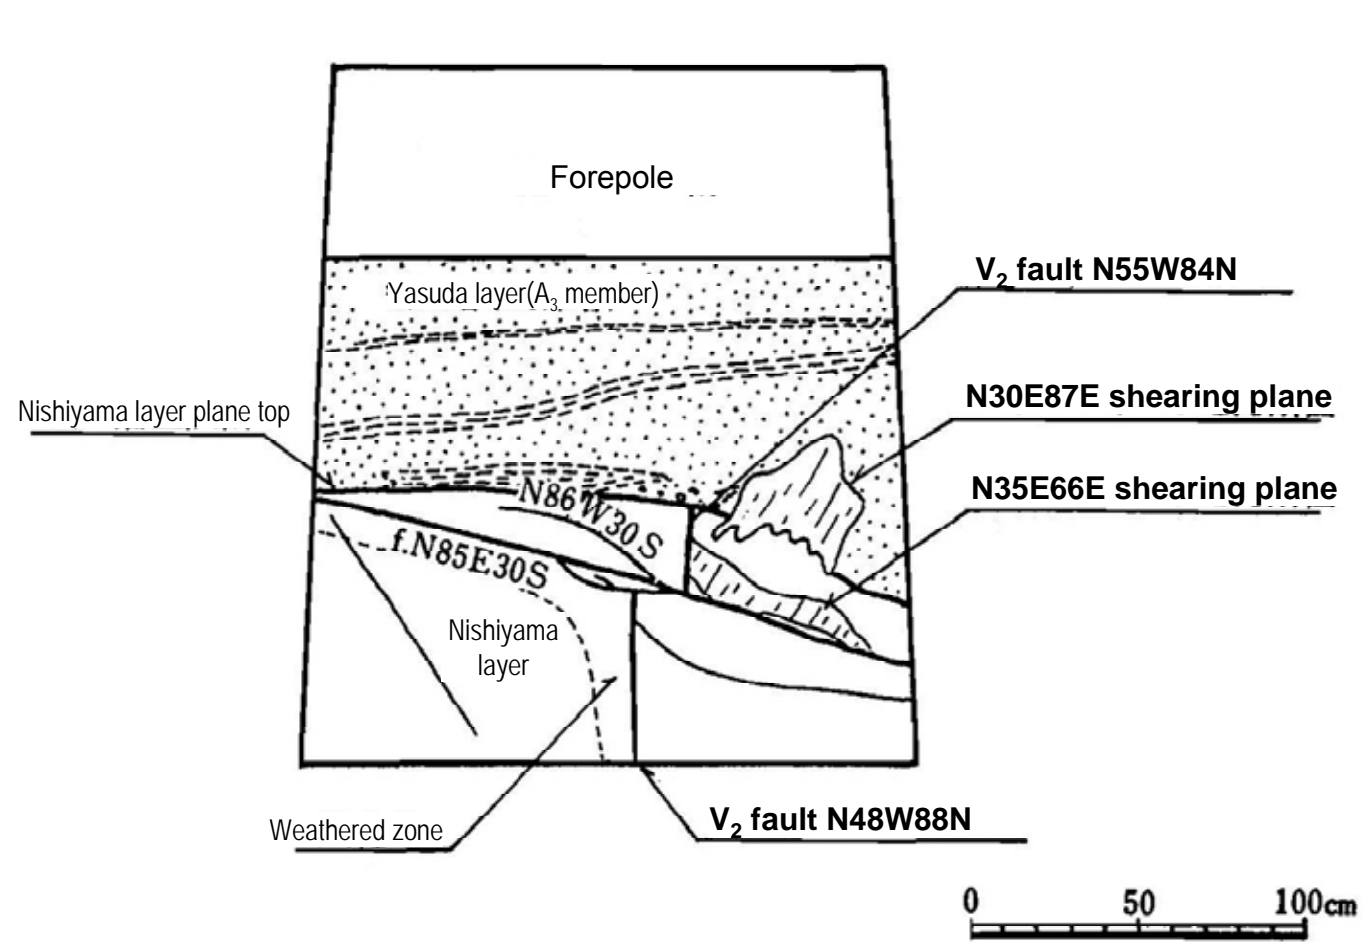
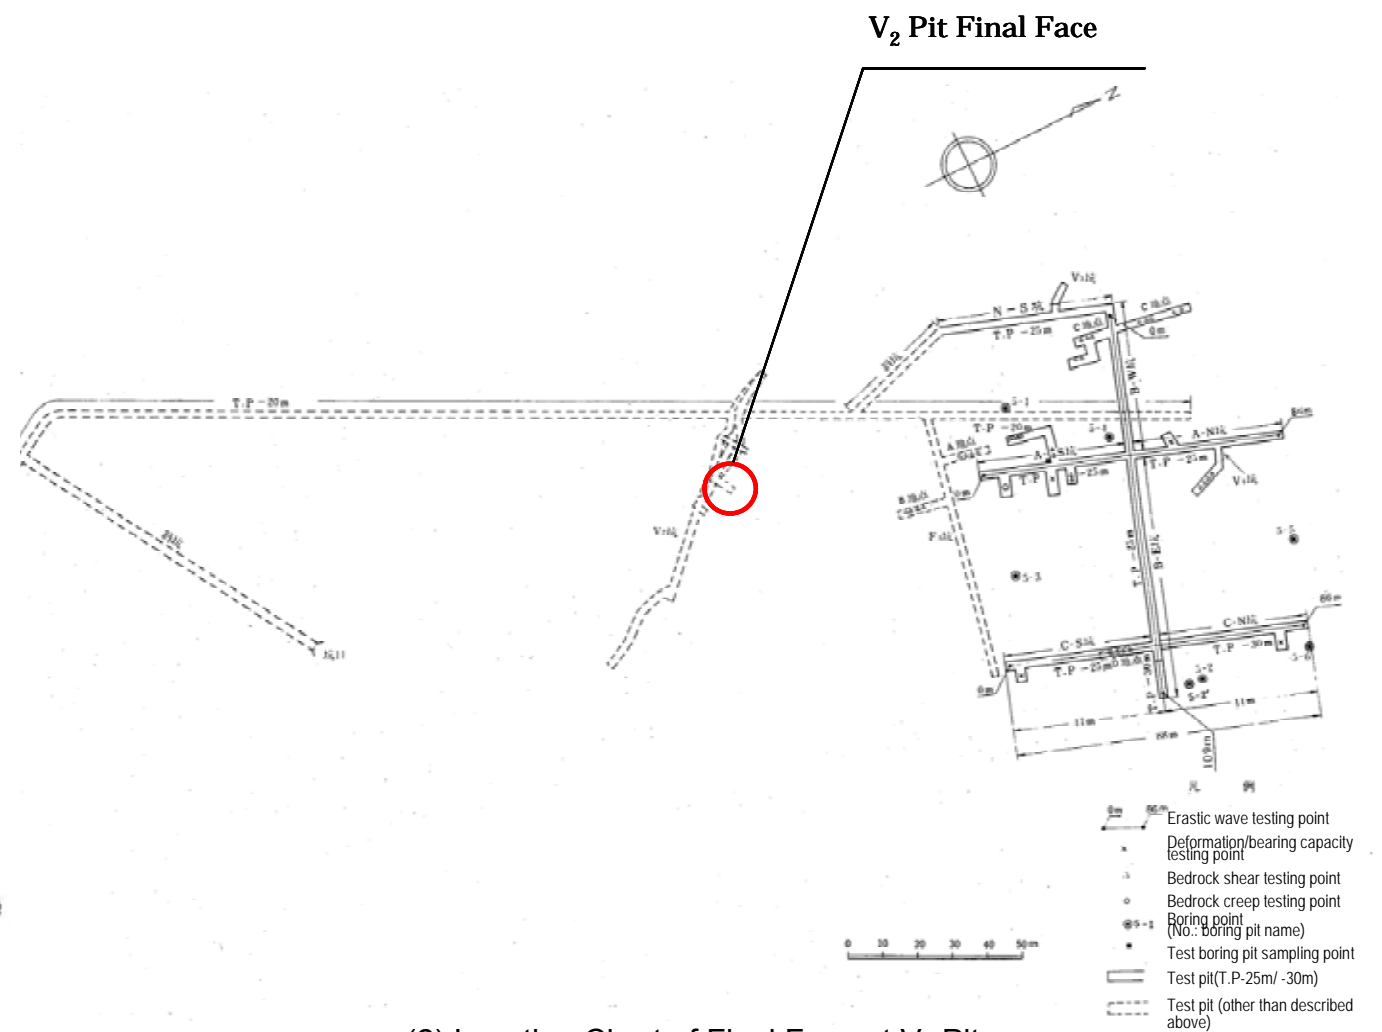
Attachment 15-2: Result of Test Pit Survey of V₂ Fault

Survey Item	Survey Method	Survey Result	Remarks
Bibliographic Survey	—	Fault Description : N/A	
Geomorphological Survey	Aerial Photographic Interpretation	Lineament : N/A	
Ground Surface Geological Survey	Ground Surface Exploration	Fault Outcrop : N/A	
Test Pit Survey	Test Pit Geological Observation	As the result of the survey on 3V-1 and V ₂ layers where they have relatively wider fracture surface and greater drop, there is no displacement at the boundary face between Yasuda layer and Nishiyama Layer, and no continuation in Yasuda Layer.	Attachment Drawing 15-1 Attachment Drawing 15-2
Vertical Shaft Survey	Vertical Shaft Wall Geological Observation	There is no displacement at macadam and asphalt in temporary yard for construction even at the time of Chuetsu Oki Earthquake.	Attachment 15-3
Comprehensive Evaluation	<p>3V-1Fault has no displacement at the boundary face between Yasuda and Nishiyama Layer, and no continuation in Yasuda Layer.</p> <p>V₂ Fault has no displacement at the boundary face between Yasuda and Nishiyama Layer, and no continuation in Yasuda Layer.</p> <p>From the above, we evaluated that at least there is no activity of V Faults after the deposition of Yasuda Layer.</p>

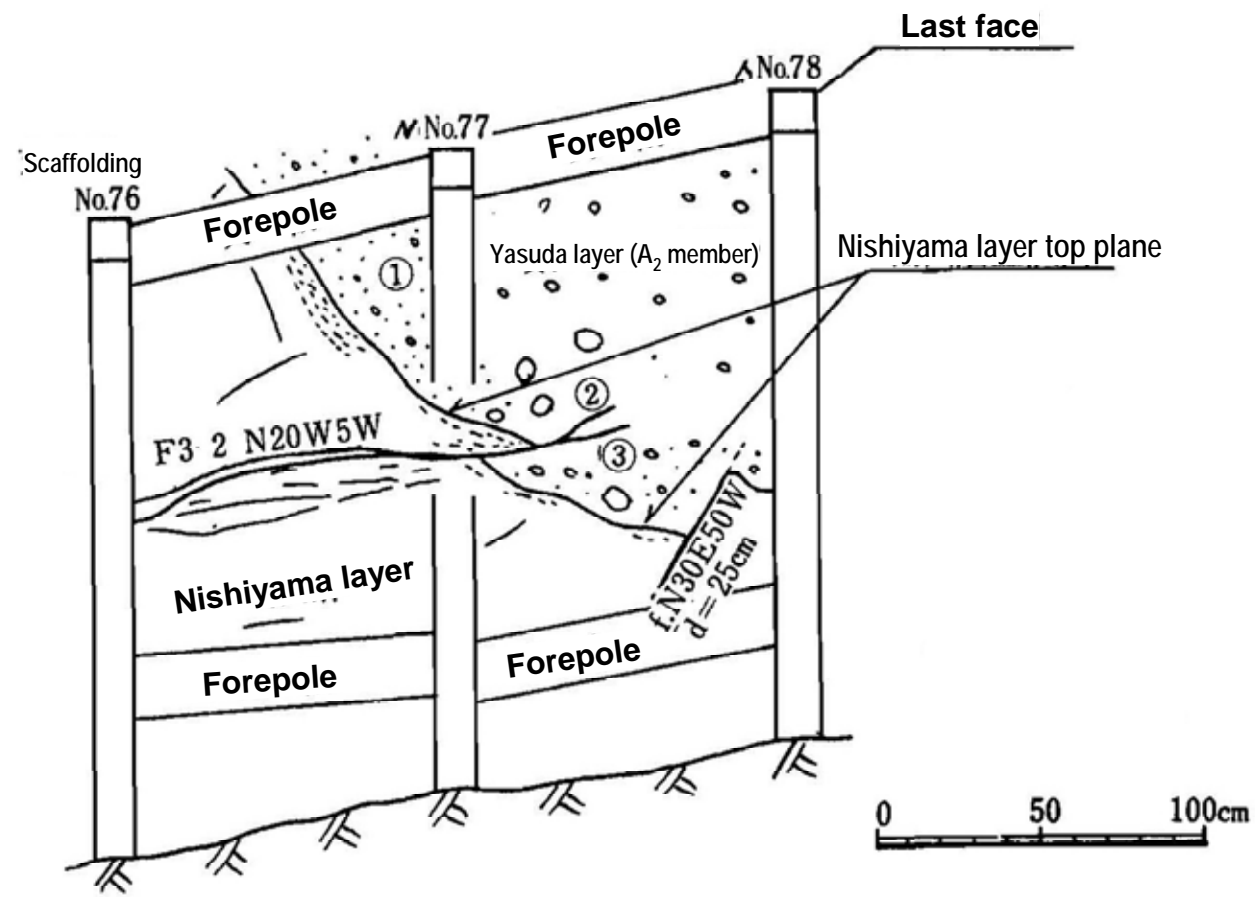
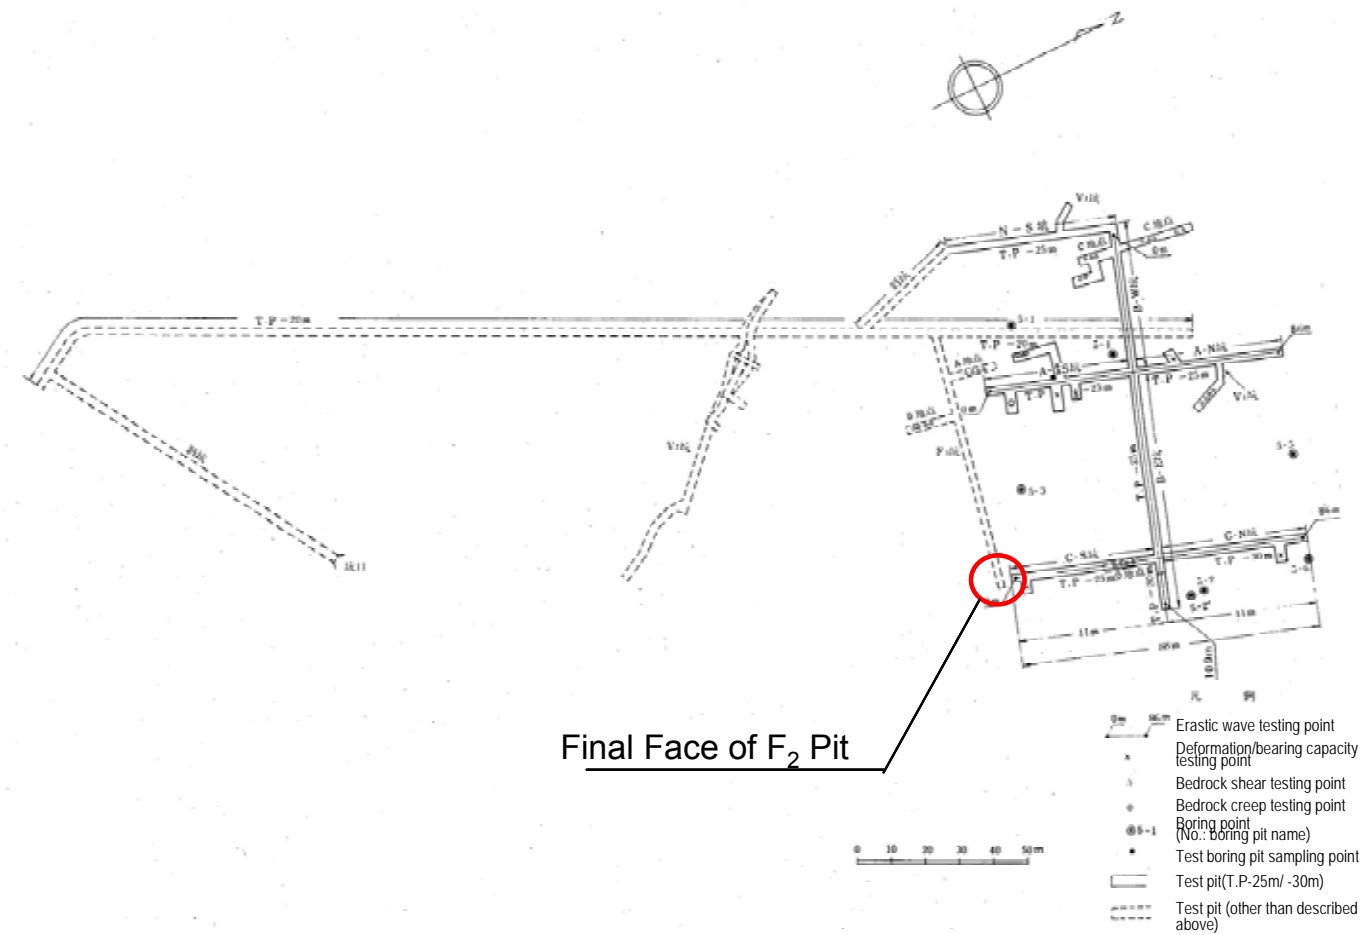
Attachment Drawing 16-1: Result of Test Pit Survey of F₃ Fault

Survey Item	Survey Method	Survey Result	Remarks
Bibliographic Survey	—	Fault Description : N/A	
Geomorphological Survey	Aerial Photographic Interpretation	Lineament : N/A	
Ground Surface Geological Survey	Ground Surface Exploration	Fault Outcrop : N/A	
Test Pit Survey	Test Pit Geological Observation	As a result of survey on F ₂ Layer where there is relatively large scale and continuity, it is observed that there is a displacement at the upper end of Nishiyama Layer, however, the displacement is disappeared soon in Yasuda Layer, and the F ₂ Fault and V ₂ Fault are connected with intercepting each other.	Attachment Drawing 16-1 Attachment Drawing 16-2
Vertical Shaft Survey	Vertical Shaft Wall Geological Observation	F ₃ Fault has no displacement in Yasuda Layer even when Chuetsu Oki Earthquake.	Attachment Drawing 16-3
Comprehensive Evaluation	<p>F₃ Fault has a displacement at the upper end of Nishiyama Layer, however, it is disappeared soon in Yasuda Layer.</p> <p>F₃ Fault and V₂ Fault are connected with interfering each other. F₂ Fault was formulated at the almost same time as when V₂ Fault was formulated.</p> <p>From the above, we evaluated that at least there is no activity of F Series Faults after the deposition of Yasuda Layer.</p>

- ① Mudrock gravel layer (Yasuda layer) includes sand in matrix
- ② N20W35W Without cray. Disappear after 20cm continuity.
- ③ N5W30W Without cray. Disappear after 20cm continuity.

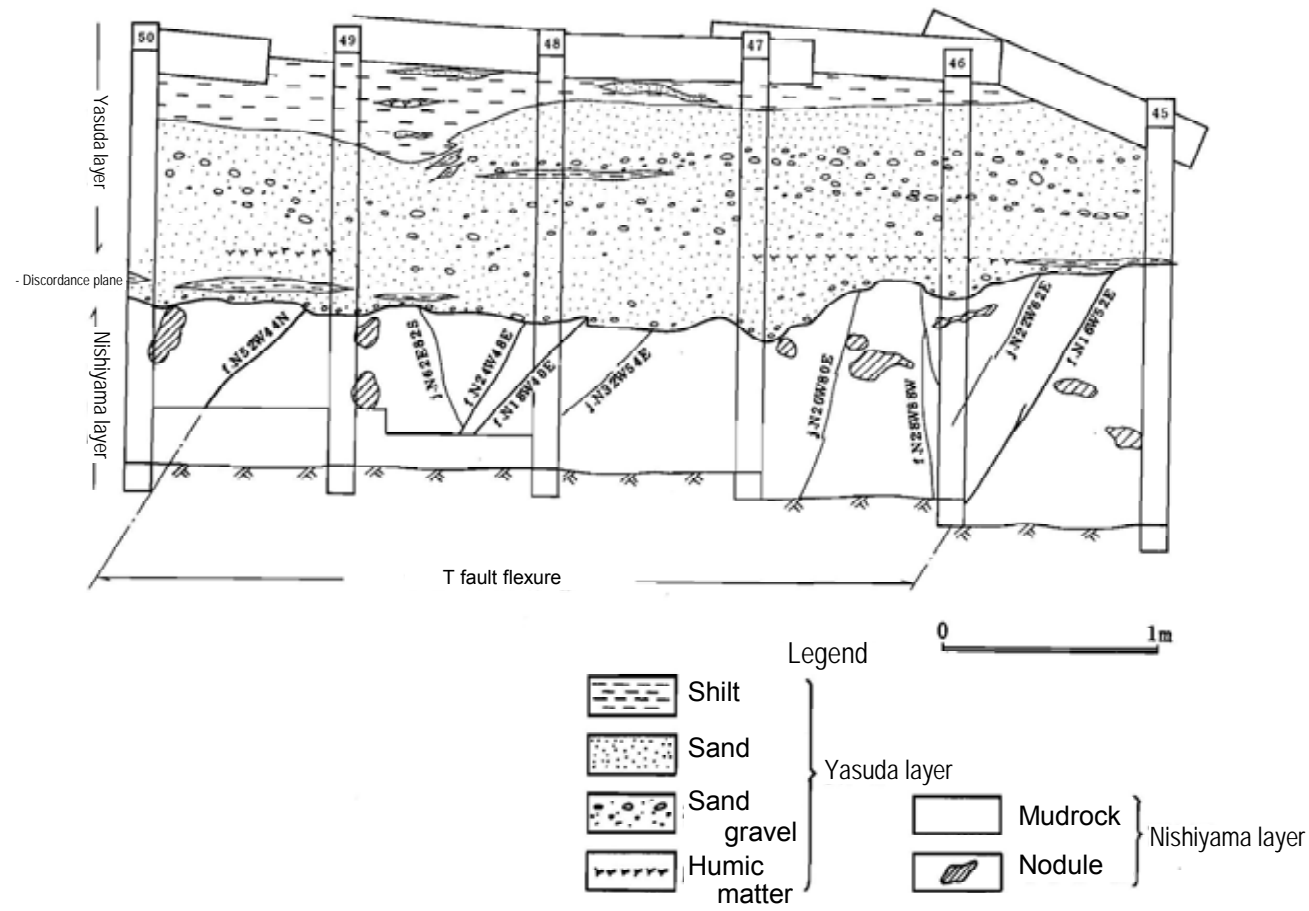
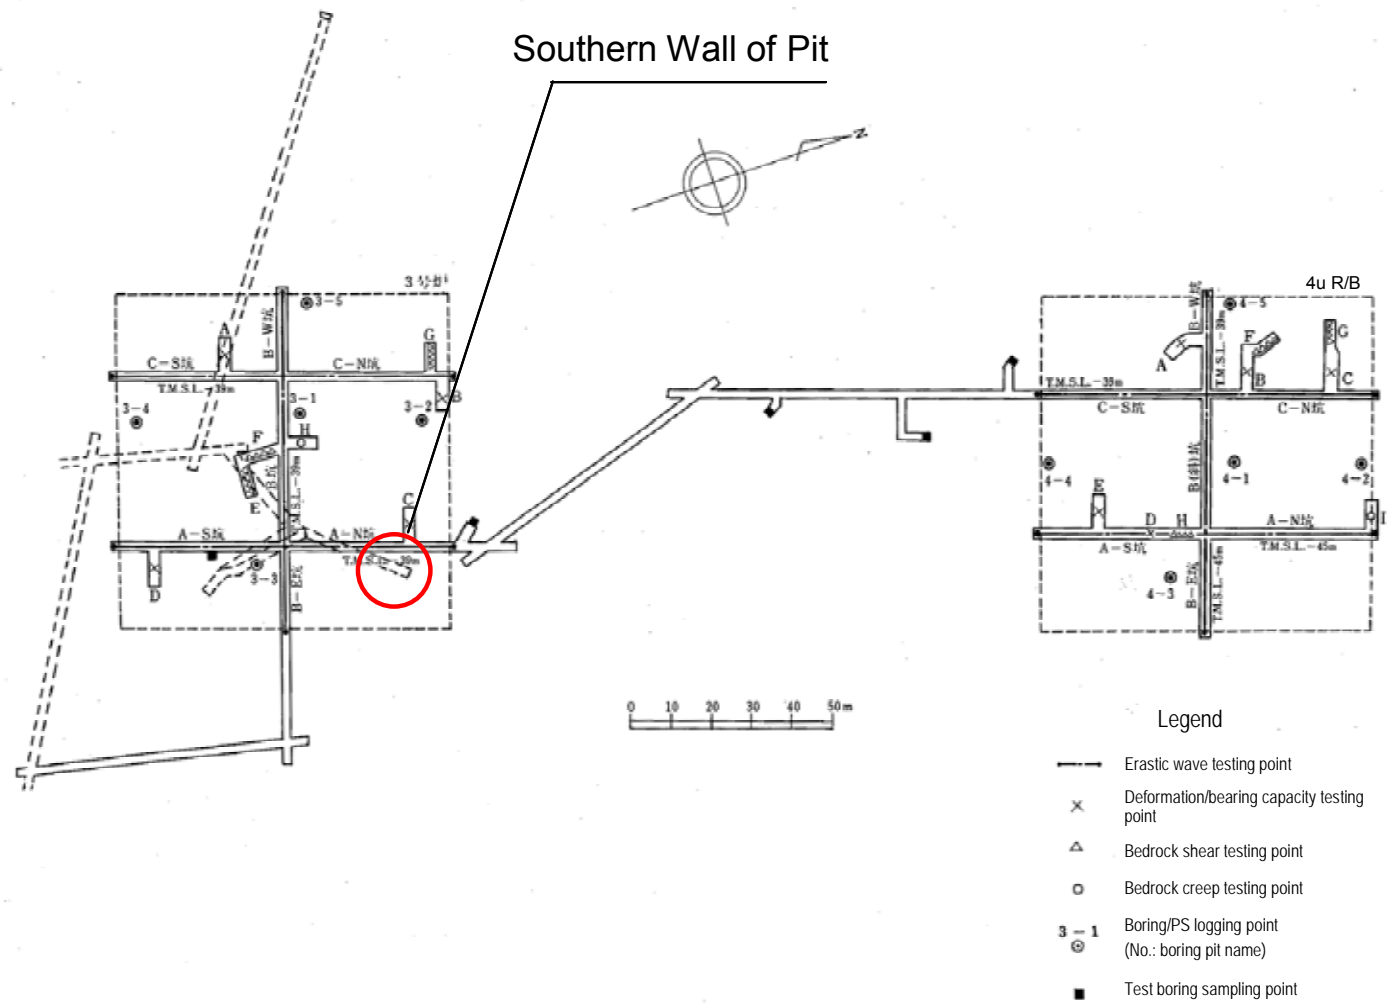
(1) Sketch of Southern Wall of Pit

Survey Item	Survey Method	Survey Result	Remarks
Bibliographic Survey	—	Fault Description : N/A	
Geomorphological Survey	Aerial Photographic Interpretation	Lineament : N/A	
Ground Surface Geological Survey	Ground Surface Exploration	Fault Outcrop : N/A	
Test Pit Survey	Test Pit Geological Observation	As the result of the survey on Fault 1, the Fault has no displacement at the boundary face between Yasuda and Nishiyama Layers, and no continuation in Yasuda Layer.	Attachment Drawing 17
Boring Survey	Boring core observation	Fault 1 and Fault 2 are connecting faults where they show annular shape on the same plain.	
Comprehensive Evaluation	<p>Fault 1 and Fault 2 have characteristics of landslide and are connecting faults where they show annular shape on the same plain. Fault 1 has no displacement at the boundary face between Yasuda and Nishiyama Layers, and no continuation in Yasuda Layer. From the above, we evaluated that at least there is no activity of Fault 1 and Fault 2 after the deposition of Yasuda Layer.</p>

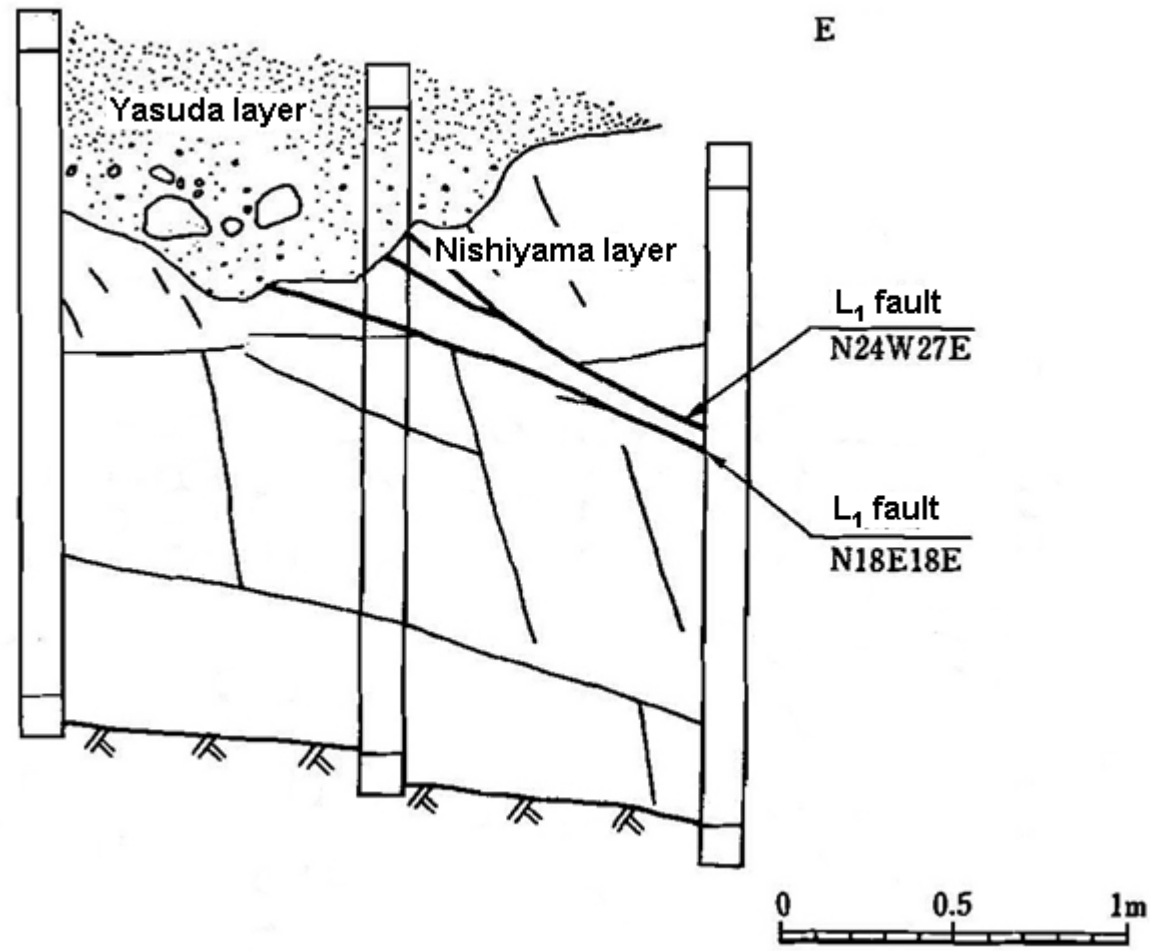
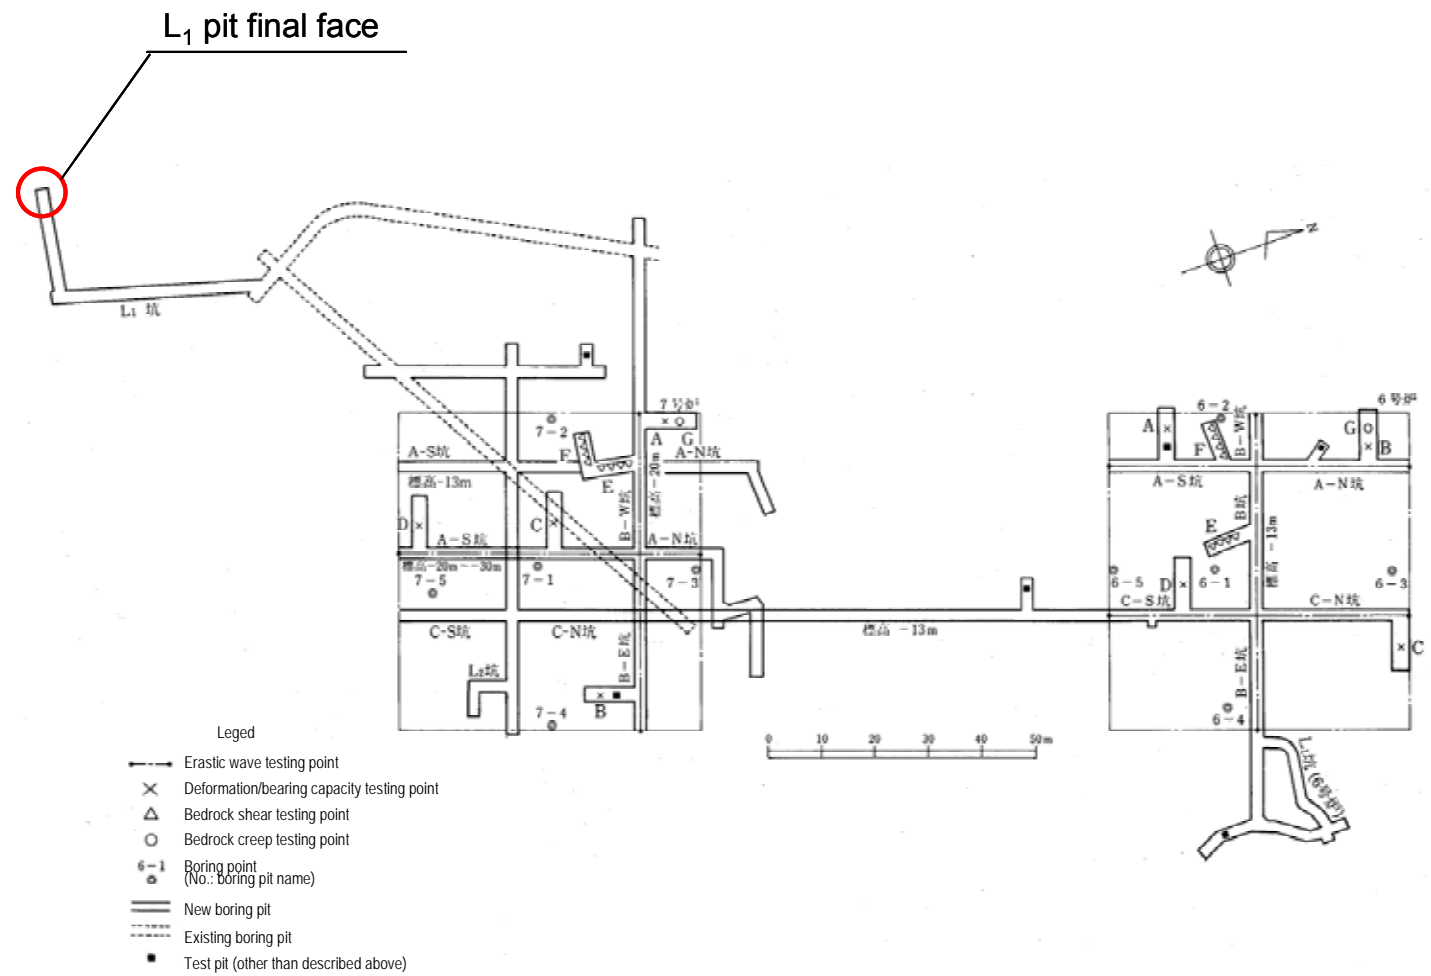
(1) Northern Wall Sketch of Final Face of L₁ Pit

Survey Item	Survey Method	Survey Result	Remarks
Bibliographic Survey	—	Fault Description : N/A	
Geomorphological Survey	Aerial Photographic Interpretation	Lineament : N/A	
Ground Surface Geological Survey	Ground Surface Exploration	Fault Outcrop : N/A	
Test Pit Survey	Test Pit Geological Observation	No Continuation in Yasuda Layer	Attachment Drawing 18 - 1 Attachment Drawing 18 - 2
Comprehensive Evaluation	L ₁ Fault has no continuation in Yasuda Layer L ₂ Fault has no continuation in Yasuda Layer From the above, we evaluated that at least there is no activity of L ₁ and L ₂ Faults after the deposition of Yasuda Layer.
