Implementation of necessary measures on fire prevention in relation to overhang-type high-voltage breakers at nuclear power stations (report)

June 2011

The Tokyo Electric Power Company, Incorporated

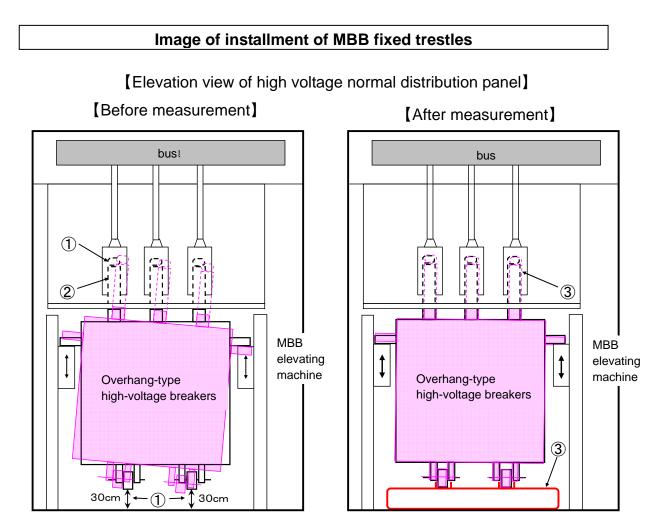
- ①MBBs with lower space (about 30cm over-hanged) is not fixed, and therefore is swung largely by earthquakes, and connected point is damaged.
- ②the heat from an arc discharged as a result of damage at connected point, caused the insulating coating of cables to torch fire, and damage the breaker (resulting in igniting fire)
- ③addition of fixed trestle at the lower space. This prevents MBBs from swinging in wide range, and prevents damage of connected point.

- a. we will install a fixed trestle at the lower space of the MBB, which will reduce the swing of MBB at earthquakes, and will endeavor to reduce the risk of fire.
- b. we will upgrade the breakers to transverse mounted vacuum circuit breakers (hereafter "VCB"), which has high quake resistance

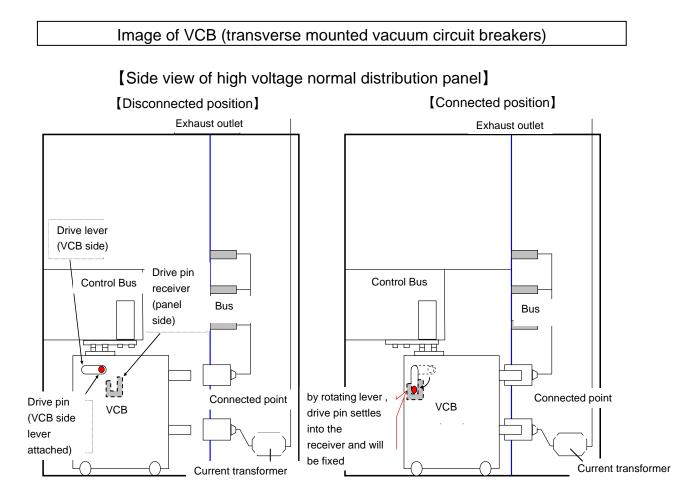
High voltage normal distribution panel, which uses vacuum circuit breakers (VCB), is transverse mounted, and by rotating drive lever on the VCB side, the attached drive pin settles into the drive pin receiver on the power panel side, and will be fixed at connected position.
