Outline of "Reports about the study regarding current earthquake-proof safety and reinforcement of reactor buildings at Fukushima Daiichi Nuclear Power Station (2)"

July 13, 2011

Tokyo Electric Power Company

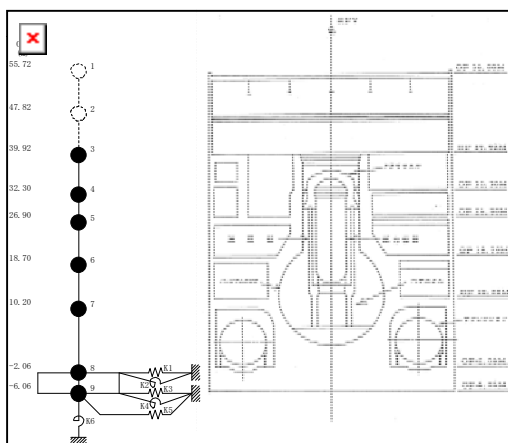
Fig 1. Reactor Building of Unit 3
Earthquake analysis earthquake response
(NS direction)

- As for the reactor building of Unit 3. the parts above the operating floor on the 5th floor was destroyed by the event what is believed to be hydrogen explosion occurred on March 14, 2011. The situation of most parts of the building above 5th floor is that steel beam and concrete member which were collapsed after explosion were piled up. The northwestern part of 5th floor was damaged. Parts of collapsed steel beam and concrete member were piled up on the 4th floor. Most of 4th floor's walls were damaged. Reflecting these information to the model of mass point system, we conducted the analyses of time history response against design basis ground motion "Ss", and decided to evaluate totally whether the seismic walls reach terminative condition of shear failure. Then, we implemented local evaluation including spent fuel pool by 3 dimension FEM analysis using the maximum earthquake load which has been obtained from the time historical response analysis and other load such as temperature load (Fig 1).

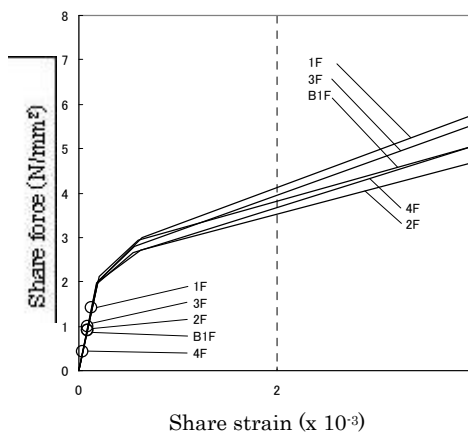
Fig 2. Maximum response values on the
shear skeleton curve
(Unit 3, Ss-2, NS direction)

- As a result of the time history response analysis with mass point system against design basis ground motion, shear strain occurred on remaining seismic wall below 5th floor was estimated 0.14×10^{-3} (Ss-2, NS direction, 1st floor) at maximum and the figure falls much below the criteria, 4.0×10^{-3} . Therefore we evaluate that the reactor building has adequate structural integrity (Fig2).

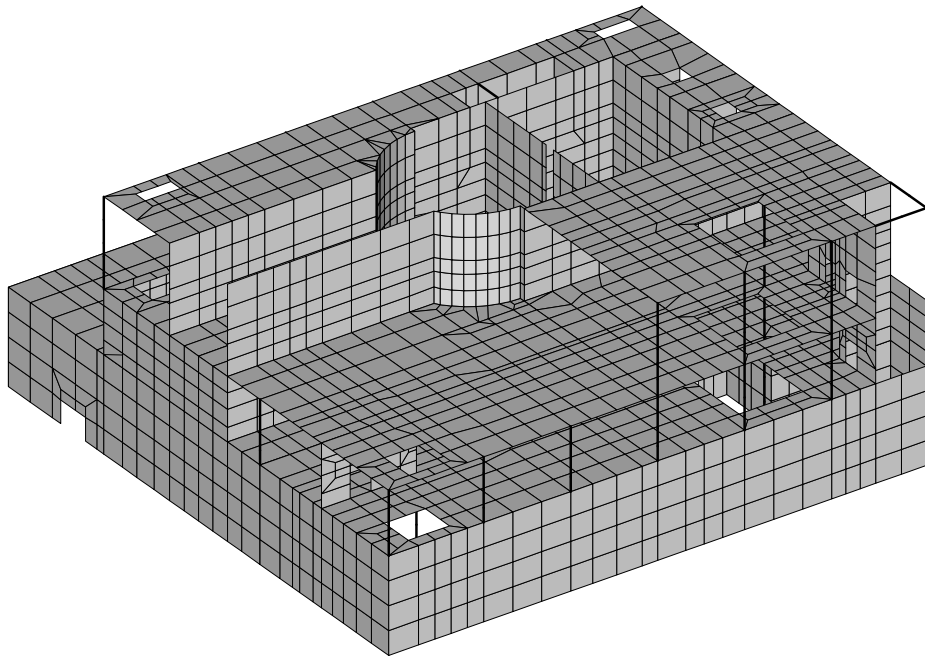
Fig 3 Local evaluation model by 3 dimension FEM (Unit 3)

- As a result of seismic safety evaluation by 3 dimension FEM analysis (Fig 3), combining with earthquake load occurred by design basis ground motion Ss and other load, the maximum strain of rebar is 1303×10^{-6} , therefore we evaluate it has an adequate margin against 5000×10^{-6} the plastic limit strain. And regarding out-of-plane shear force at the minimum part was 1689 (N/mm) against the criteria, 3130 (N/mm). , therefore we estimate the SFP has the adequate structural integrity.
