Outline of "Reports about the study regarding current seismic safety and reinforcement of reactor buildings at Fukushima Daiichi Nuclear Power Station (3)"

August 26, 2011  
Tokyo Electric Power Company

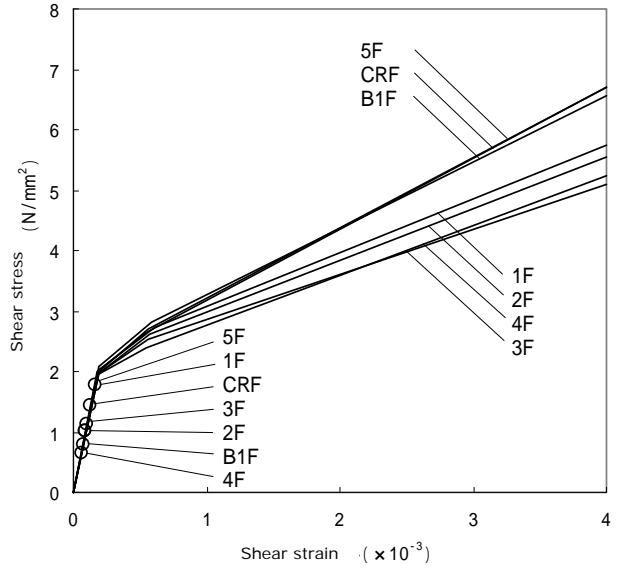
Fig.2 Maximum response value on shear skeleton curve (Unit 2, Ss-1, E-W direction)

- Time transient response analysis using design basis earthquake ground motion (Ss) was used for the back-check of seismic safety. As a result, shear strain occurred in anti-earthquake walls was estimated at maximum  $0.17 \times 10^{-3}$  (Ss-1, E-W direction, 5th floor) that was far below the standard value  $4 \times 10^{-3}$ . Thus it was evaluated that the building had enough safety.

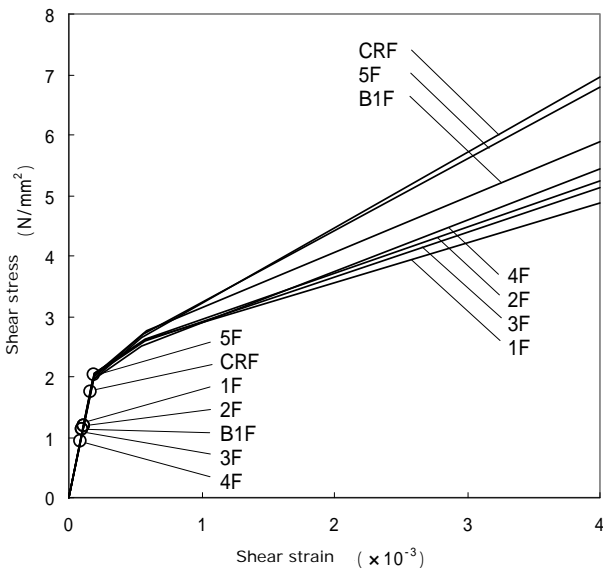
Fig.3 Maximum response value on shear skeleton curve (Unit 5, Ss-1, E-W direction)

- Time transient response analysis using design basis earthquake ground motion ( $S_s$ ) was used for the back-check of seismic safety. As a result, shear strain occurred in anti-earthquake walls of Unit 5 was estimated at maximum  $0.19 \times 10^{-3}$  ( $S_s-1$ , E-W direction, 5th floor) and shear strain occurred in anti-earthquake walls of Unit 6 was estimated at maximum  $0.33 \times 10^{-3}$  ( $S_s-1$ , N-S direction, 2nd floor). Those values were far below the standard value  $4 \times 10^{-3}$ . Thus it was evaluated that the building had enough safety.
